# Operation Phase Problems of Prefabricated Residential Buildings with Integrated Autoclaved Aerated Concrete Panel Walls

**Abstract:** Growing technical problems with the maintenance of precast concrete housing stock result in the search for efficient repair methods. The paper analyses the effects of flaws in the design concept and assembly accuracy of integrated AAC (autoclaved aerated concrete) panel walls, type GWO (Gazobetonowa Wielka Płyta Osłonowa which means large cover panel from aerated concrete in English), used as curtain walls in a system of precast concrete housing blocks erected in Lublin. The results of in-situ observations and laboratory tests of the panel walls have been described, and the opinion on the further use of these elements has been presented. As for the analysed case, there is no possibility of replacing damaged elements, thus, additional reinforcement with steel tendons has been proposed as a repair measure.

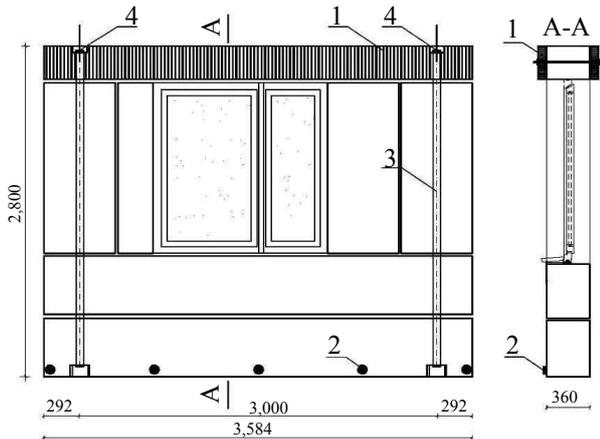
The next stage of the research was to measure the vertical displacement of selected panels and determine the deflection on the steel supports at probationary load. The scheme of the load method is shown in Fig. 3.

- 1—test load 100 kg/m
- 2—strain clock gauges
- 3—tie rods in the panel
- 4—strain clock gauges in the point of suspension

Fig. 3 Scheme of GWO plate load, external view (units in mm).

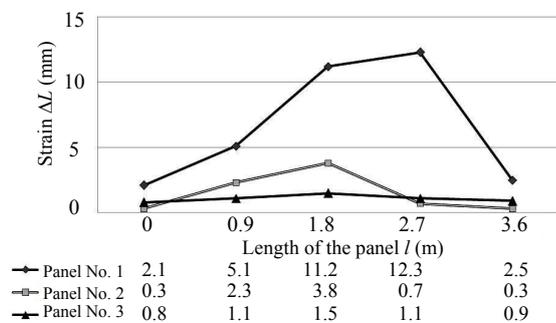
Deformation measured by the clock strain gauge in the bottom part of plates (Fig. 4) showed a large variation in the length of the plates, from 1 mm to 12 mm. However, steel brackets strain measurements were small and ranged from 1 mm to 2 mm.

Fig. 4 Sample strain of GWO plate after additional load  $q = 100 \text{ kg/m}$  in bottom of the panel.

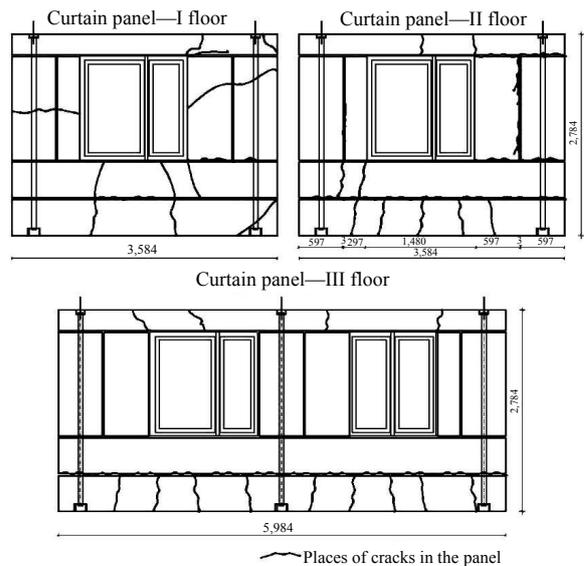
The main task of building research was to determine the causes of cracks in slabs. The conducted survey showed that about 20% of the panels in all tested buildings have this type of damage. Scratches and cracks most frequently occur in lintel stripes above the window openings and in the lower stripes of panel. Other kinds of panels damage were visible in the joints connecting the stripes made of autoclaved aerated concrete. The phenomenon of connections delamination most frequently occurred in the horizontal and vertical directions of pillars between windows. The instances of panels damage are shown in Fig. 5.

Fig. 5 Delamination in the joints and cracks in the panel stripes at various floors of building (units in mm).

Significant defects observed in the buildings included cracks in individual GWO panels which can be divided into:

- defects caused by deformation of steel in bars—tie rods;
- damage resulting from improper assembly;
- deformation caused by temperature;
- damage caused by transport and improper storage on site.

readings unacceptable, load transfer from top panel to bottom was observed. There was more damage in the joints of stripes and in individual elements in panels on the lower floors. Geodetic measurements of the verticality of the suspended panels constitute another study that confirmed irregularities of assembly. The lack of verticality of many panels was observed and the differences between the upper and lower measurement of panels with the height of 2.80 m amounted to 35 mm. Therefore, the eccentric and wrong stability of some curtain panels appeared. In addition, the assessment of the technical condition of steel components in terms of corrosion, which showed good condition of hangers and galvanized rods, was also performed.

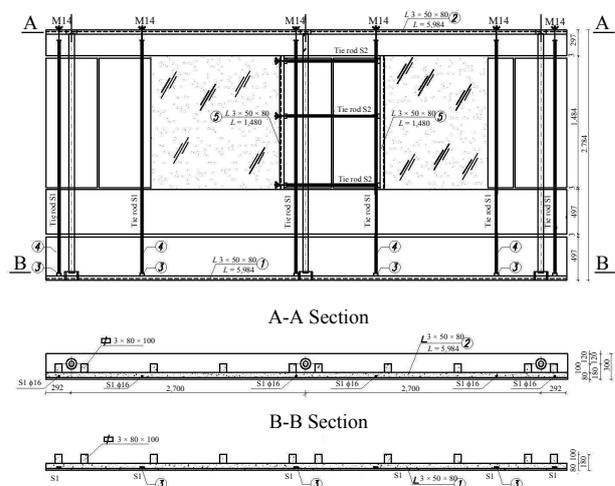
Fig. 6 Strengthening of pillar between windows and GWO curtain panel (units in mm).

In the case of specificities and continuous operation of the building, it is not possible to replace damaged, cracked panels. Thus, to prevent the demonstrated mechanism of panels destruction, it was resolved to reduce the concentration of compressive stresses, transmitted from the top plate to the bottom by strengthening and safeguarding individual plates with additional steel tie rods, which is shown in Figs. 6 and 7.

Moreover, pillars between windows were strengthened in the similar way (Fig. 6). The joints between the panels were cleaned and filled with plastic putty. Firstly, the vertical tie rods S1 should be made, and secondly, the pillar between windows should be supported by using tie rods S2.

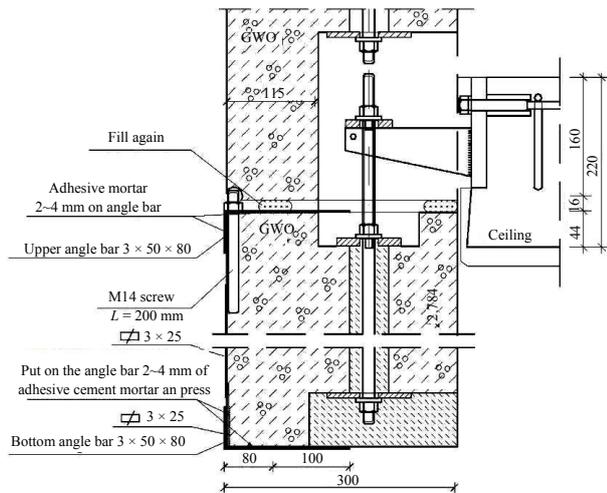
**Fig. 7 The detail of GWO panel suspension on the bracket with strengthening (vertical section, units in mm).**

the upper and lower angle bars of  $3 \times 50 \times 80$  mm connected through flat bars of  $3 \times 25$  mm, twisted by the use of M14 screws. In order to angle bars, steel paws of  $3 \times 80 \times 100$  mm were welded. In the site of flat bars, external plaster should be gently forged to a thickness of 4~5 mm.

The cross section of vertical tie rod is presented in Fig. 7.
