Strengthening and Restoration of Historical Structures— Mirahor Ilyas Beg Mosque in Korça*

The Mirahor Ilyas Beg Mosque, built in 1496 in Korça, is one of a few Ottoman mosques still existing in Albania and the only Ottoman monument in the city. The mosque was built using cut stone and brick. It has a strong image; a cubic mass rising over a square plan. Inside there are found pictures of the mosque in the past and different famous mosques. During its existence, it was damaged from many earthquakes occurring at this area. Due to amortization, the mosque's structural properties were weakened and architectural values were dimmed. Proper strengthening methods need to be applied, not only to improve structural conditions, but also to preserve architectural features of the mosque. In this paper assessment of existing conditions of the structure is carried out. Based on the obtained results, solutions for the structural problems are investigated. As for restoration, the repair methods to be applied were examined taking into consideration at what extent the historical values of the building will be preserved. The proposed strengthening methods are the ones which would affect the least th

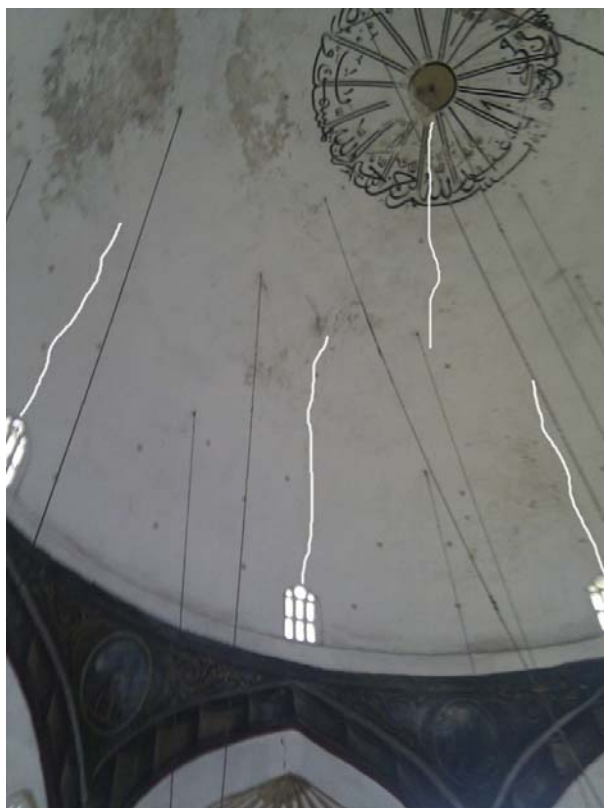
Dome structural conditions seem adequate to carry static load. However, structural cracks are seen throughout it. Improper connection of the lanterns hanged at the top of the ceiling after the dome was built, has caused extra distresses at the very top causing cracks around it. Other structural cracks may have been caused by earthquake loads. Improper isolation system of the roof has caused moisture problems and spall of plaster (see Figure 4).

The pendentives and arches suffer from the same problems. Thrust coming from these loads has exceeded

the pendentive load carrying capacity. Propagation of these cracks is seen until the bottom of the load bearing walls. Due to inadequate isolation, spall of plaster is seen too.

Figure 4. Cracks on the dome and spall of plaster.

The dome is of a high importance. It encloses the maximum volume with a minimum of surface area and distributes loads to support through a doubly curved plane. Dome is to be designed to resist compressive and circumferential tensile stresses. For this reason it should be strengthened using FRP laminates along its surface.

Moreover, external and internal steel plate rings should be tied at the bottom of the dome (see Figure 8). The same procedure was applied in the leaning tower of Pisa. Pre-stressing rings were placed all along the tower.

It is suggested that the layer of lead is removed, the roof to be properly isolated and then leaden cap to be put back in place.

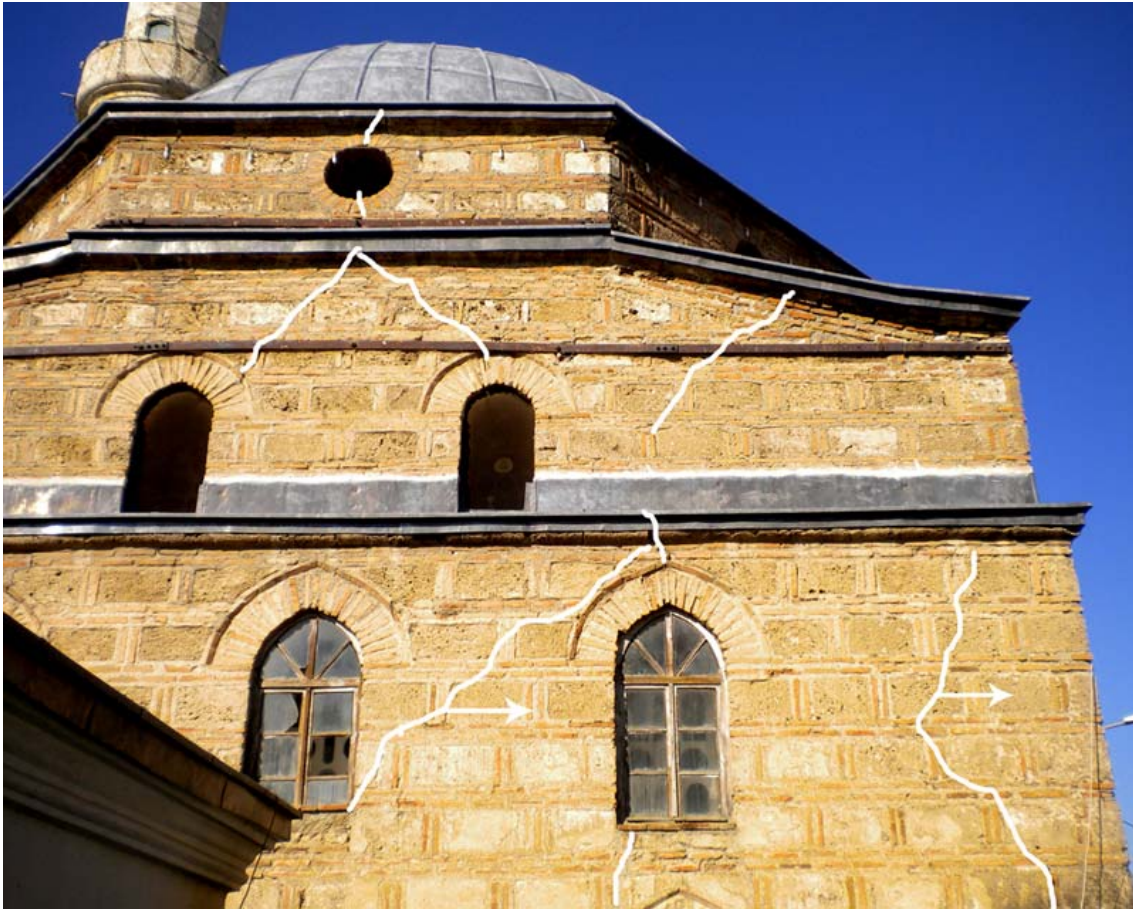
In the load bearing walls, there have been observed serious structural cracks. The causes of those cracks are excessive stress concentrations such as: compressive stress caused by vertical load (static); shear stress caused by lateral load (earthquake); and propagation of cracks due to successive earthquakes and amortization during centuries.

Propagation of structural cracks from the pendentives to the bottom of the wall is observed in some places. Spall of plaster due to improper isolation is seen.

In load bearing walls containing openings, a different crack pattern is observed. As the maximum stresses are located at the edges of these openings, every window is cracked at the bottom corners of its frame. The cracks propagate diagonally from top windows to the lower windows in the same way. It is very dangerous for the stability of the wall (see Figure 5).

Figure 5. Cracks on the load bearing walls in the south facade of the mosque.

Structural cracks wider than 10 mm should be repaired using longitudinal FRP bars (see Figure 7). This technique would provide the load bearing walls with better resistance against tensile stresses, higher shear capacity and more ductility.

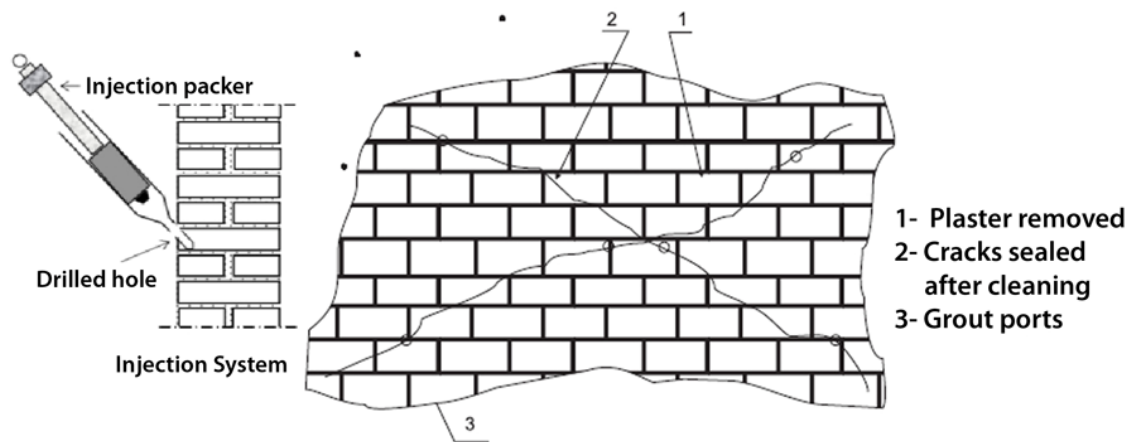
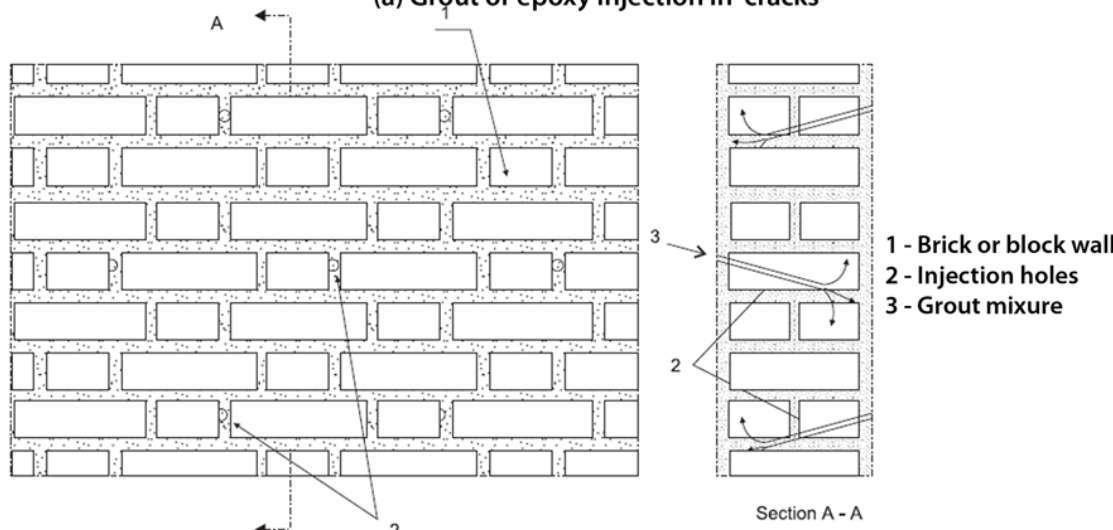
Figure 6. Strengthening by grout or epoxy injection in (a) cracks (b) weak walls.

The proposed strengthening methods aim to preserve the mosque's architectural and historical values. Non-structural cracks less than 10 mm should be filled with lime mortar injection (see Figure 6). These cracks will be sealed preventing water from penetrating inside of the wall and damaging plaster. This procedure leaves no trace as it is applied inside the wall. Thus, it has no effect on architectural features of the mosque. It is widely used in restoration projects for historical constructions (e.g., Outeiro Church, Portugal).

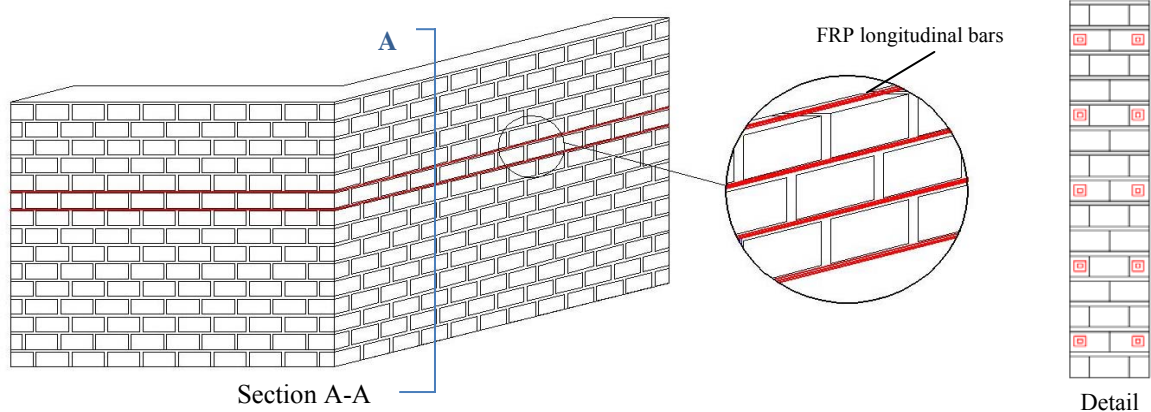
Figure7. FRP reinforcement in the load bearing wall.

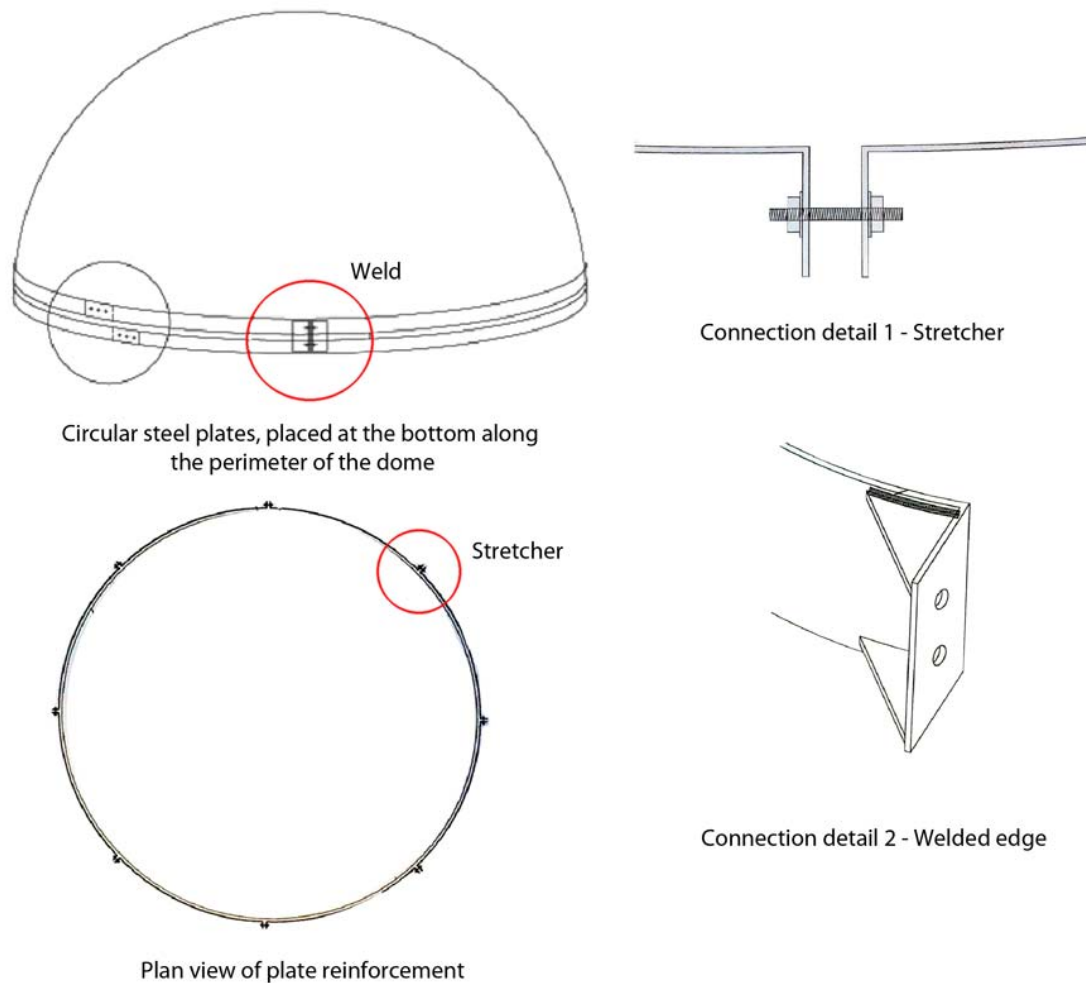
Figure 8. Strengthening with internal and external rings.

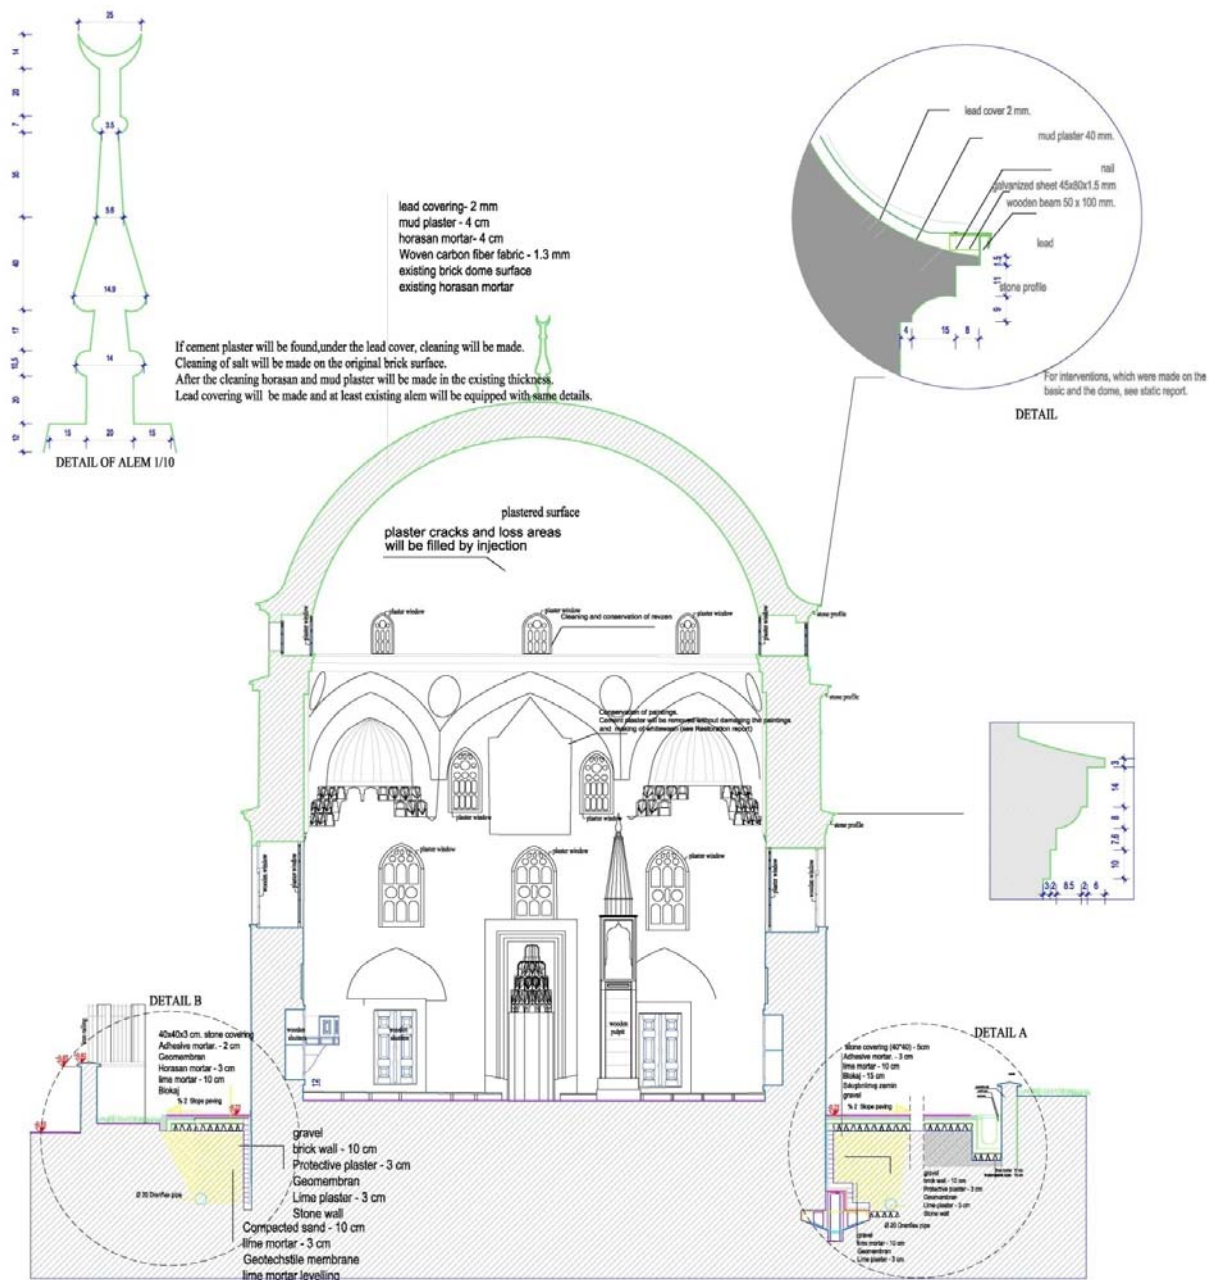
Figure 9. Proposed interventions.

Humidity problems would be solved by creating a new ground water drainage system. It would cover the entire perimeter of the mosque, and would remove all surface and excess water away from the mosque (see Figure 9). Even though the leaden cap of the roof was recently replaced (in 2008), water leakage is seen in the dome which has caused spall of plaster and damage of paint and calligraphic ornaments on it.

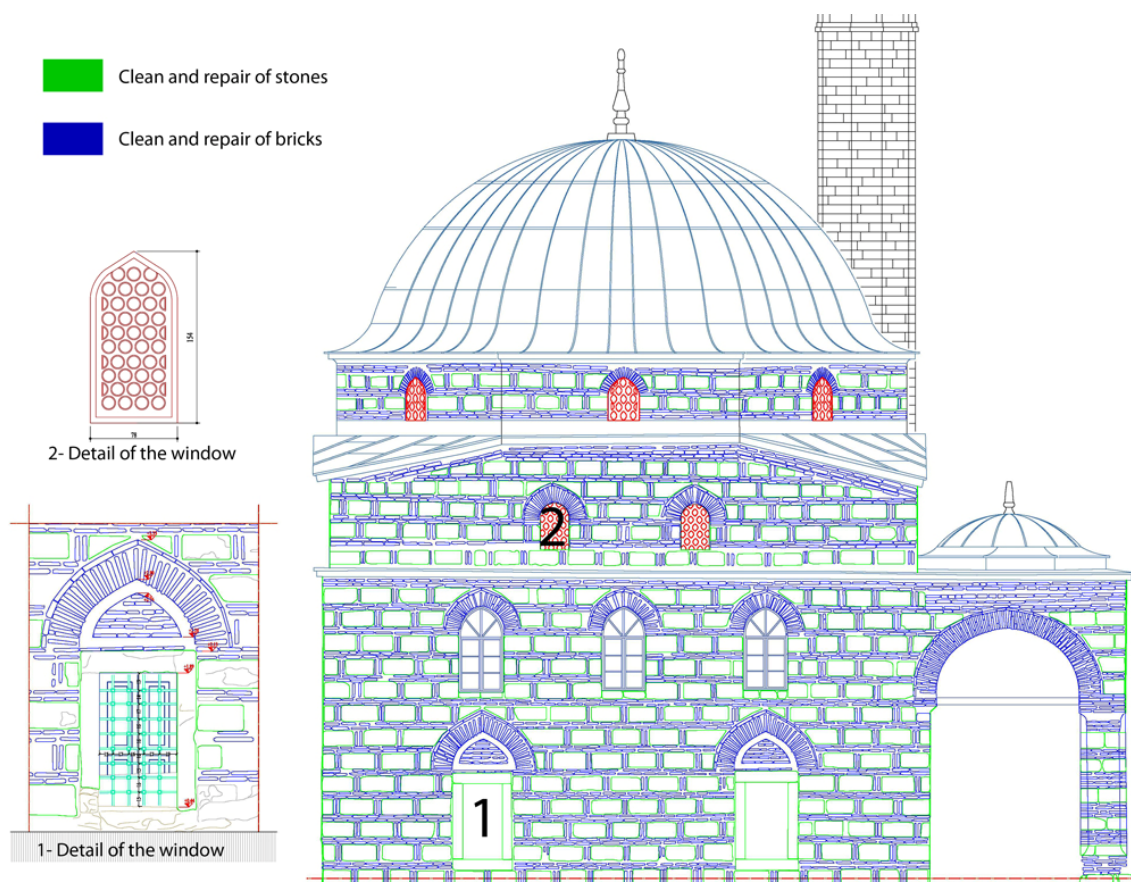
Figure 10. Proposed interventions.

Missing stones in the main facades will be replaced with new ones which would be prepared using the powder of the original stone bonded with hydraulic lime repairing mortar. It will be completed in accordance with original details. Earlier interventions made to repair the stones by cement added mortar will be removed without damaging the original material (see Figure 10).
