# Characteristics of Tsunami Damage to the Tide Walls in Iwate Prefecture from the Great East Japan Earthquake

Tetsuya Oyamada, Shunsuke Hanehara, Hideaki Deto and Shoji Iwasaki

*Department of Civil and Environmental Engineering, Iwate University, Iwate 0208551, Japan*

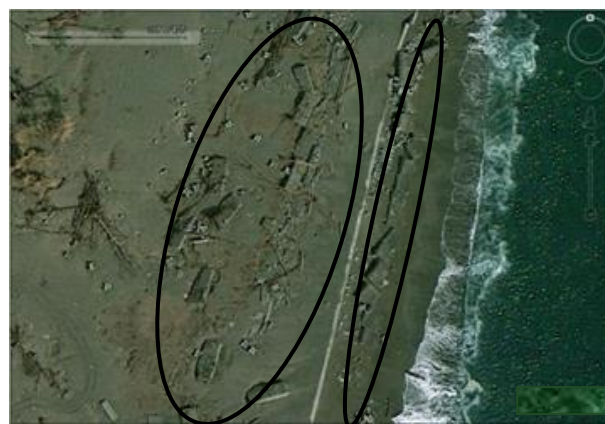
Fig. 3 shows an aerial photograph of the severely damaged Tofugaura Coast area (No. 1). The slightly inclined vertical white line falling a little to the right of the photograph's center indicates that a concrete foundation and concrete superstructures are scattered on both the sea and land sides. A section of the damaged tide wall is shown in Fig. 4. There is sea sand inside the wall's structure. Fig. 5 shows the collapsed tide wall. In this area, the sea side slope, or the front side slope, of the tide wall has collapsed toward the sea, the concrete blocks which protected the back slope have fallen towards the land side, and the infill sand has flowed out. This damage suggests that spilling waves first knocked down the concrete blocks and scoured the infill sand, and the backrush then caused the front slope to fall down.

Fig. 3 Aerial photograph of Tofugaura Coast (No. 1).

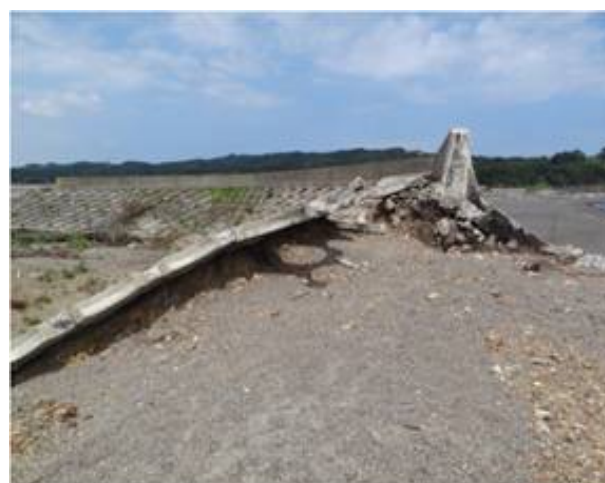
Fig. 4 Section of tide wall (No. 1).

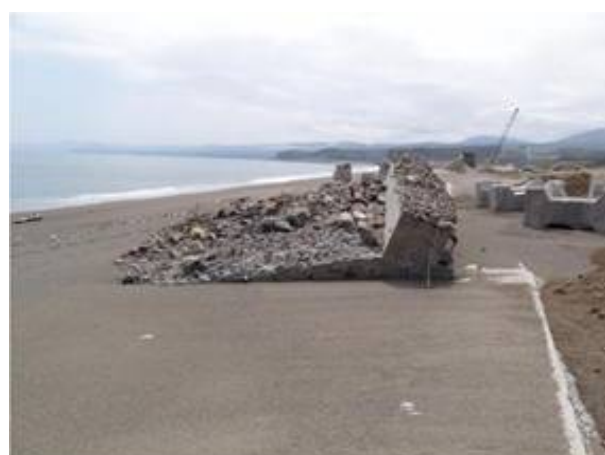
Fig. 5 Collapsed tide wall (No. 1).

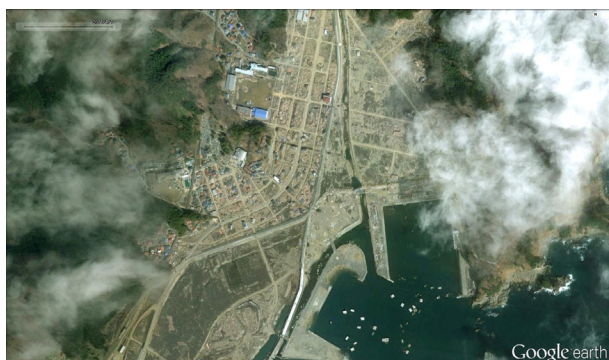
Fig. 6 shows an aerial photograph of the coast at Taro Fishery Port (No. 2). In this area, two tide walls intersect at their centers to form an X shape. The tsunami overflowed both of them and damaged the shore side tide walls. The southern parts of the tide walls had the surface of the back slopes torn off and the infill sand washed out, as shown in Fig. 7. In contrast, their northern parts suffered from more devastating damage. Fig. 8 shows the damage to the northern part photographed from the sea side. The

**Fig. 6** Aerial photograph of coast at taro fishery port (No. 2).

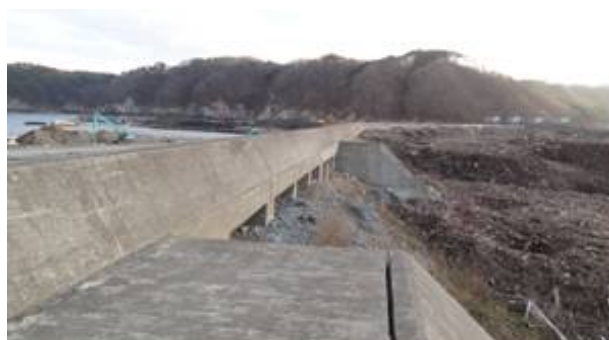
**Fig. 7** Damaged tide wall (south side) (No. 2).

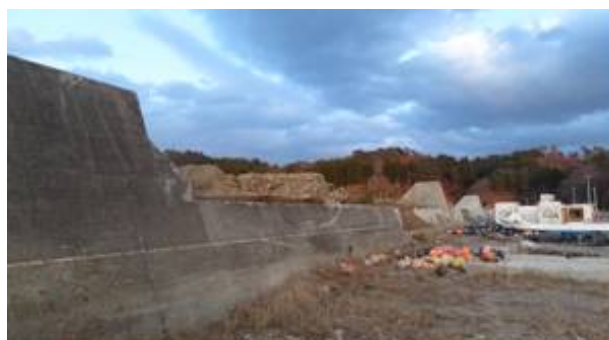
**Fig. 8** Damaged tide wall (north side) (No. 2).

concrete blocks of the front side slope have been knocked down and the infill sand washed out. Only the concrete which supported the front slope remains.

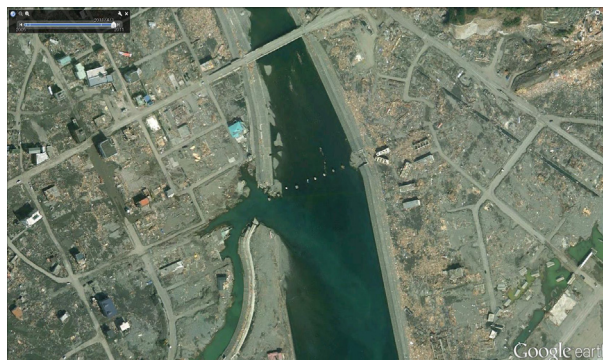
Fig. 9 shows an aerial photograph of the Otsuchi River (No. 6) bank after damage by the tsunami. It can be seen that the river bank has been broken and the rear side of the bank flooded with overflowed water. The back slope of the damaged river bank is shown in Fig. 10. Similar to the other cases described above, the concrete blocks of the river banks have slipped off, as shown in Fig. 11, and pools of water can be identified.

**Fig. 9** Aerial photograph of Otsuchi River Bank (No. 6).

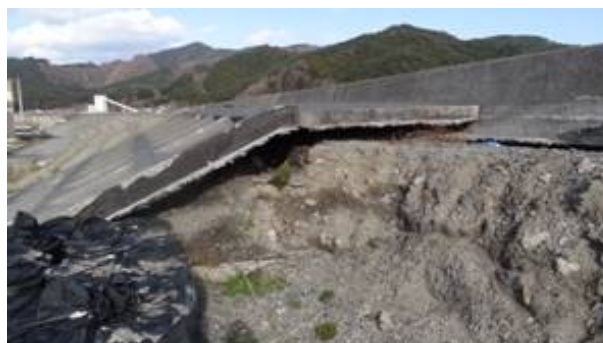
**Fig. 10** Damage to tide wall (No. 6).

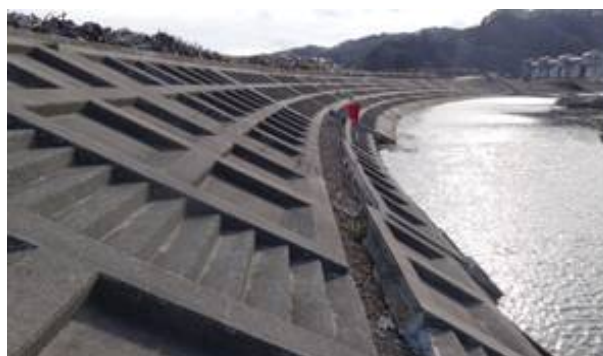
**Fig. 11** Slipped off tide wall (No. 6).

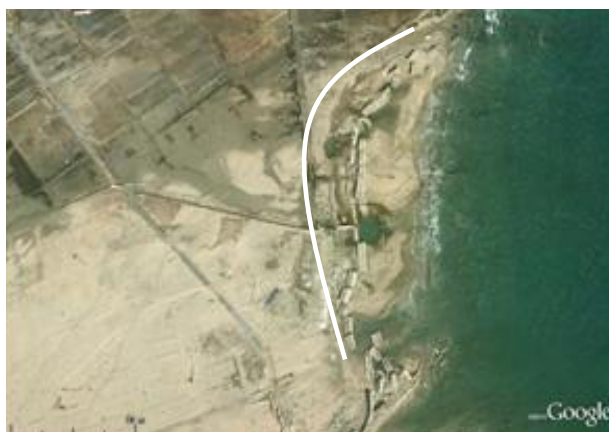
Fig. 12 shows an aerial photograph of the coast at Yoshihama Agricultural Field (No. 8) after the tsunami. The white line in the photograph indicates the location of the tide wall before the disaster, its total

**Fig. 12** Aerial photograph of coast at Yoshihama agricultural field (No. 8).

length being around 0.6 km. The wall collapsed toward the sea side along its entire length. The seaward collapse of the main body of the wall can be seen in Fig. 13.

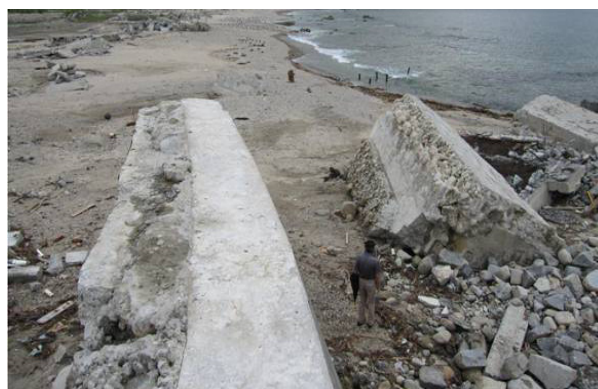
**Fig. 13** Damage to tide wall (No. 8).

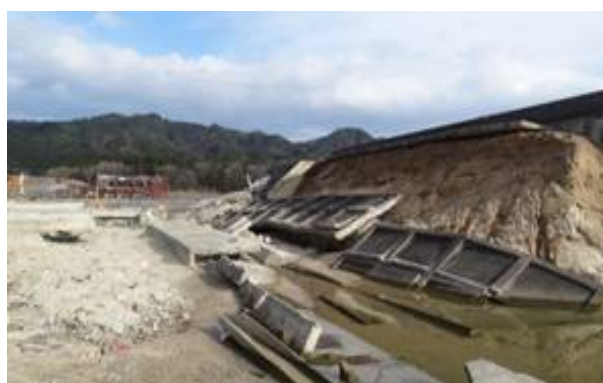
The tide wall on the Koyadori Coast (No. 4) also had the back slope torn off and the infill sand washed out, as shown in Fig. 14. The damage to the front slope of the wall is shown in Fig. 15. Judging from these observations, the backrush is believed to be the reason for the seaward collapse of the tide wall.

**Fig. 14** Slipped off tide wall (No. 4).

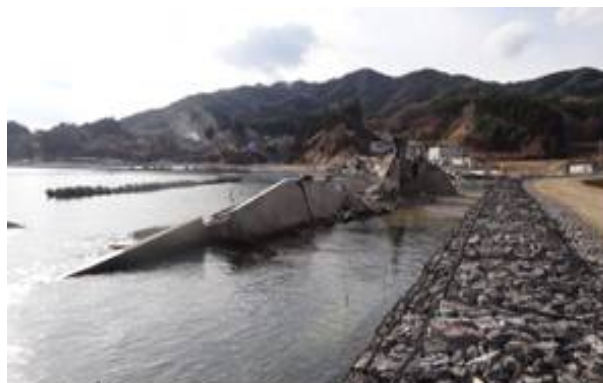
**Fig. 15** Damage to tide wall (No. 4).

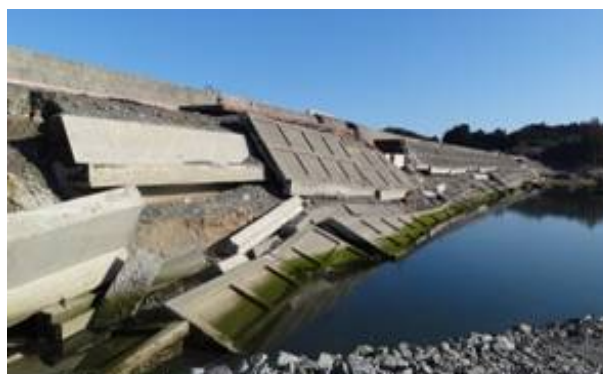
In the case of the tide wall on the Mutsugahama Coast (No. 10), the back slope slid down and the infill sand was washed out, as shown in Fig. 16. The damage to the front slope of the same tide wall is shown in Fig. 17. The concrete blocks were bent at around the center in a vertical direction but no displacement of the wall was observed. This situation suggests that a preceding scouring of the infill sand lessened the support of the concrete blocks.

**Fig. 16** Slipped off tide wall (No. 10).

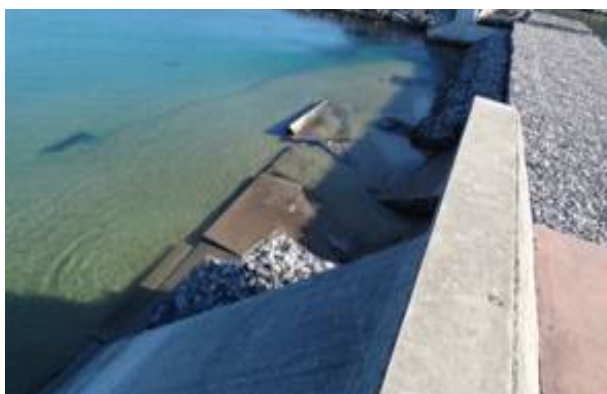
**Fig. 17** Damage to tide wall (No. 10).

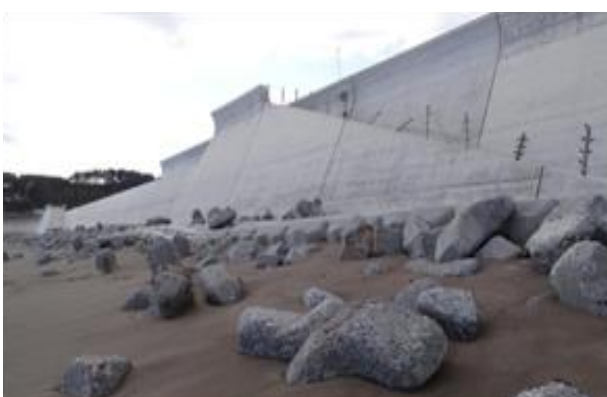
On the Tofugaura Coast (No. 1) located next to the Mutsugahama Coast, a vertical type tide wall had been constructed. The back slope of the wall was lost and part of the infill sand washed out, but the tide wall itself was saved from collapse, as shown in Fig. 18. This wall is known to have been constructed at a different time from the other structures. The foundations of this seawall take root in the bedrock.

**Fig. 18** Tide wall which did not collapse (No. 1).

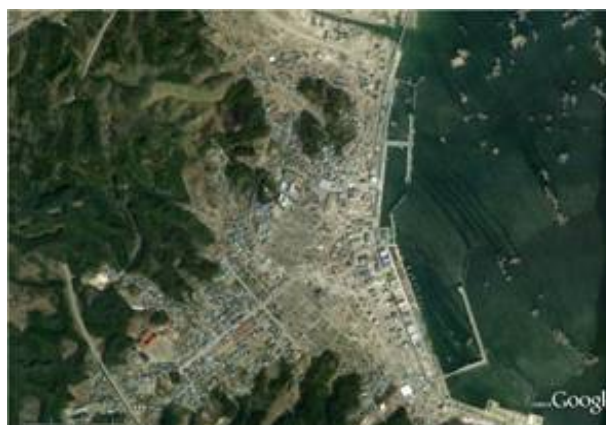
Fig. 19 shows an aerial photograph of the coast at Yamada Fishery Port (No. 3) after the disaster. In this area, a self-standing tide wall had been constructed, with a total length of 1.3 km. A large part of the tide wall remains nearly unaffected by the tsunami, except for a severely damaged section of length 0.2 km. In the damaged section, some segments fell down from their bases and others had their parapets torn off, with detritus scattered on the land side, as shown in Fig. 20. This indicates that the section collapsed because of spilling waves. It can also be seen in the photograph that there are pools of water on the rear side of the original position of the damaged section, which suggests that overflowing and scouring caused the

**Fig. 19** Aerial photograph of coast at Yamada Fishery Port (No. 3).

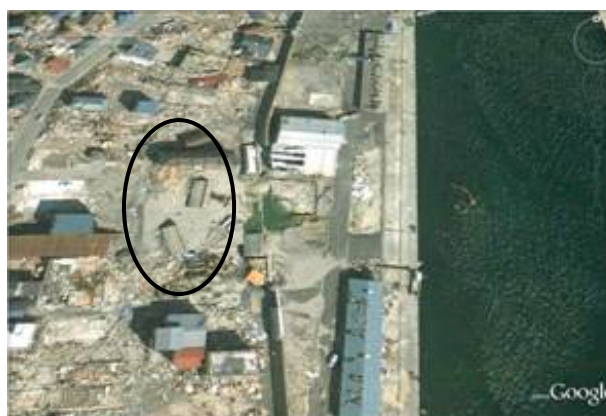
**Fig. 20** Damaged tide wall (No. 3).

damage. This idea is supported by the fact that no water was discovered on the rear side of the unaffected section. Because urgent restoration work was in progress when we visited the site and the damaged section was protected by sandbags, we could not confirm the damage that had occurred.

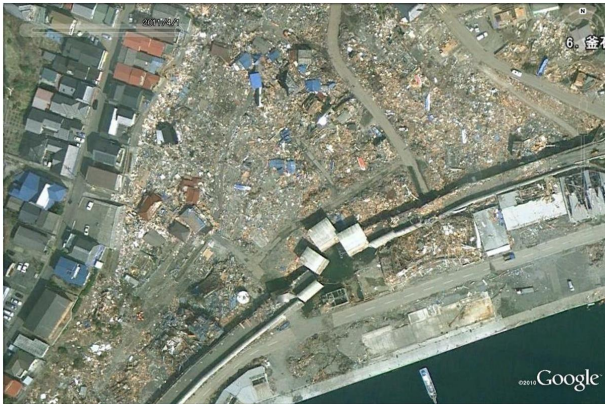
Fig. 21 shows an aerial photograph of the coast at Kojirahama Fishery Port (No. 7) after the disaster. The total length of the tide wall in this area is 0.6 km. The four rectangular blocks in the center of the photograph indicate the location of the damaged section of the wall and the block positions show that the tide wall collapsed or leaned over toward the land side. The damage is shown in Fig. 22. The soil at the rear side of the collapsed tide wall has largely been scoured and pools of water can be observed. Here again, the scouring is believed to be the reason for the collapse.

Fig. 21 Aerial photograph of coast at Kojirahama Fishery Port (No. 7).

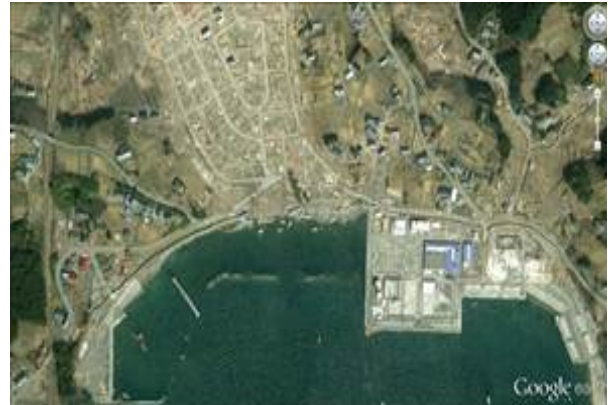
Fig. 23 Aerial photograph of coast at Kadonohama fishery port (No. 9).

An aerial photograph of the coast at Kadonohama Fishery Port Coast (No. 9) after the disaster is shown in Fig. 23. The damage in this area is shown in Fig. 24. The damaged section of the tide wall collapsed toward the sea side. The wall at the front of the photograph shows seaward collapse and that at the back indicates landward collapse with drifting toward the sea occurring. Some traces of scouring can be seen on the rear side of the tide wall in other sections saved from collapse, as shown in Fig. 25. The main reason for the scouring is contributed to the overflow by the tsunami, with the situation being the same in the collapsed section.

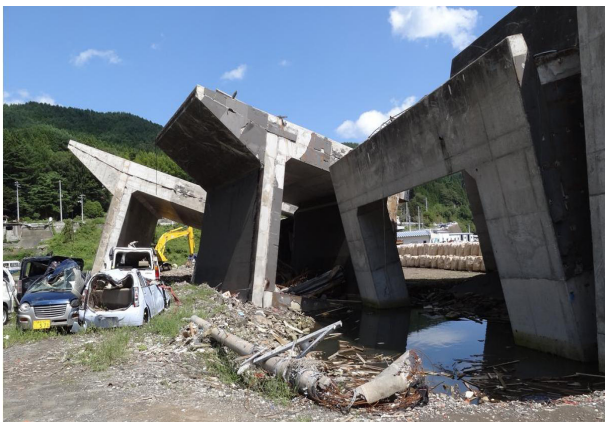
Fig. 22 Damage to tide wall (No. 7).

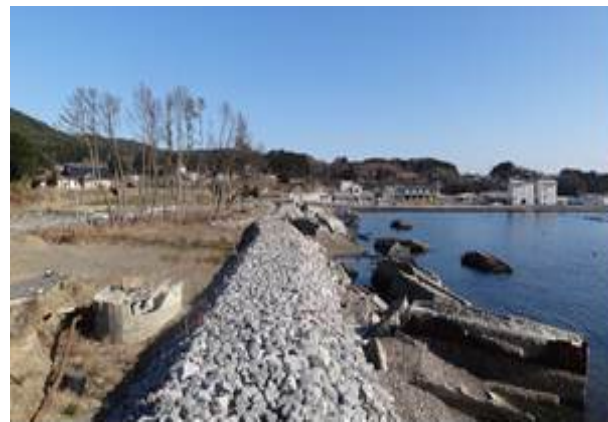
Fig. 24 Damage to tide wall (No. 9).

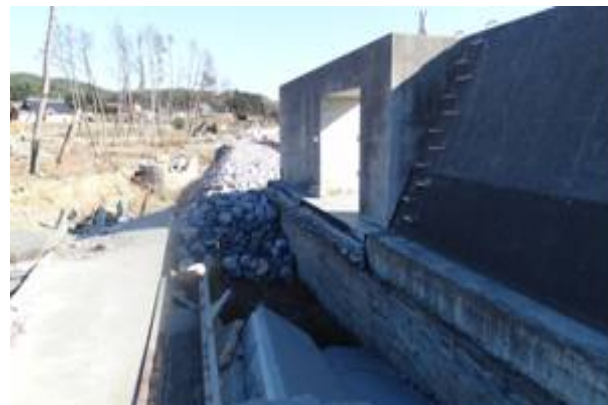
Fig. 25 Rear side of the tide wall at no damage section (No. 9).
