# Evaluation of Reinforced Concrete Structures with Views for Rehabilitation

**Abstract:** The increasing number of pathological occurrences is found in reinforced concrete structures, so does the demand for inspection and maintenance services in residential communities in the state of Pernambuco, which aim to detect damage to the structure in a timely manner to minimize repair costs, thus applying preventive maintenance in order to guarantee the estimated useful life of the project for the building. However, it is observed that the practice of periodic inspections is not yet part of the culture of a certain segment of the population that does not have economic means and knowledge of the importance of maintenance to ensure the integrity of the structure. It was used in this work an inspection script with use of tests and methodology to quantify damage and to check the state of degradation of two residential buildings with more than 20 years and built near the seafront where environmental aggression is strong. The deterioration found in each of the buildings has been differentiated due to different corrective maintenance performed at every building. The last maintenance, performed

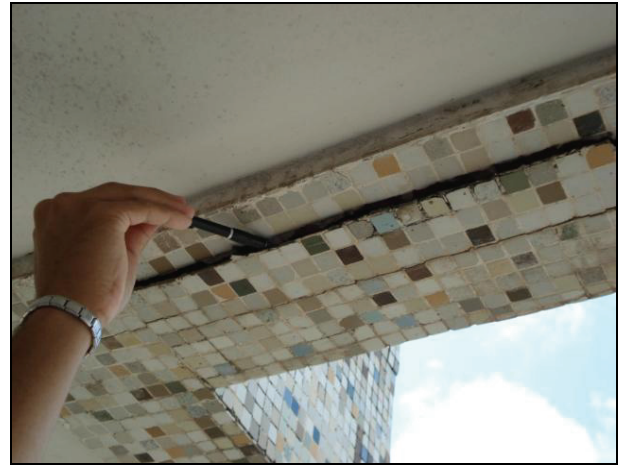
In Building A, on visual inspection (Fig. 1), we observed detachment of the tablets on the facade, some cracks in the pavement edge beams at the level of infiltration stilts and the ceiling slab from the sanitary system facilities. Condo information was found that there were attempts to fix the leaks, but they did not succeed. Buildings regarding maintenance and condominium realize that information is held whenever it is necessary and possible financially to the tenants.

Fig. 1 Fissure in the edge beam of Building A.

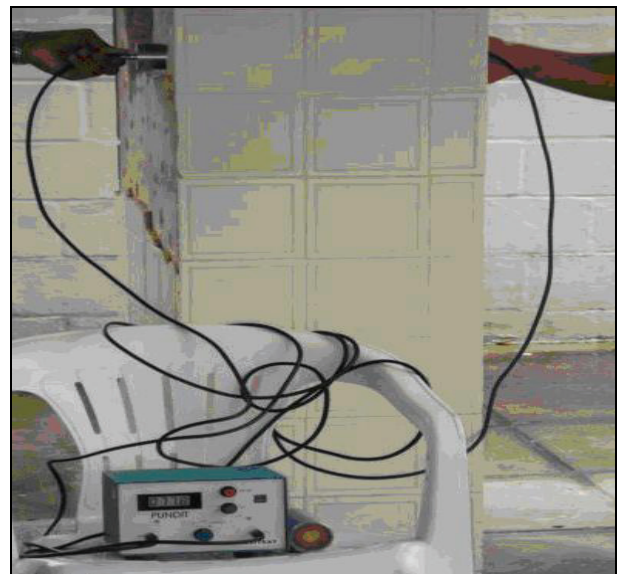
Despite the observed variation in the results obtained in this test (Fig. 2), the concrete quality is considered good according to the classification of Ref. [9].

Fig. 2 Test speed of the ultrasonic pulse on Column P1 of Building A.

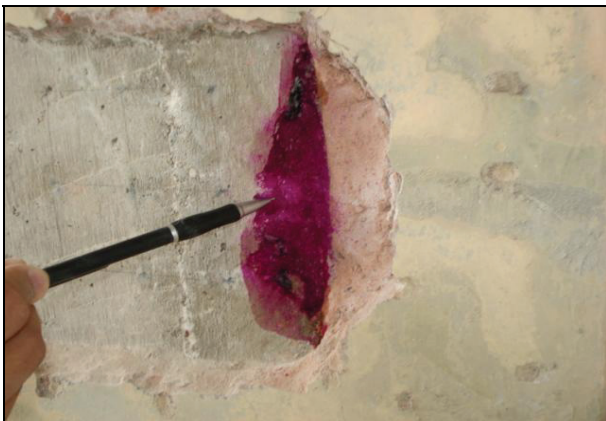
The carbonation depth found in the tested columns of the building (Fig. 3) was small, compared with the result of the two buildings. Table 3 gives the depth of carbonation columns of Building A.

Fig. 3 Carbonation depth test of Column P20 of Building A.

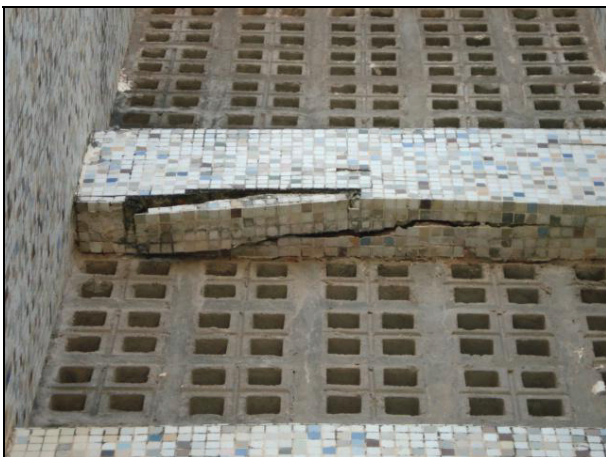
Fig. 4 Detachment of reinforced concrete beam of Building A.

Despite showing damage in just two beams, it can be seen in Fig. 4 that intensity damages were considerably high, since equipment corrosion was observed (Table 5).

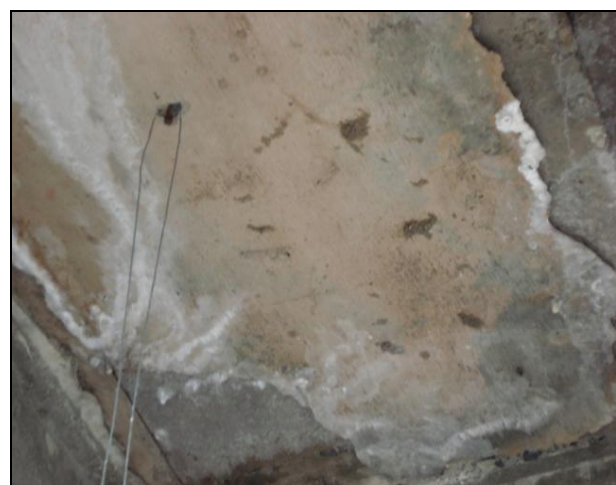
As shown in Table 6, the damages found in slabs (Figs. 5 and 6) were punctual but in an advanced state.

Fig. 5 Efflorescence on slab of Building A.

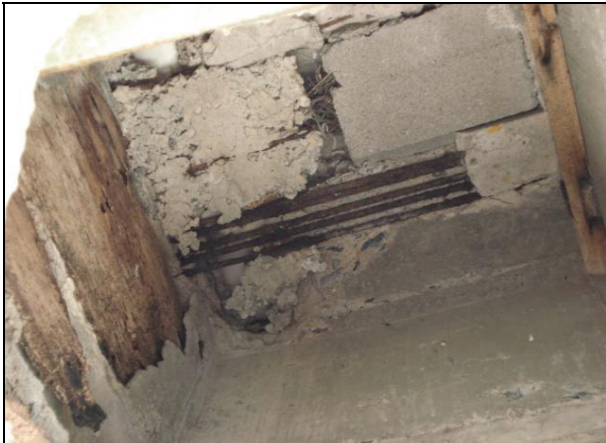
Fig. 6 Corrosion of slab reinforcement of Building A.

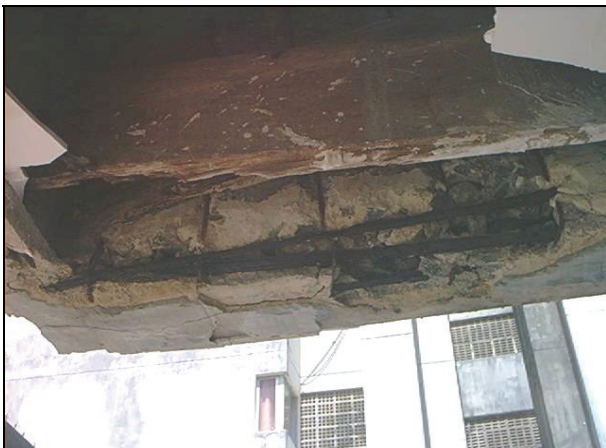
Fig. 7 Beam reinforcement corrosion with section loss in Building B.

Through visual inspection (Fig. 7), some conditions were observed in Building B that require immediate interventions, in order to minimize damage to the stability of the building. Infiltrations on stilts ceiling

slab come from sanitary system facilities, corrosion of reinforcement comes in slabs, columns and beams in some cases at an advanced stage. There is also detachment of ceramic plates on the facade among other pathologies. It was also observed that the maintenance services and repairs are carried out improperly. It was found that part of the shareholders do not agree with the need for periodic maintenance.

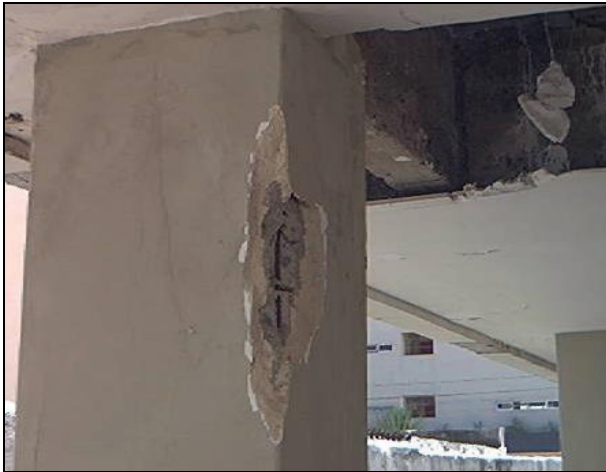
**Fig. 8 Detachment column due to reinforcement corrosion.**

at the time recommends coatings (least 1.5 cm) for reinforced concrete subjected to aggressive environments in Class III. And even with the recommended coatings, it can be seen that the carbonated thickness reaches the reinforcement (Fig. 8).

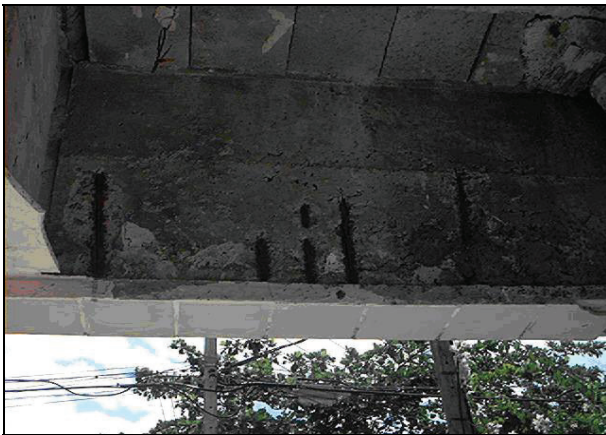
Table 12 shows the damages found in the beams of Building B (Fig. 9), where  $Gde_1$  and  $Gde_2$  are expressions used by Castro [3], Lopes [4] and Boldo [5], respectively.

**Fig. 9** Stirrup of the exposed beam, with corrosion, in Building B.
