Guy Structure with Galvanic Corrosion: Case Study

Abstract: Reinforcement bar corrosion depends heavily on environment and the processes used. This study will address galvanic corrosion. Based on a case study of galvanic corrosion in a guyed power transmission tower, experiments using a number of methods were made on a small sample of eight poles chosen for excavation and visual inspection, to assess the various resulting diagnoses. Method that provided the best results both in location and classification of the points was adopted, where corrosion had already begun, considering the concern of finding a non-evasive process. To diagnose the status of the poles inserted in rock, after applying the methods, the main types of corrosion affecting them were listed and classified. With the results, the possible means of preventing and maintaining the structure were presented.

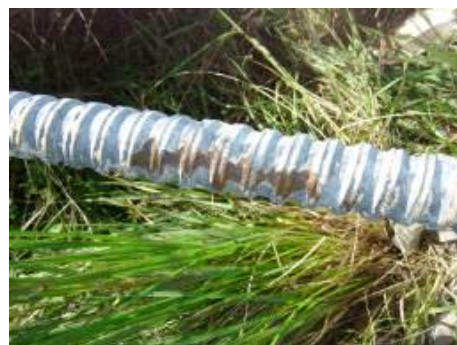
- corrosion by bacteria: a special situation occurring when chemical reactions of corrosion are produced, resulting from the high incidence of certain microorganisms;
- corrosion by leakage current: parasite currents created by systems of electrical traction or direct current transmission systems that cause corrosion by electrolysis from buried metal elements;
- galvanic corrosion: two underground metals considered as an electrolyte, operating as anode and cathode in the presence of an electrical current circulating between them, as shown in Fig. 5.

Fig. 5 Detail of failure in zinc protection and start of the corrosion process.

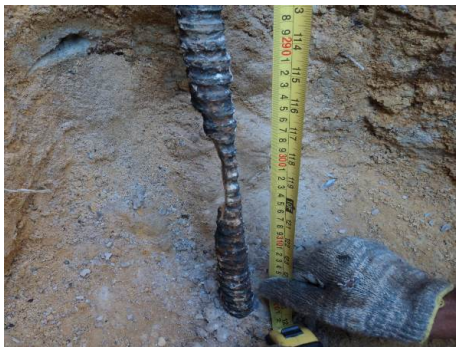
Fig. 6 Detail of severe local corrosion at the depth of occurrence.

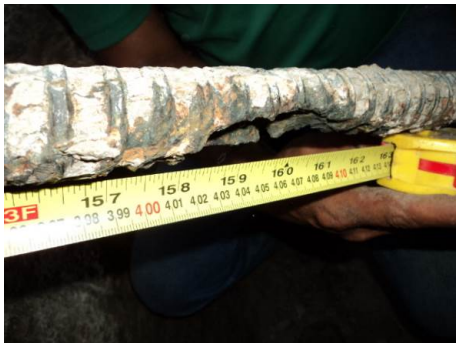
Fig. 7 Detail of severe corrosion caused by the galvanic cell at a considerable depth.

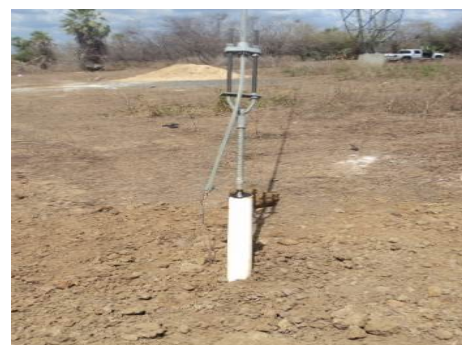
Fig. 8 Detail of the guy ready for the second assessment stage.

KV Sobral III~Fortaleza II-C2. Some poles tested in the first stage were retested. We will consider as an example the results obtained in the foundation anchor bar—that of Tower 62/2. Both the stretch above ground (outside and inside the PVC pipe) and the underground stretch, with their characteristics in relation to the dielectric are considered. The average velocity of the signal is 14~15 cm/ηs.
