# Van Earthquake's Effects on Mud-Brick Houses in Van and the Last Survived Buildings

Yasar Subasi Direk

**Abstract:** The city of Van is located to the Eastern Region of Turkey and has experienced two large earthquakes recently. Van earthquakes have caused big damages and demolitions in the city center, districts and in villages. As a result of precautions works have been realized to remove its effects shortly. However, it can be seen that the either urban or rural areas of the city carry the earthquake's traces. Damages that the earthquake left on the buildings formed the most apparent and standing ones of the traces. Mud-brick buildings are the primary of those damaged buildings both in the centre of Van and in villages. Especially roofs' collapsing and then walls' demolition for mud-brick houses which were abandoned, and therefore were not maintained properly for a long time, are quite familiar situations after the earthquake. However, inhabited and maintained houses have been survived sturdily by contrast of other houses with modern materials and they helped life to continue after the earthquake. In this study, mud-brick houses which were survived after earthquakes in Van an

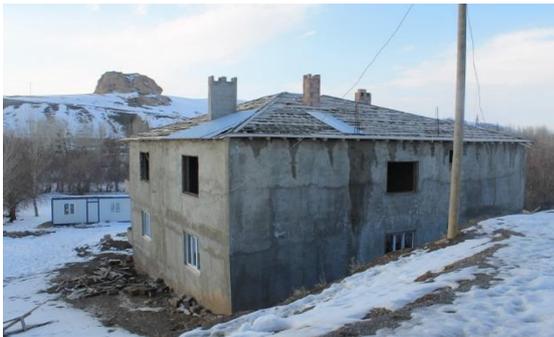
(2) It is watched that people prefer to use brick which is easier to supply rather than mud-brick in most of the villages (Fig. 8).

**Fig. 8** Usage of bricks instead of mud-bricks (Bağdaşan Village).

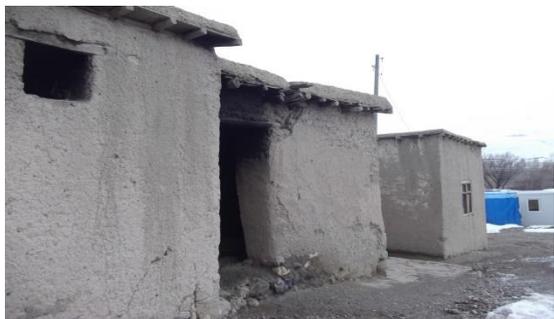
(4) With damages on the mud-brick structures after the earthquake, it is seen that most of the buildings are not used for a long time or used as barn or depot, without sub-basement and again, did not undergo maintenance for a long time (Fig. 9).

**Fig. 9** Mud-brick buildings whose sub-basement elevation is not enough (Adıgüzel Village).

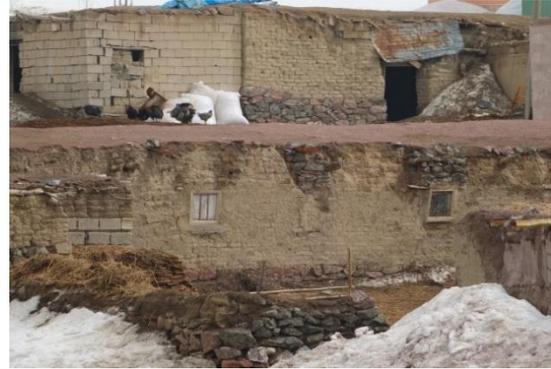
(5) Another reason of damages on the mud-brick structures has been the heavy and neglected roof covering (Fig. 10).

**Fig. 10** The damages caused by the heavy and neglected roof covering (Dibekli village).

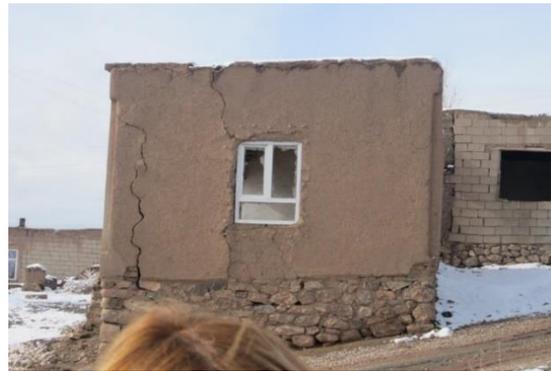
(6) Splits are seen in mud-brick buildings, especially in the edges and corners of doors and windows. These damages existed in the buildings whose horizontal joists are seen either non-existing or irregular (Fig. 11).

**Fig. 11** Damages on the mud-brick buildings whose horizontal joists are non-existing (Ilıkaynak Village).

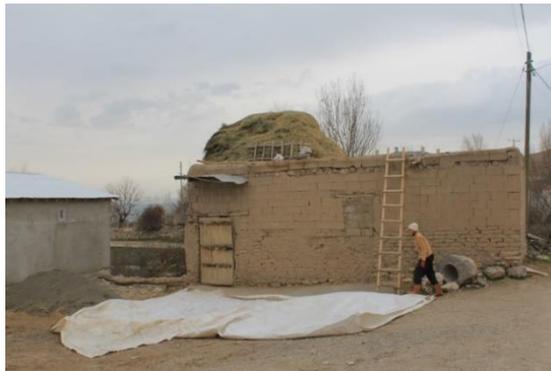
(7) Another reason of the damages is those caused by differing in the way of shrinking at mud-bricks and bricks when two materials were used together (Fig. 12).

**Fig. 12** Damages caused by usage of mud-bricks and bricks' being used together (Yeşilsu Village).

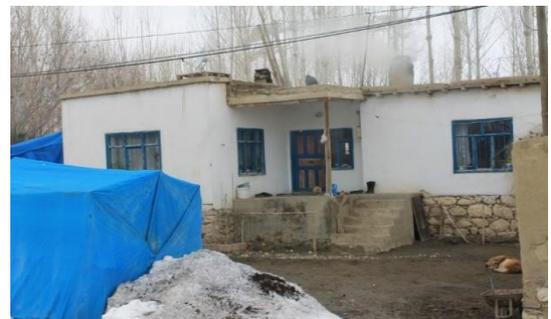
- (1) Which has a sub-basement (Fig. 13);
- (2) Where horizontal joists were used in decently (Fig. 14);
- (3) Continuously maintained (Fig. 15);
- (4) Whose wall and roof covers were in decent thickness;
- (5) Buildings whose materials for mud-brick have been used in right proportions and methods, with right workmanship.

**Fig. 13** A mud-brick building whose sub-basement elevation is sufficient (Kaymaklı Village).

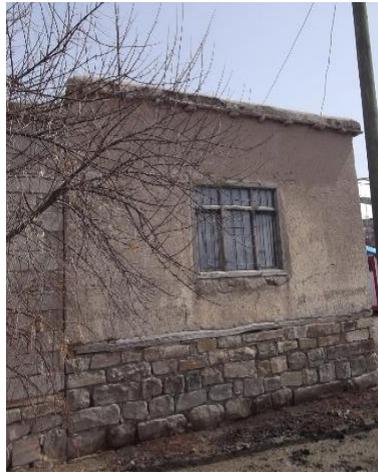
**Fig. 14** A mud-brick building where horizontal joists were used in decently (Çalmlı Village).

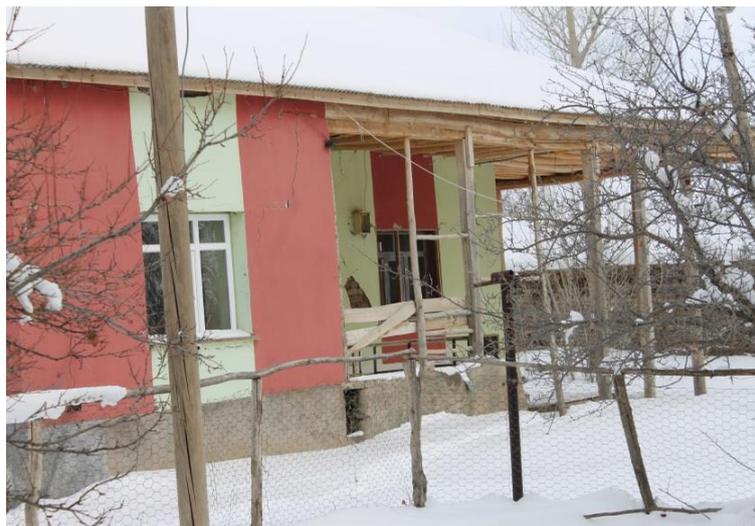
**Fig. 15** Inhabited and maintained mud-brick building which is approximately 100 years-old (Esenpınar Village).
