The Basilica of Santa Maria di Collemaggio in L'Aquila: Modern Provisional Measures

Sabatino Cecchini and Francesca Curotti

Abstract: The case in analysis is Santa Maria di Collemaggio, the church symbol of the town of L'Aquila and the most important example of Romanesque style in Abruzzi, tragically damaged by the earthquake in 2009. The following paper starts with an accurate analysis of the Basilica, whose historical, stylistical cultural characteristics make it an unicum in the whole urban environment. The authors tried to identify in which way these values have been compromised or altered after the earthquake through several analysis (surveys, historical researches etc.) aiming at the recognition of collapses, the cracks profile, the structural transformations caused by the provisional measures: the goal is to provide a kind of Basilica "cognitive manual" that will be useful for the future interventions. This first analysis allowed to understand many aspects: on the one hand, the constructive phases and which damages were caused by past careless interventions of restoration, drawing attention to the vulnerability elements of the Basilica; on the other hand, the innovative te

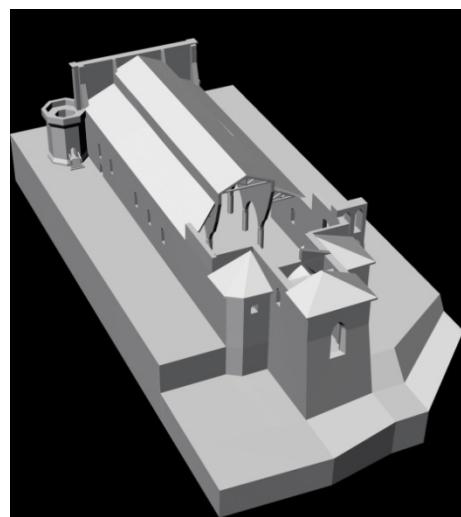
The most considerable damages, registered on April 6, 2009 (Fig. 5), are mainly imputable to wicked renewal works realized in the 1970s, in particular, the insertion of reinforced concrete structures caused:

- the dome's collapse (Fig. 6);
- the partial tumbling down of the presbytery;
- the collapse of the barrel vaults of the transept;
- the collapse of the two monumental clustered pillars sustaining the dome and of the triumphal arch;
- the collapse of an half of the last span of the nave;
- the collapse of the whole wooden roofing of the transept [3].

Fig. 5 One of the Rhino models showing the damages of the roofing.

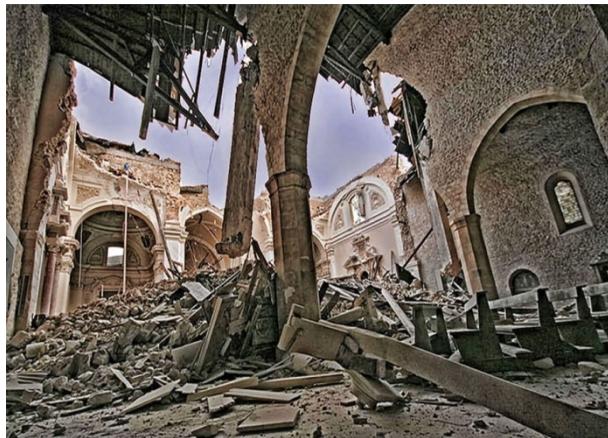
The restoration of these years had the unjustified aim to re-establish the original medieval setting. Mario Moretti was the architect who followed the works. The dome was completely rebuilt in reinforced concrete without any connections with the riddles inserted inside the wall of the central nave, moreover, the walls of the aisles were raised up (almost 3 mt) putting new riddles at the height of trusses. New windows were opened according to the “medieval style”, finally, the cross vaults were abolished as well as the whole baroque decoration, including the wooden ceiling of the nave.

All these interventions are some of the main causes of the huge breakdown of the April 6, 2009.

Fig. 6 April 6th, 2009: the collapse of the dome.

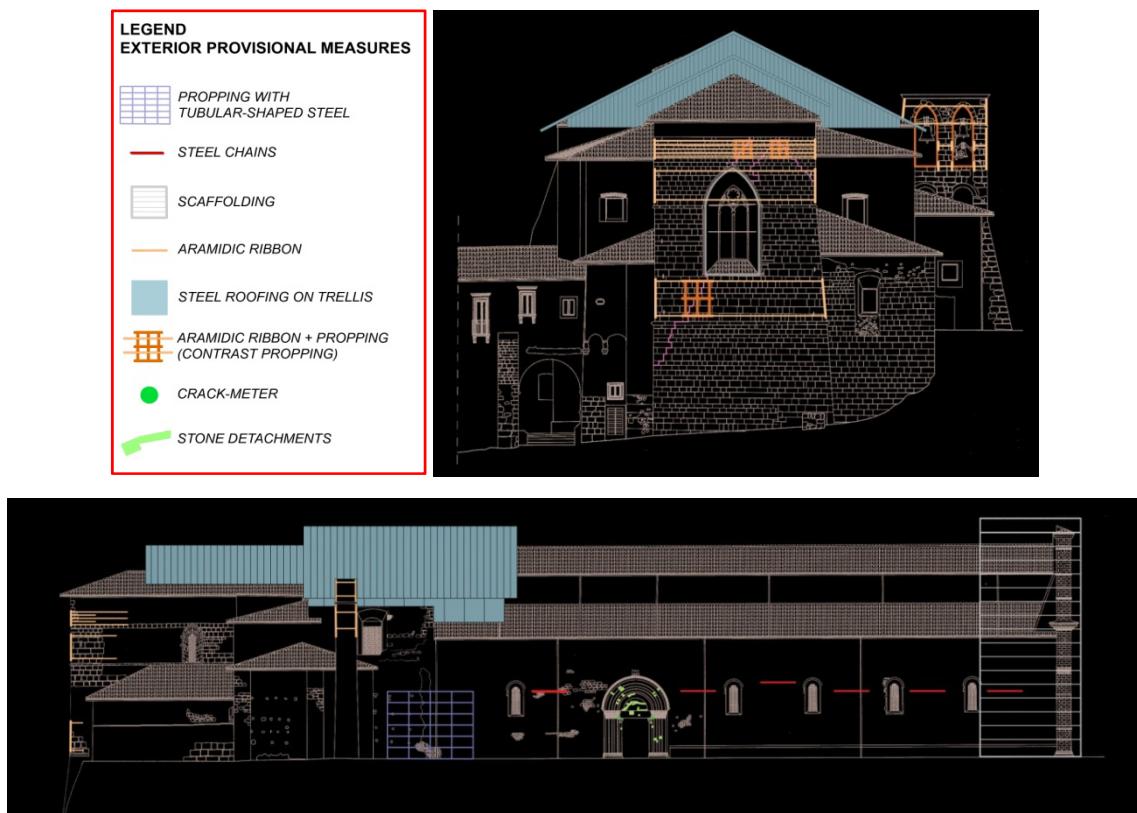
Fig. 7 The survey of the provisional measures on the east and north fronts.

The exterior (Fig. 7): the most used method is the wood propping to contrast above all the expulsion wedges and the steel propping of the openings (above all next to the bell tower and the windows of the apse), as the façade did not register huge damages (it is a sort of "slab" anchored to the main body of the church, and this has strongly strengthen it) in front of it there is only a scaffold to restore little localized damages to the sculptures.

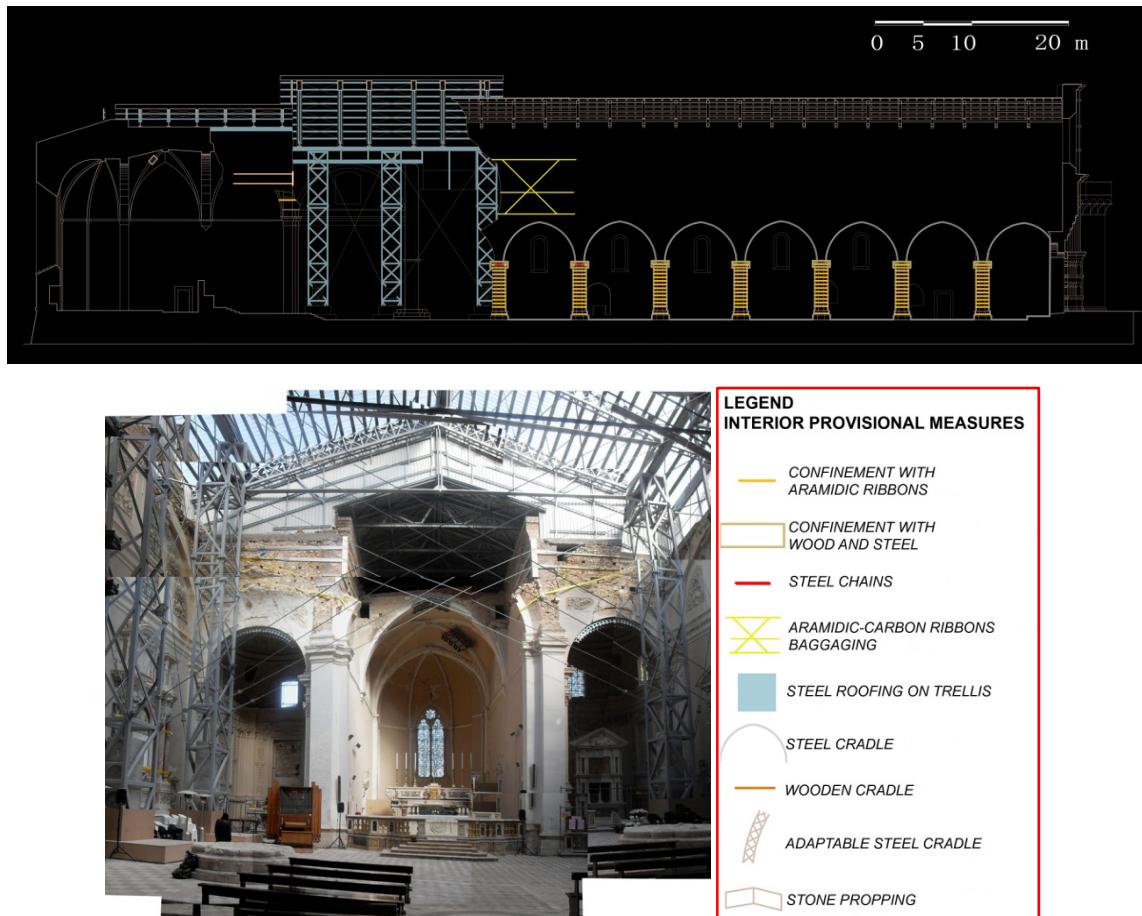
Fig. 8 The survey of the provisional measures on the nave's wall (section) and in the presbytery.

The interior (Fig. 8): the most used method is the steel propping and steel adaptable cradles of the arcades, steel chaines to connect the perimeter walls of the aisles, the installation of a provisional roofing completely realized in steel and plastic materials to cover the portion of the church completely knocked down by the seismic.
