# Wind-induced Damage in Two Regions of Argentina

**Abstract:** Information on wind-induced damage to civil structures in Argentina is scarce. In this paper, general trends regarding both meteorological conditions and patterns of damage when damage occurred in two regions of Argentina are presented. The regions under study were the north-east of Argentina (NEA) and the north-Patagonia. This research is based on a collection of data comprising field surveys conducted after the passage of destructive storms, NCEP/NCAR Reanalysis, a Global Data Assimilation System model and other secondary sources like emergency services, local press, local councils and the National Weather Service. It is shown that both regions have similar problems of vulnerability, even though they have different meteorological environments. Topics that must be addressed to reduce the vulnerability of civil structures have been identified.

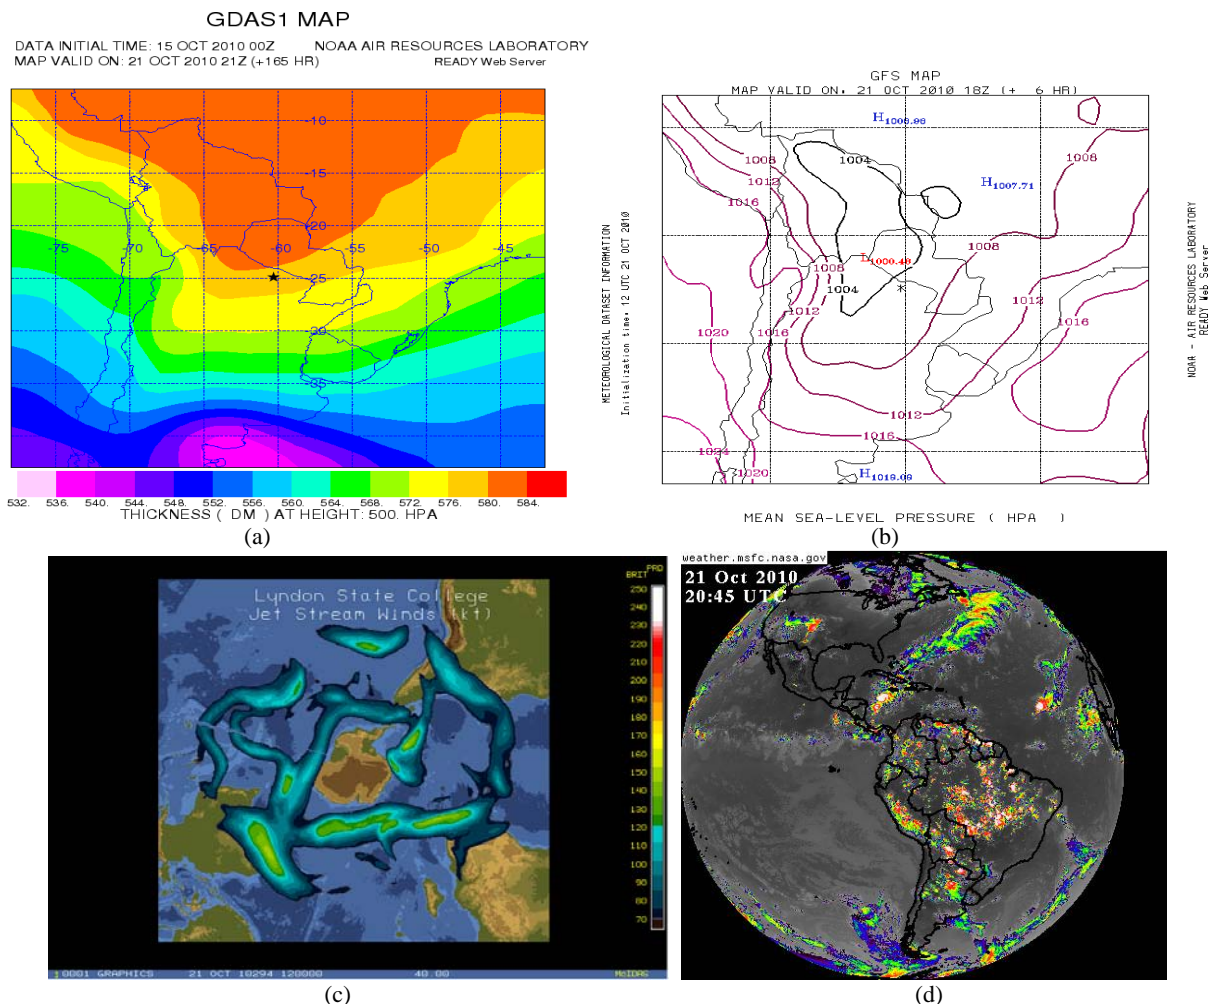
Several factors took part on the formation of the 21<sup>st</sup> of October tornado. The inflow of a warm, humid mass of air from the north (Fig. 1a) was activated on the surface by a low pressure system positioned on the Bolivian Altiplano that extended to the south (Fig. 1b). Together with the presence of an upper-level subtropical jet stream (Fig. 1c), they contributed to the formation of a very intense convective cell (Fig. 1d).

Fig. 1 21st of October tornado. (a) thickness map showing the inflow of warm air into Formosa area. (b) sea-level pressure isobars chart where it can be seen a low centre situated NW of the area of development of the tornado. (c) jet stream over the area. (d) GOES image showing an intense convective cell over the area, fifteen minutes before the event.

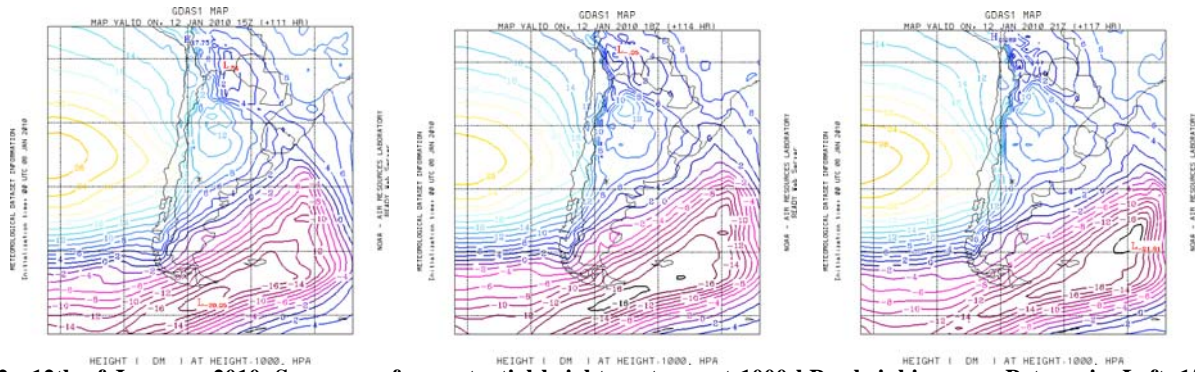
centres where the storms reached its maximum intensity. However, it must be noted that these storms acted over large areas. A typical example of this kind of events occurred on 12th of January, 2010, when the passage of an extra-tropical low pressure system off the south coast of Tierra del Fuego Island induced a pronounced shrinking of the isobars over the continent in Patagonia (Fig. 2). Another similar event occurred in winter, on June 23rd, 2010. In the first case, the affected area was the centre and south-east of the province of Neuquén; in the second case, the centre and north-west. In both cases, damage was caused in places as far as 200 km and gusts of about 44 m/s were recorded.

Fig. 2 12th of January, 2010. Sequence of geopotential height contours at 1000 hPa shrinking over Patagonia. Left, 15:00 (UTC), centre 18:00 (UTC) and right 21 (UTC). It can be seen the squeezing of the contours between the Pacific Subtropical Anticyclone and the extra-tropical low pressure centre in the South Atlantic Ocean.

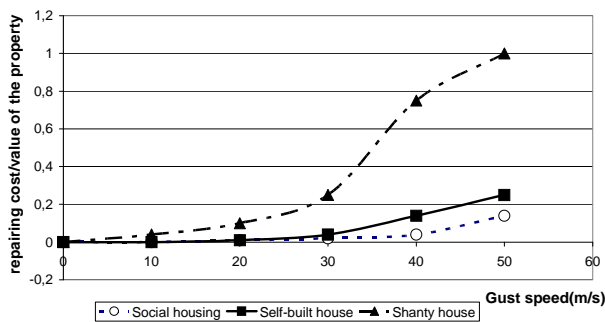
the total value of the buildings in that location. However, a simple exercise to illustrate the vulnerability of dwellings is presented here. First, the dwellings have been grouped in three typical categories: (1) **Social housing**: engineered houses with metallic roof and masonry walls reinforced with concrete; (2) **Self-built houses**: non-engineered houses with metallic roof and masonry walls without reinforcement; (3) **Shanty houses**: non-engineered shelters made with wood, cardboard and iron sheets. Then, features of prototypes for every category were defined, including typical damage according to the wind speed. The value of each kind of house and repairing costs were estimated and the relationship repairing cost/value of the property was plotted against the wind speeds in Fig. 4. Typically, for gust speeds between 44 to 55 m/s, social housing experienced unroofing, self-built houses suffered unroofing and damage to walls, while shanty houses were demolished.

Fig. 4 Plot of the relationship between the repairing cost/total value rate and gust speeds for three typical kinds of houses in Neuquén.
