# Renovation of the Centennial Hall

**Abstract:** The Centennial Hall was designed as a monumental building entirely of reinforced concrete. Soon it became a model for modernist buildings of that era. During the years 2009-2011, the biggest renovation since its completion took place. All activities described in the following paper aimed to put the Centennial Hall into good repair and adjust it to the applicable requirements of modern public buildings. The primary aim is to preserve the authenticity of the original materials used in construction through the use of remedial technologies, thereby maintaining the historical integrity of the building.

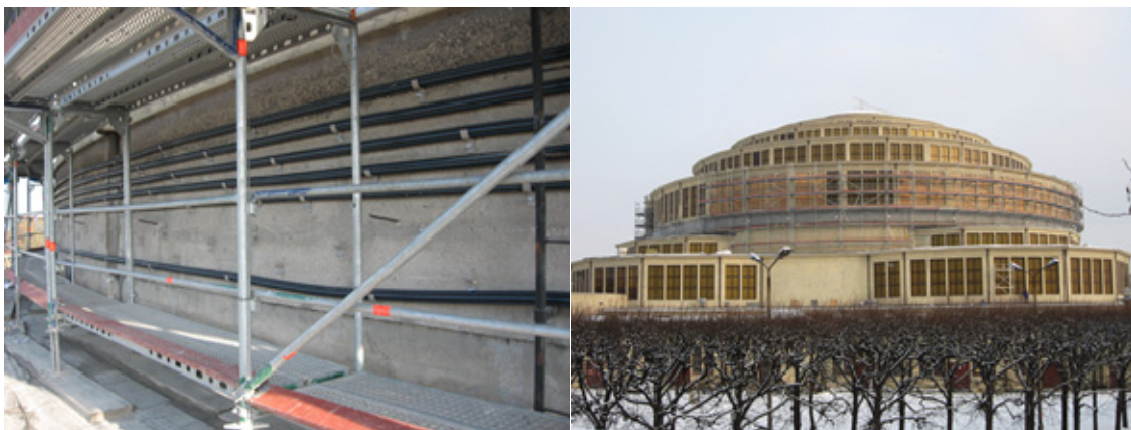
Fig. 3 Reinforcement of the lower extended rim—arrangement of cables and securing of the mortar (photographer: R. Dzugaj).

Part of the renovation involved securing the main structural element of the Centennial Hall, i.e., the lower extended ring under the ribbed dome, 218 m long and located at a height of 19.0 m above ground level. Such securing was justified due to the periodic suspension of sound and lighting equipment from the ribs of the dome, when needed during large events in the hall. The securing of this structural element as proposed by the main contractor, Alpine Bau GmbH, involved girding the extended ring from the outside with 27 non-adherent cables ( $\varnothing 15.50$  mm) put together in nine “super-cables” (Fig. 3) made up of three strands each. The cables, located in pipe covers made of PEHD (polyethylene), are arranged on the outer surface of the extended ring of the dome with spacing every 140 mm. Prior to anchoring, the cables were stretched with a force equal to 15% capacity of the cables, thus ensuring the proper functioning of the anchoring devices. Having been tightened, the cables

were injected with a cement grout and secured from the outside with a layer of mineral low-shrink mortar of a texture [8] and color consistent with the requirements of the city conservator and corresponding to the other surfaces on the facade of the Centennial Hall.

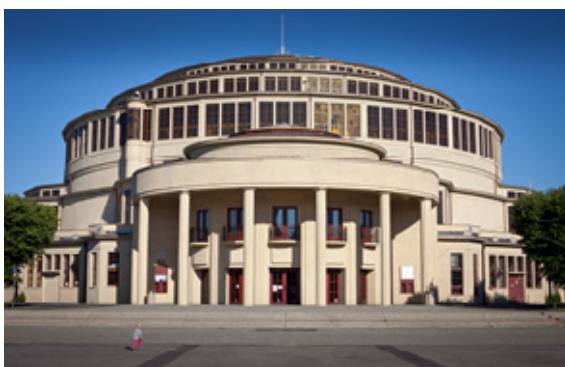
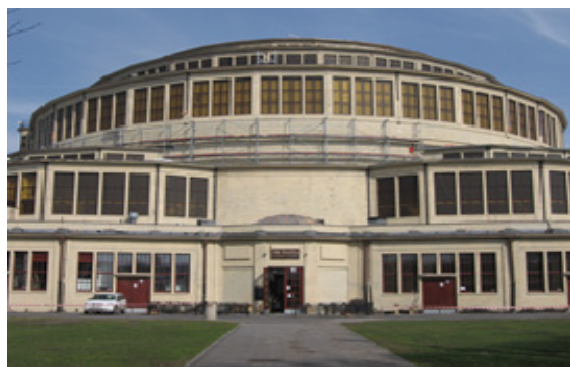
**Fig. 4** After the renovation: (a) front façade; (b) south-west façade.

The general reception of the color of the facade is influenced not only by the color of the concrete surfaces, but also by the color of the window woodwork (Fig. 4). In the case of windows, we are dealing with two different materials: wood constituting structure and glass constituting the filling. The color of the paint for the wooden elements of the windows had been determined earlier, during the renovation of the window and door woodwork in the Centennial Hall's corridors. It was then established that it was color No. S 4050-Y80R according to the NCS template.

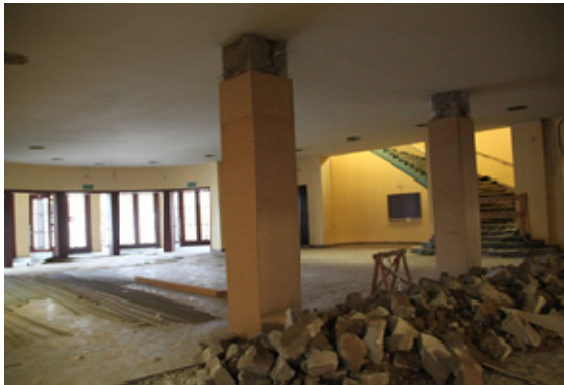
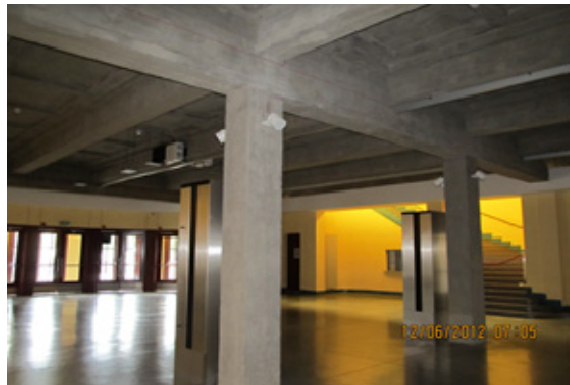
Fig. 5 Main entrance hall: (a) before; (b) after removal of the suspended ceiling.

- fans in the arcade pillars were replaced with more efficient ones;
- all historical staircases and banisters were preserved;
- the suspended ceiling in the main entrance was removed;

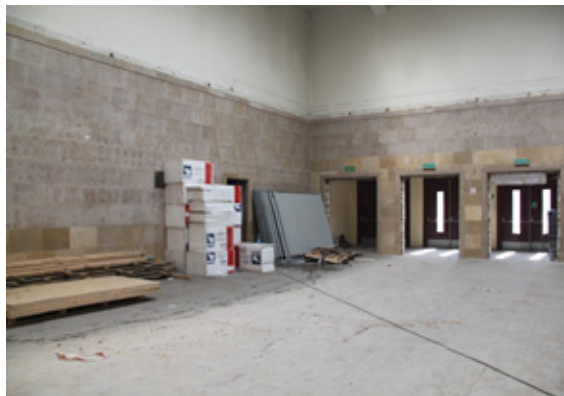
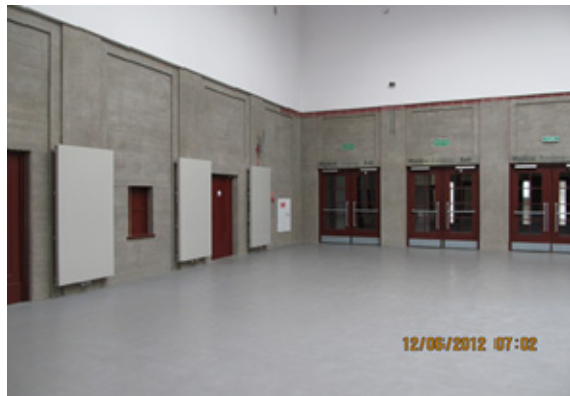
Fig. 6 Square hall: (a) during and (b) after removal of the stone facing.

- removal of the secondary stone facings on the walls of the square halls at the south and north entrances, and restoring their original appearance (Fig. 6).

- stone facings in the square halls were removed, thereby exposing the natural surface of the reinforced concrete;
- demolition of the existing grandstands with their substructure to the floor level, was permitted, except for the balconies made in 1913;

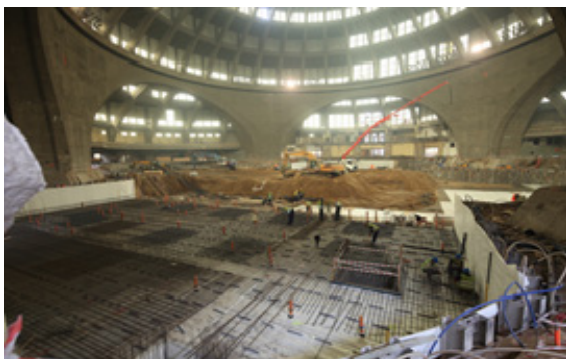
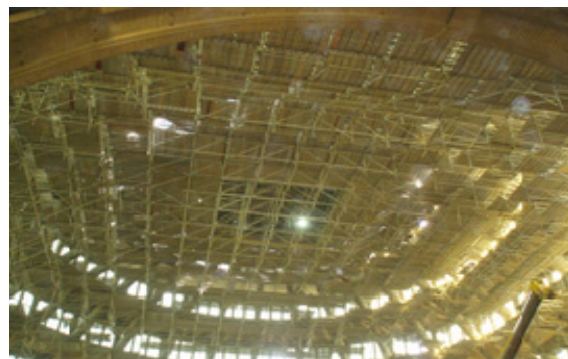
**Fig. 7** Renovation of the interior: (a) lowering the flooring in the performance hall; (b) the scaffolding suspended from the dome.

- demolition of reinforced concrete grandstands and flooring (installed in 1996) within the performance hall;
- lowering the flooring of the performance hall by 3.70 m (Fig. 7a) to enable the installation of the movable floor [9, 10];
- securing and reinforcing the dome's lantern using a carbon fibre tape (Fig. 7b);
- construction of new reinforced concrete structure of the fixed grandstand and the telescopic steel grandstands;
- repair of the reinforced concrete construction elements inside the hall (re-profiling);
- installation of new conduits under the floor for plumbing and heating installations.

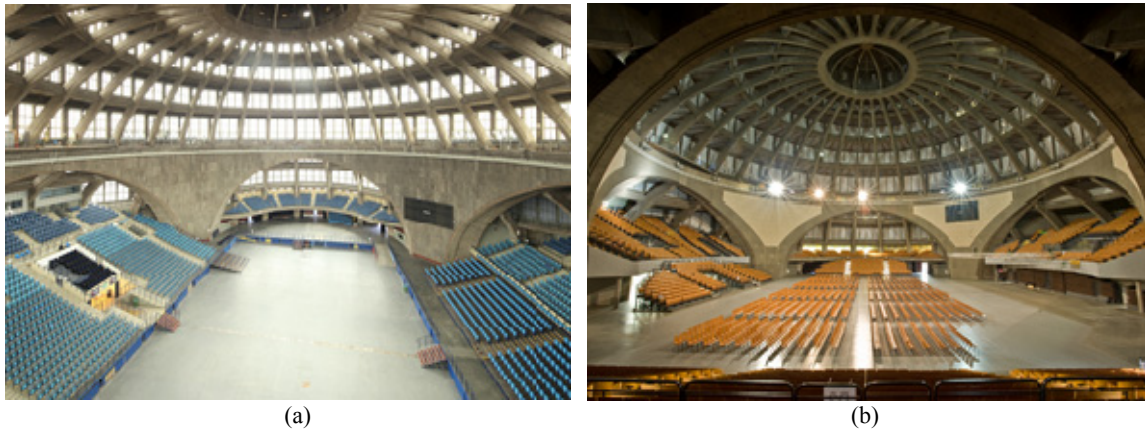
**Fig. 8 Auditorium: (a) before; (b) after the renovation (photographer: M. Golen).**

- decor from 1913 was the guiding model for the permanent interior design (Fig. 8);
- because of the acoustics, facings made utilizing the latest technology were used on the pillars of the arcades, instead of "suprema" (Heraclitus);
