Failure in Fuel Injector Nozzles Used in Diesel Engines

The main objective is the macroscopic and microscopic investigation of the section failures in the needle and nozzle of an injection unit

It was used one injection unit in the engine brand MTU model ADEC S4000 damaged as specimen for conducting the case study. The needle and nozzle were characterized by optical macrograph using an optical microscope stereoscope brand Tecnival model SQF-F. The specimen was handled in order to prevent damage to and fracture surface. To analyze the inside of the nozzle it was used a metallographic cutter brand Arotec Arocot-40 model.

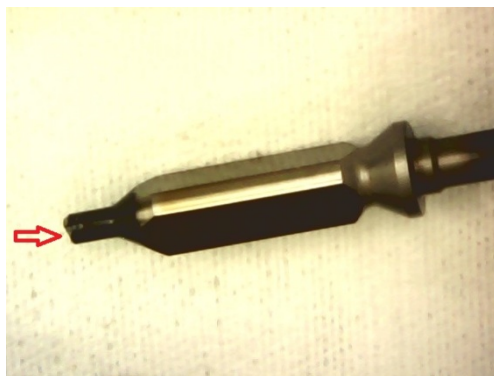
During the analysis, it was found that the needle of the injector nozzle has excessive wear on the tip, resulting in a higher flow at the specified limit (Fig. 1). The fracture by fatigue was caused by contact under high cyclic stress of the needle tip with the internal nozzle region (Fig. 1b) [8]. The initial crack fracture was initiated by the erosive wear.

The Figs. 1a and 1b show the needle nozzle with the presence of failure caused by wear by erosion with solid particles (Fig. 2b—central region) as well as fatigue fracture (Fig. 2b—outer region). Failure by

erosion with solid particles was caused by contaminated fuel [7].

Fig. 1 (a) Macroscopic wear of the needle and (b) wear at the needle tip.

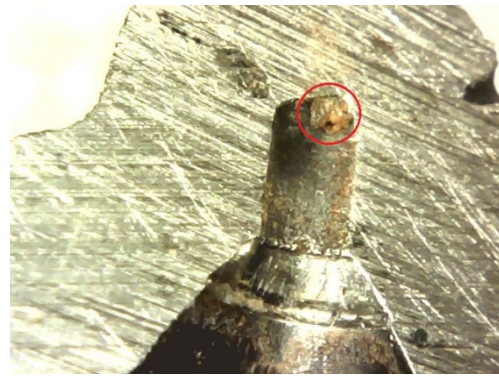
Fig 2a shows the wear by erosion with solid particles located in the fuel inlet port. The cause of this wear was due to contaminated fuel [7].

Fig. 2 Analysis microscopic wear on fuel injector nozzle (a) localized erosion wear by the oil inlet hole and (b) of the inner nozzle region with cavitation pits.

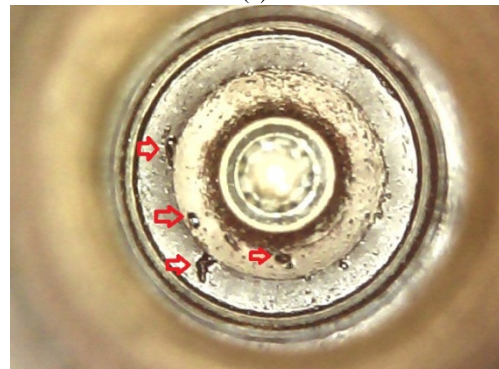
(b)

It was conducted one metallographic cut in the nozzle to examine the inside of the nozzle (Figs. 2a and 2b). Fig. 2b shows the macrography of the internal region of the nozzle where occurs the limit of the needle, the arrow shows the abrasive wear under high cyclic stress caused by contact of this area with the needle tip. It is also observed a hard, dark layer that is organic deposits caused by fuel impurities [7].

According to Fig. 2b, there was the occurrence of wear by cavitation in the inner region near the nozzle head. Cavitation occurred due to the reduction of pressure in the fuel flowing in the inner region of the nozzle. The reduction of pressure in the liquid fuel caused nucleation and growth of air bubbles that collapsed (exploded). The energy released by these

explosions promoted the impact of liquid fuel against the inner regions of the nozzle. The shock due to the impact caused the plastic deformation and material removal, resulting in failure formed as deep and rounded microcrateras called pits, as indicated by arrows in Fig. 2b.
