Analysis of a Concrete Structure that Was Exposed to Fires in the Metropolitan Region of Recife

3. Results (Case Study)

3.1 Fire Description

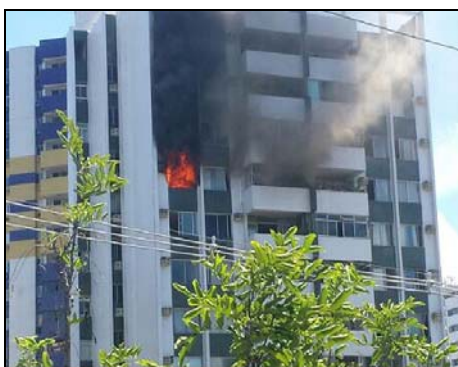
On the second week of February 2014, between 12:00 p.m and 1:00 p.m, there was a fire in a building in the metropolitan region of Recife, Brazil. The flames reached not only the adjacent rooms, but also the apartments on the upper and lower floors, as shown in Fig. 1.

Fig. 1 Fire in the apartment reflected in the upper and lower apartment [8].

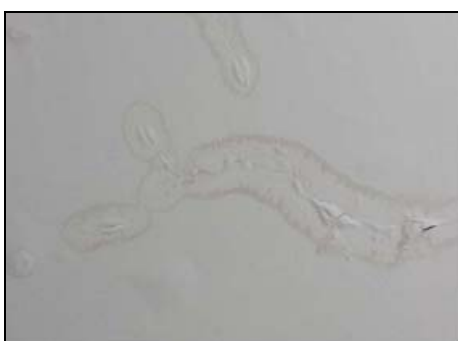
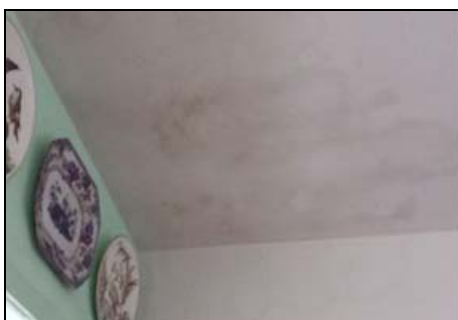
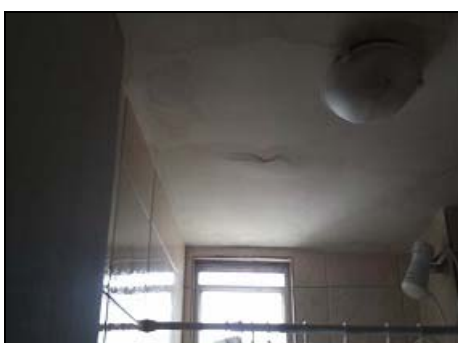
Fig. 2 Damage to the apartment ceiling painting.

Fig. 3 Damage to the living room ceiling.

Fig. 4 Damage on the bathroom ceiling painting plaster.

The damages to the lower apartment were highlighted in the ceiling of the bedroom, the living room and the bathroom, where there were formations of blisters and spots in the three rooms due to the use of the water used in firefighting. Malfunctions are observed in Figs. 2-4. To correct them mixed lime,

cement and sand mortar of ratio of 1:1:6 should be applied in the parts that need to be redone, including the areas that were exposed to the chance of new short-circuits. In other stained parts, the painting must be redone (Fig. 5).

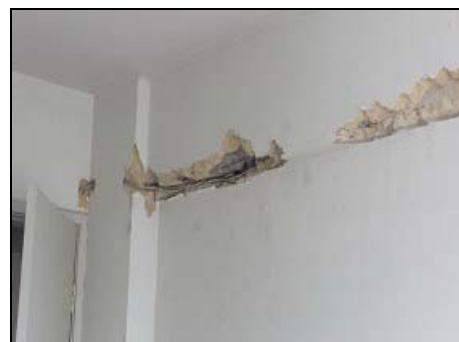
Fig. 5 Inspection of the electrical wiring (the repair must be done with ratio of 1:1:6 cement lime and sand mortar).

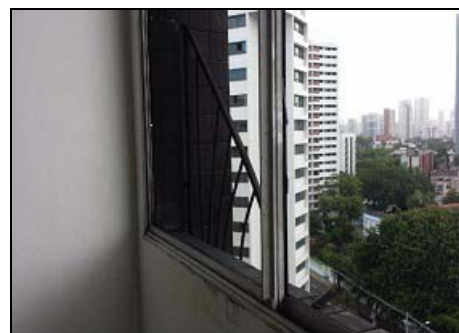
The damages on the upper apartment are highlighted on the balcony, as the flames reached the border of the damaged window completely, as shown in the detail of Fig. 6. It should soon be made to be replaced and their eventual settlement. The ceramic stone facade around the site, where the frames developed as a result of contact with high temperatures resulting from gases expelled during the fire, may have weakened the mortar of the stones which were also damaged, then were to be inspected by a typical percussion test, so that after identified, must be exchanged.

Fig. 6 Detail of the damaged aluminum frame.

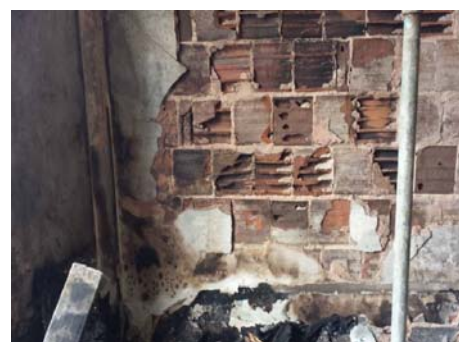
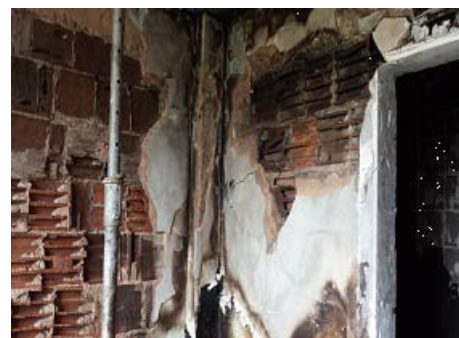
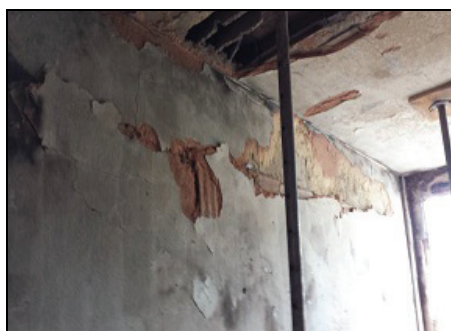
The partitions of the apartments were constructed with ceramic sealing blocks with eight holes and the coating was carried out with layers of slurry mortar, grout and paint. Figs. 7-9 show the state of the lining of the walls after the fire, where high temperatures reached the painting and then the mortar conditioning the remaining water present in the element to evaporate, thus increasing the steam pressure and exerting a voltage exceeded the tensile strength of the mortar layer and the side of the sealing block. It is also worth noting that the sinister extinction mode achieved through action by firefighters, influenced the outcome of the constructive elements. Since releasing water to control the firesoaked walls that were mostly dried, would lead to their absorbing and again, having the appearance of internal stresses which tend to expel the peripheral parts of the element [9].

Fig. 7 Bedroom wall: damage to the plaster and coating mortar.

Fig. 8 Outer wall and bathroom partition.

Fig. 9 Damage to the wall and the slab concrete block.

Due to surface wear in the grout and ceramic blocks caused by the situation, the removal of the damaged

surface layer is suggested, followed by restoration of masonry, using techniques that employ the use of

lightweight concrete in conjunction with polystyrene beads. The application of slurry mortar and plaster mortar with a maximum of 2.5 cm on the resulting surface is proposed, followed by sealing, spackling, and painting similar to those of other environments.

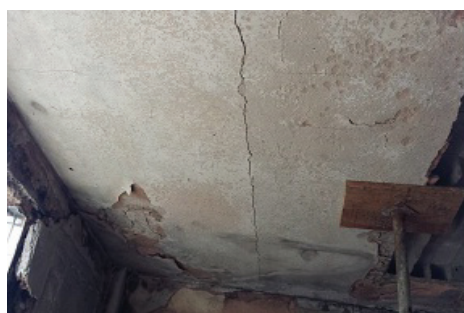
Fig. 10 Apartment ceiling with crack parallel to the ribs.

There was no evidence of cracks or fissures in the ribs, just a crack in the parallel direction to it (Fig. 10). And the simple structural concrete used in slab capping is insufficient to ensure a high adhesion between the block and the rib, which is justified the surface of the rib hindering the smooth being connection between old and new concrete and the small thickness of concrete between the block and the rib, which easily gives a high percentage of water present in the elements. Because the ribs are smooth, there is also poor adhesion between them and the capping, in a section situated on the rib.

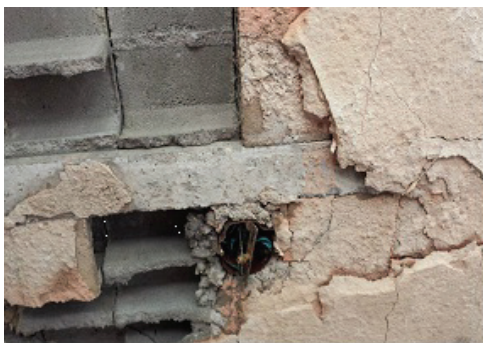
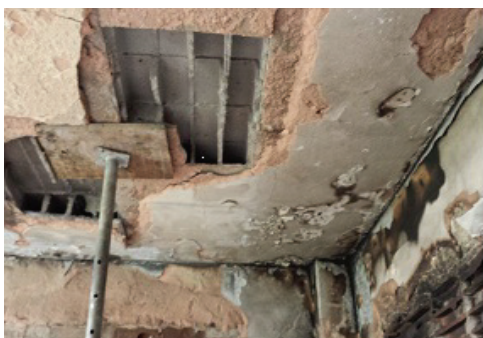
Fig. 11 Damage to the clay coating of mortar and concrete blocks.

Fig. 12 Damage mortar and clay coating.

There was no apparent damage to the slab ribs as seen in Figs. 11 and 12. However, there was no way to access the top of the rib, on which the capping slab is supported. So it is recommended to be made load proof test at the slab region comprising the affected veins [8]. The test should be performed for the project value of overload of use of 150 kgf/m^2 , which should be measured offsets through gages.

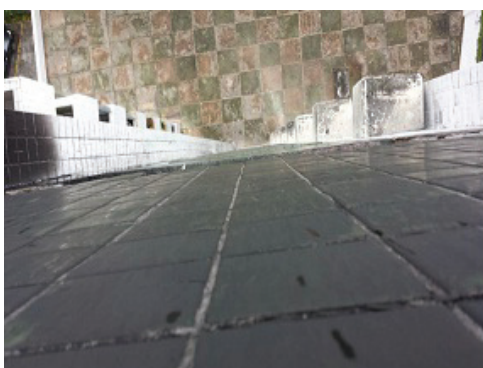
Fig. 13 The exposure to high temperatures damaged the adhesion between the ceramic plate and its substrate.

On the floor it was observed that the ceramic plates had a hollow sound when knocked on, indicating that due to high temperature and pressure, the ceramic coating lost part of its adhesion to the substrate, Fig. 13 released adjustment layer of the floor.

Percussion tests are suggested for both situations and once ceramic pieces without proper grip are identified, they must be replaced.

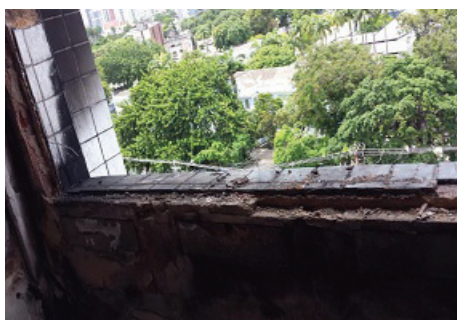
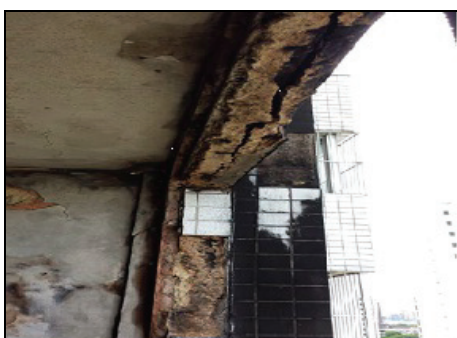
Damages were presented on the windowsill that were highly damaged, holding the mortar to deteriorate laying of ceramic, which naturally should be recovered together with the same. Figs. 14 and 15 show the necessity of retrieving the elements.

Fig. 14 Details of the damages.

Fig. 15 Detail of the joint recovery point and ceramic plates.

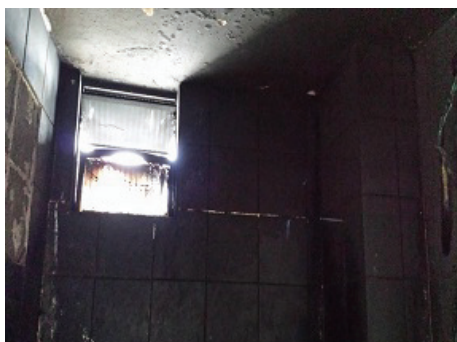
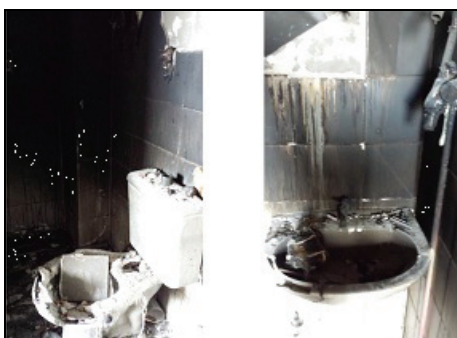
Fig. 16 Damages in the bathroom.

Fig. 17 Details of the damages of the sanitary ware.

In the bathroom area, faults were found in the coating of the ceramic walls, on the loss of adherence

of the parts to the substrate, also the window, shower, basin, sink and mirror were extremely damaged, necessitating proper exchange of all crockery and metals, electrical, hydraulic, and sanitary system facilities (Figs. 16 and 17).
