Consequences on the Urban Environment in Greece Related to the Recent Intense Earthquake Activity

George C. Manos

Laboratory of Strength of Materials and Structures, Department of Civil Engineering, Aristotle University, Thessaloniki, Greece

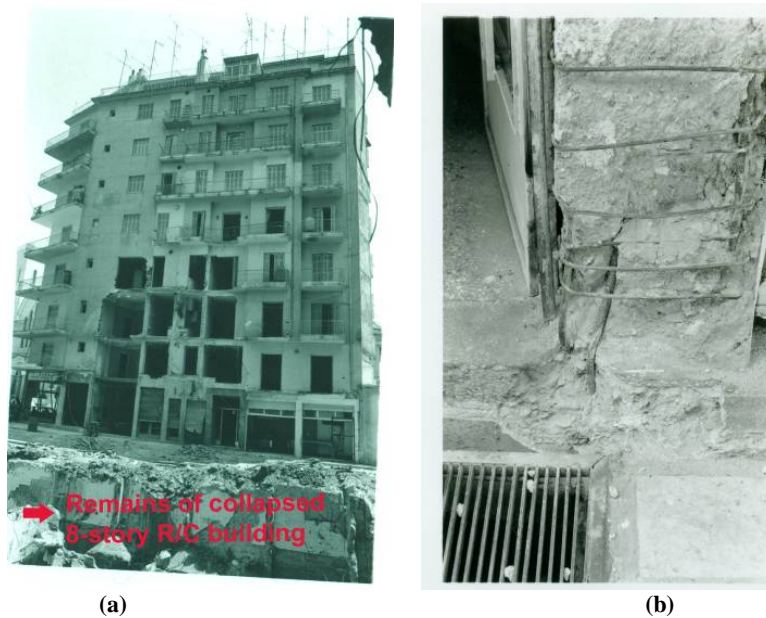
inhabitants (25 km from the epicenter). It included a large number of relatively newly constructed R/C multi-story apartment blocks up to 9 stories high, being designed according to the provisions of a seismic code dated from 1959. An 8-story R/C apartment building collapsed in the city center (Fig. 2a). The death toll in the city was mainly due to this collapse. Factors contributing to the collapse of this building as well as to the structural damage of similar buildings are the badly designed structural system for resisting earthquake forces together with the non-ductile nature of its R/C members and the considerable eccentricities between the center of mass and the center of stiffness. In addition, the observed serious structural damage can be attributed to the poor foundation of such structures built on the underground remains of the ancient city by means of spread footings. The pounding effects from attached buildings and the amplification of the strong motion that was caused by the soft soil conditions, as demonstrated by acceleration recordings during the aftershock activity, were also significant contributors. The detrimental influence of a “soft story” at the ground floor was not recognized at the time and it continued as an architectural feature, being used either as a shop or as a parking lot, for many buildings and for many years to come (Fig. 2b).

Fig. 2 (a) The remains of the collapsed building together with the damaged adjacent structure; (b) Damaged column at the ground “soft story” floor.

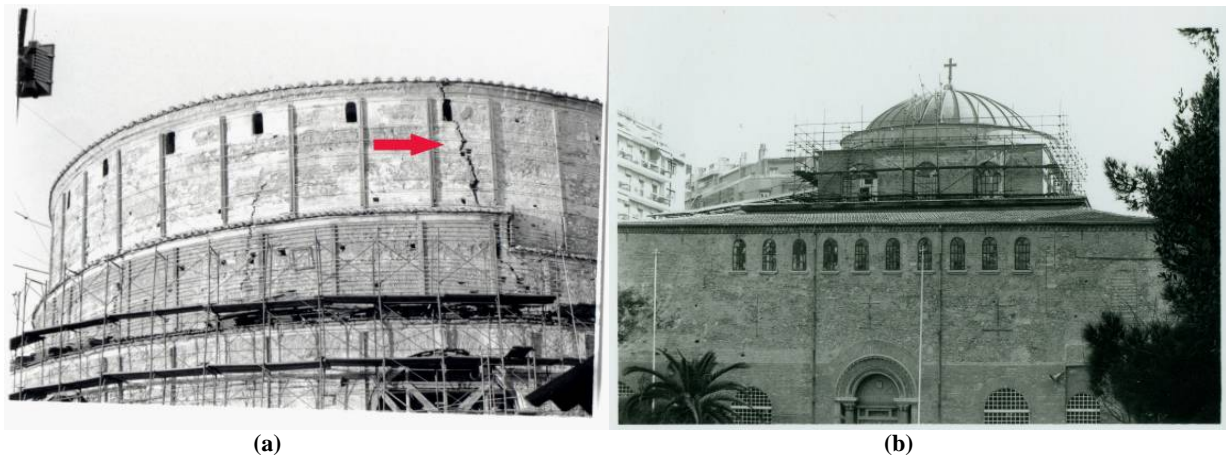
- The most demanding projects were those of the cultural heritage structures (Figs. 3a, 3b and 4a), mainly churches as well as relatively old state owned masonry buildings. For a small number of such structures, external or internal jacketing was permissible. Such a case was the 80-year-old cathedral church of Thessaloniki (St. Grigorios Palamas, Fig. 4b). For the much older Byzantine churches in Thessaloniki and the surrounding area such “drastic” intervention with irreversible repair and strengthening solutions was deemed unacceptable. The intervention-repair effort for most of these cases took a long time. These monumental structures, some of them more than 1500 years old, have interior features (e.g., mosaic) attached

Fig. 3 (a) The St. Sophia old Byzantine church at the city center; (b) The Rotunda's damaged cylindrical dome.

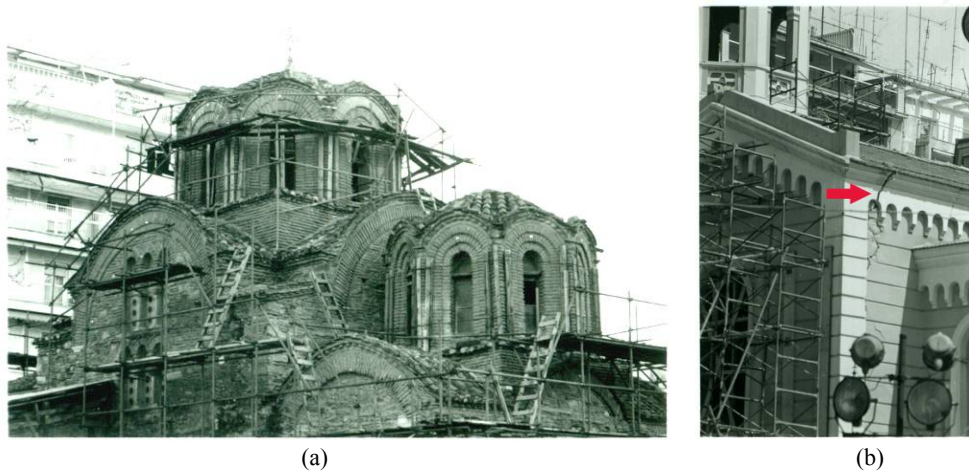
Fig. 4 (a) The St. Panteleimon old Byzantine church at the city center with the scaffolding for temporary support during the repairs; (b) The damaged Cathedral (St. Gregorios Palamas).

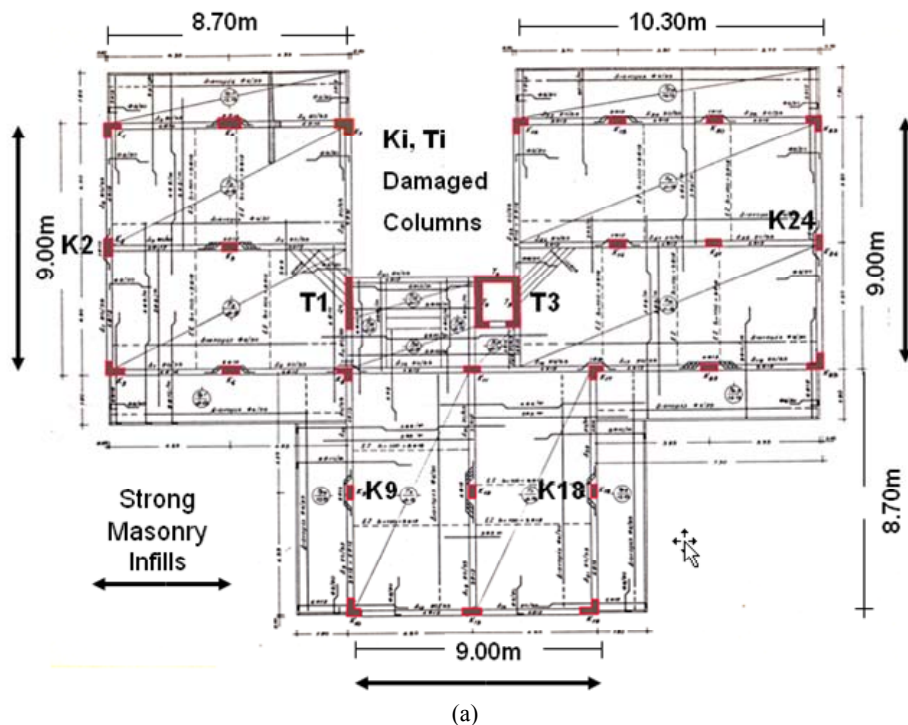
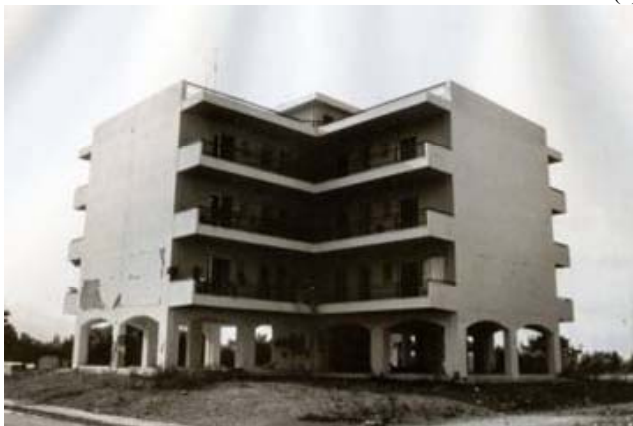
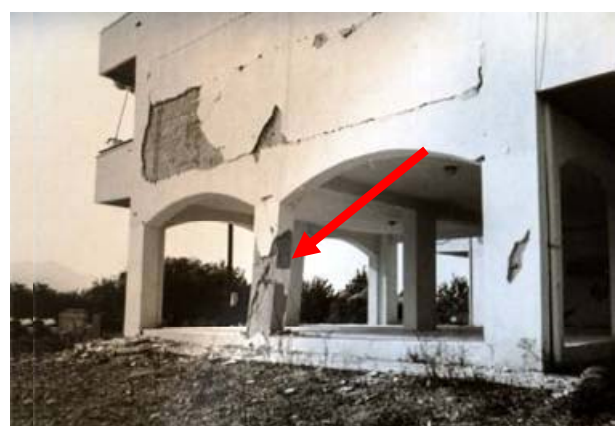
- The shear type of failure was the common pattern of damage in many ground floor columns, indicating shortcomings in the design provisions of the time that did not require checks to ensure flexural ductile behavior. Moreover, in many cases the ground floor became a “soft story” because of the presence of strong masonry infills in the upper floors. The four-story building in Figs. 5a, 5b and 5c is indicative of this type of “soft story” failure.

- The severely damaged columns (Ki, Ti, Fig. 5a) are shown together with the position of the strong masonry infills in the upper stories (see also Figs. 5b, 5c and 6). A numerical analysis performed by Mpoufides [32, 33], similar to the one presented in section 3, verified the cause of such damage. This structure was constructed as a typical building by the Department of Workers Housing.

Fig. 5 (a) Damaged “soft story” in workers building (Kalamata); (b) Damaged “soft story”; (c) Damaged “soft story”.

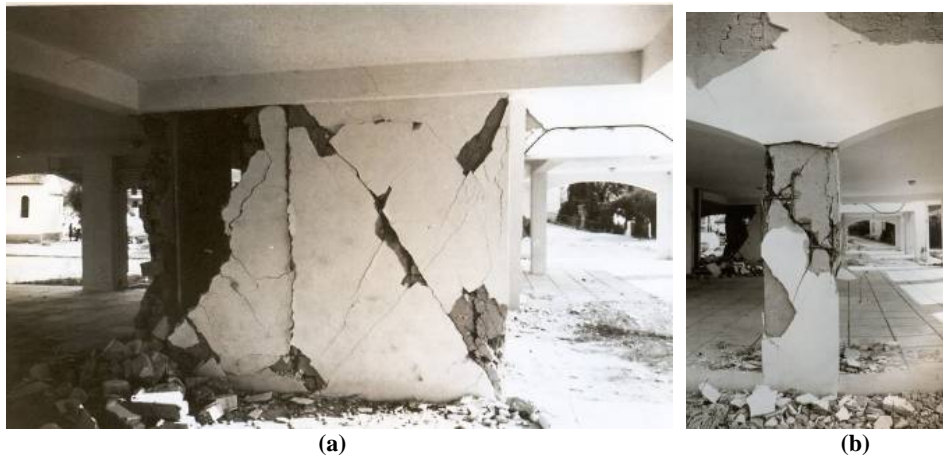
Fig. 6 (a) Damaged column T1, “soft story” workers housing building; (b) Damaged column K2.

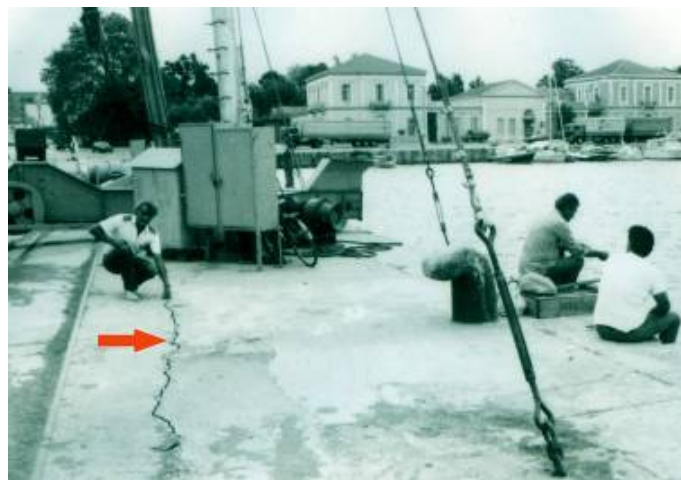
- Lifelines, industrial facilities, bridges and other civil engineering works survived this earthquake virtually unaffected. A few examples of damage to a facility were recorded at the city harbor, where the dock wall separated from the infill and gaps up to 10 cm were formed (Fig. 7); in addition, a silo had its wheat unloading machinery dislodged from its supports.

Fig. 7 Damage of the dock abutment.

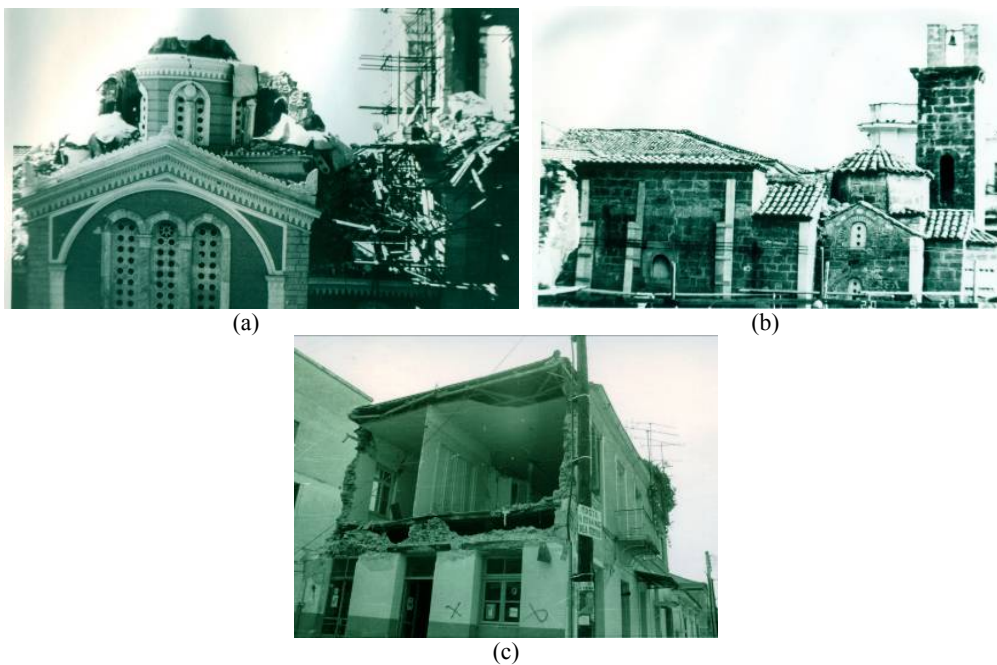
Fig. 8 (a) Collapsed church at the city center; (b) Collapsed old cathedral church at the city center; (c) Collapsed 2nd story of old masonry house.

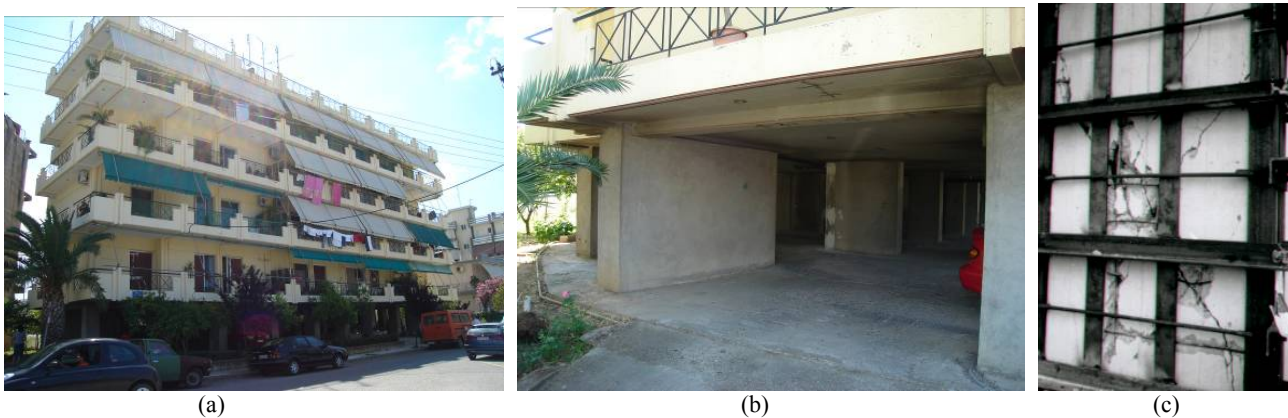
Fig. 9 (a) A 5-story structure damaged at the “soft story” ground floor as it stands today; (b) The damaged vertical elements of the “soft story” after being repaired; (c) A typical “soft story” shear wall damage being temporarily strengthened.

from previous earthquakes, the author being among them. Epoxy resin injections were also used. The whole effort was very successful resulting in maintaining the structural integrity of all the heavily damaged structures, without the occurrence of any collapse, despite the sequence of aftershocks.

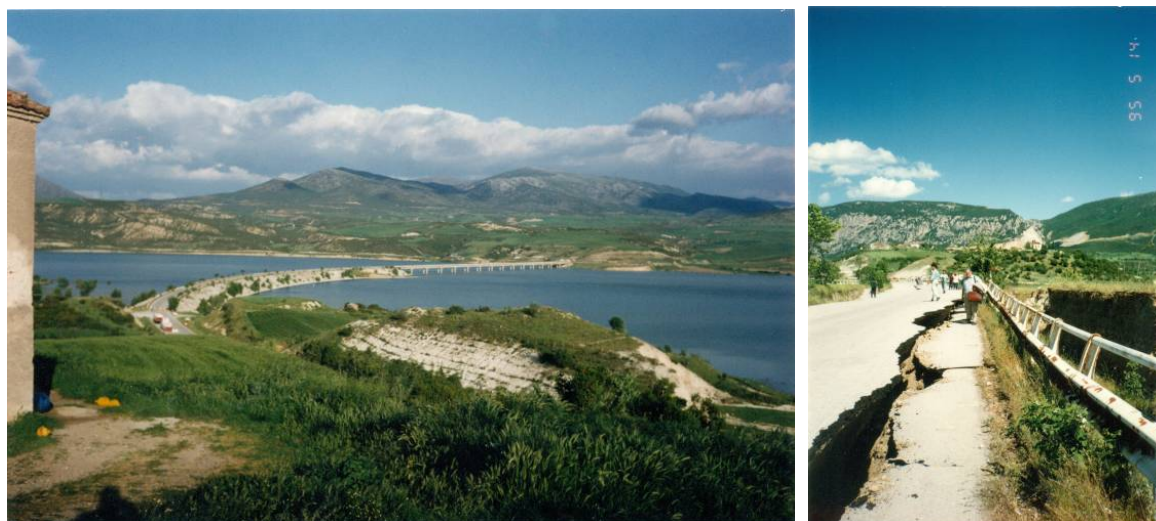
- An interesting failure was sustained in the fill of the south abutment of the bridge crossing the Polyphyto artificial lake at its South-West corner. This was the location where the seismic-fault rupture was initiated and must have experienced very strong ground motions. This bridge includes a number of free supported spans on multiple column supports founded at the bottom of this lake by pile foundation. The performance of this part was satisfactory without any damage. However, the gravel fill of the south abutments exhibited a spectacular failure that disrupted the road connection for at least two weeks (Fig. 10 and [50]).

Fig. 10 Damaged abutment of the “Rymnio” bridge.

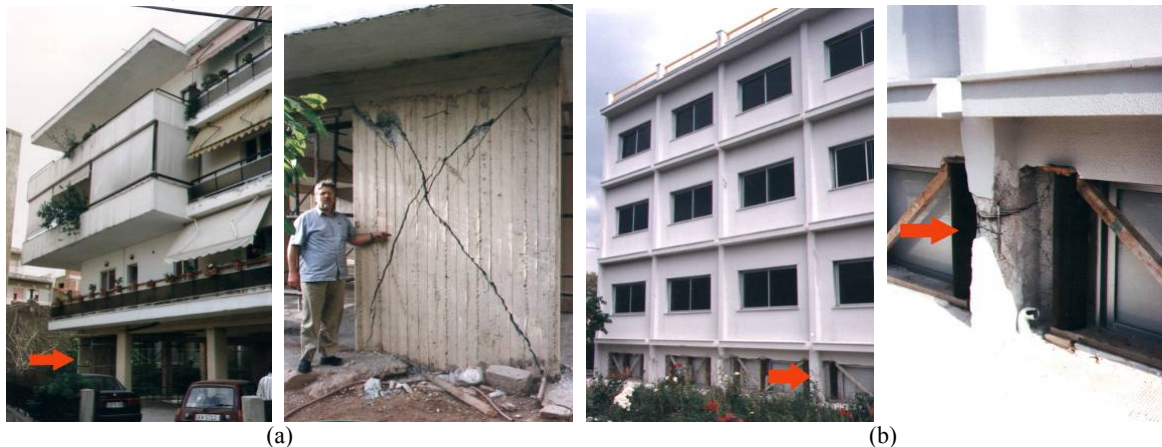
structures was similar to that in other regions of Greece; consequently, the damage that developed was similar, namely shear type of failure in shear-walls and columns, “soft” story damage, and heavy damage in short columns (Fig. 11 and [30]).

Fig. 11 (a) Damaged “soft story”; (b) Damaged “short” columns.

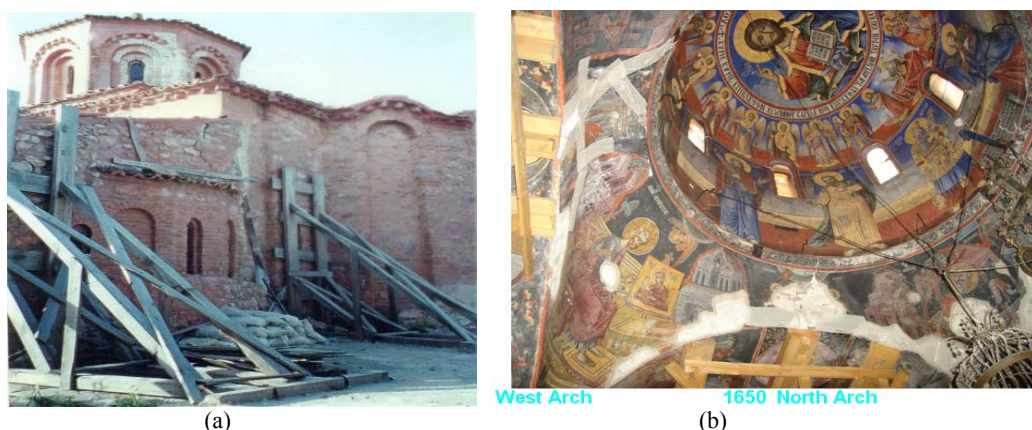
- Heavy damage was sustained by relatively newer churches, built with reinforced concrete elements, incorporating contemporary construction practices. One of the many churches in this category to sustain structural damage and one of the largest in the area is located in the city of Kozani, devoted to St. Konstantine [26]. The most spectacular damage in this category was observed in the village of St. Paraskevi and the village Kentro. Apart from these relatively newer churches, numerous other old Byzantine and Post-Byzantine churches, mostly built with stone masonry, were also heavily damaged. These churches span a period of over 800 years [28, 29]. The most spectacular damage to an old church is that of Taxiarchis in the outskirts of Eani (12th century AD). Despite its small size, the walls of this church were totally destroyed, indicating the severity of the ground motion. A short distance away, at the center of Eani, the church of The Virgin Mary (11th century) also sustained damage; however, this was less severe. Other examples of such damage are at the Monastery of St. Nikanoras (Zaborda, 15th century, Fig. 12), and at the church of The Virgin Mary (Tourniki, 12th century).

Fig. 12 (a) 3-D representation of the Katholikon of the Metamorfosi tou Sotiros with its narthex; (b) Damage of the cruciform vaults and the pendentives supporting the central dome.

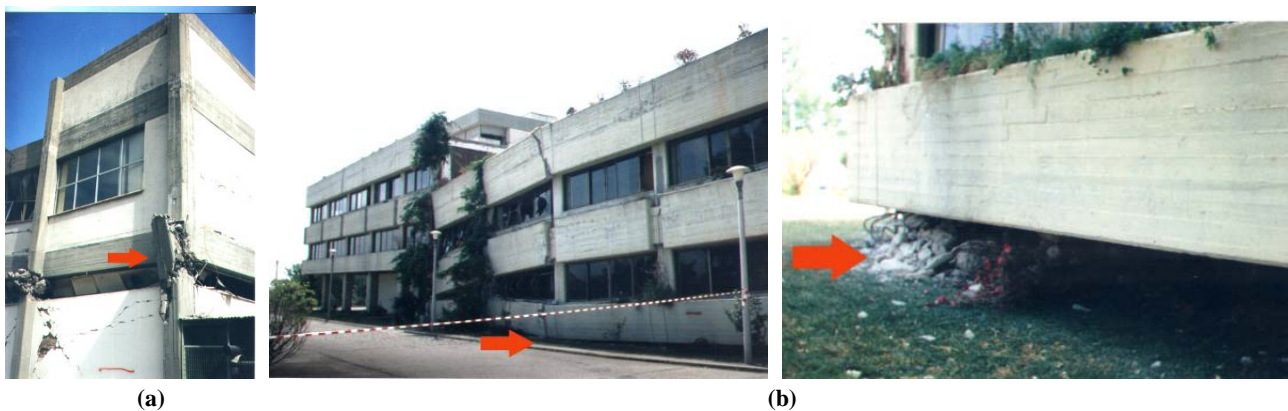
13a), “soft story” (Fig. 13b) at the ground floor, unsuitable structural system for resisting lateral loads, structural elements of low ductility prone to shear failure, foundation of spread footings connected with beams, irregular shape in plan and in elevation, absence of adequate number of shear walls etc.

Fig. 13 (a) Short column failure; (b) Total collapse of ground floor (failure of all ground floor “soft story” columns).

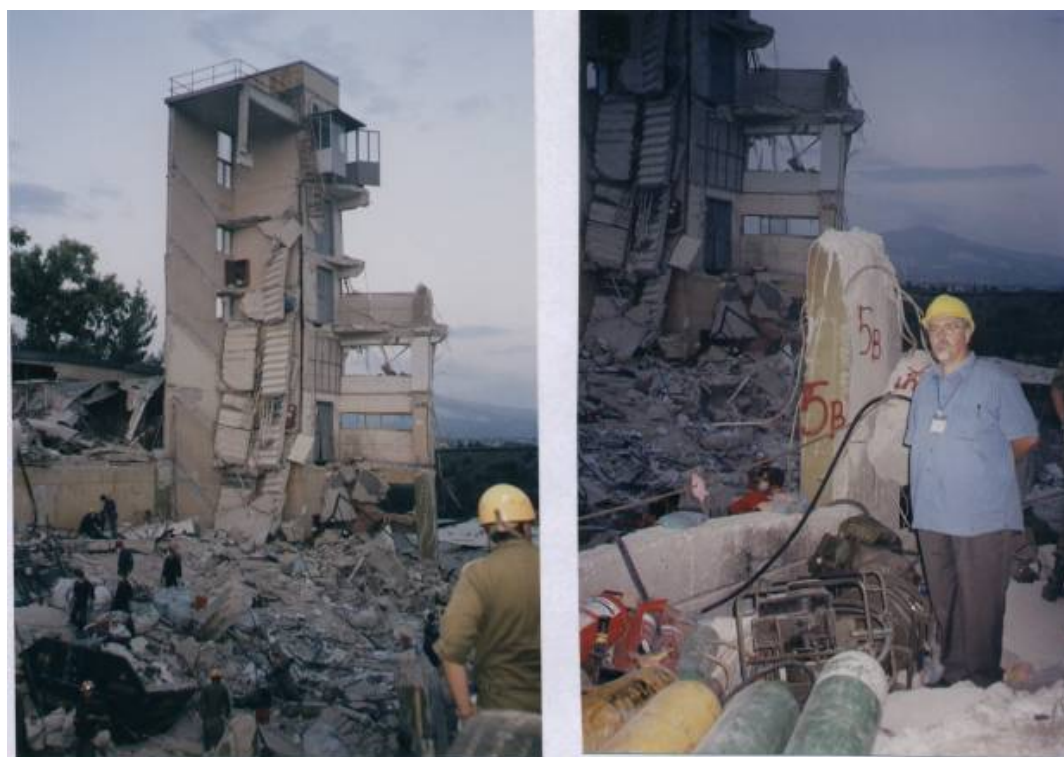
- There is a special category of building structures where the cause of damage lies in the fact that they have been extended or altered without any seismic design provisions being followed (Figs. 15 and 20). This is particularly valid for facilities housing small industries. The damage in these cases is very heavy. Faults in detailing and the severity of shaking caused spectacular damage in the epicentral area (Fig. 16)

Fig. 15 The collapse of the “Ricomex” building (epicentral region).

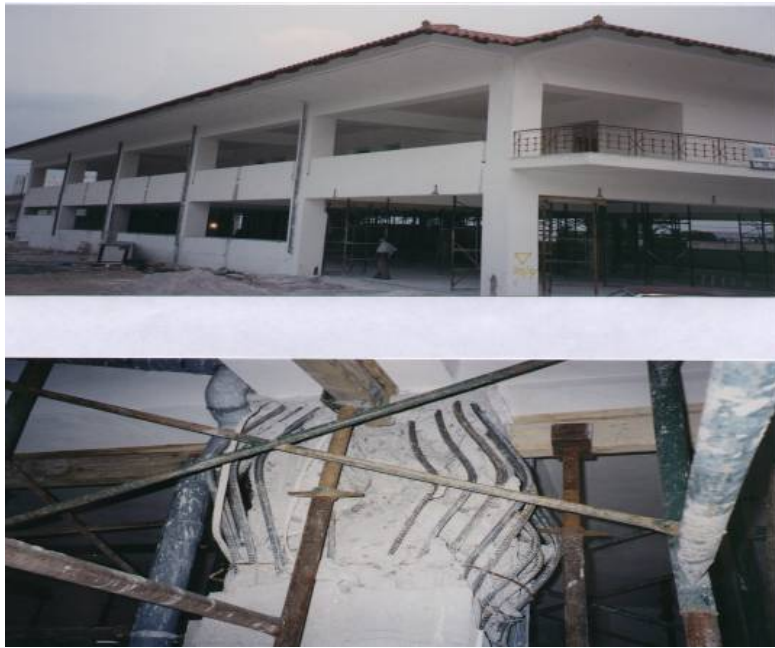
Fig. 16 Failure of all the central columns (epicentral region).

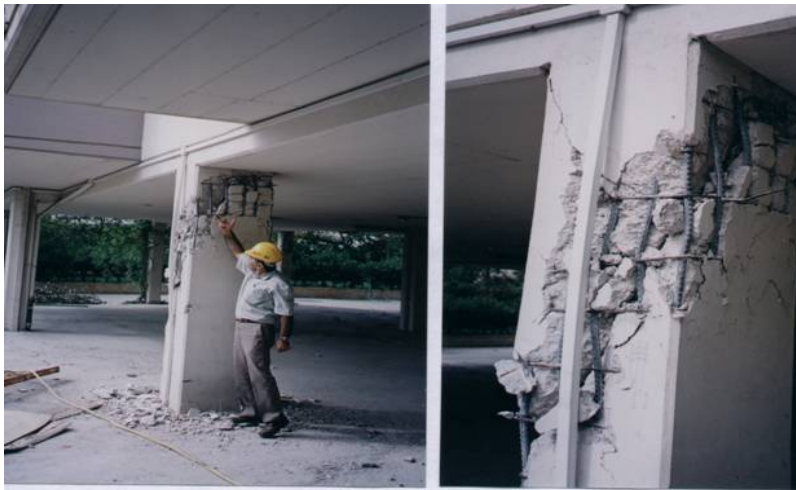
- Main causes of damage for multi-story R/C structures in all presented cases arises from “soft-story” mechanisms (Figs. 17 and 18) and short columns. The most common case of “soft-story” is at the ground floor to be used as parking lot.

Fig. 17 Column shear failure – “Soft story” Metamorfosi building.

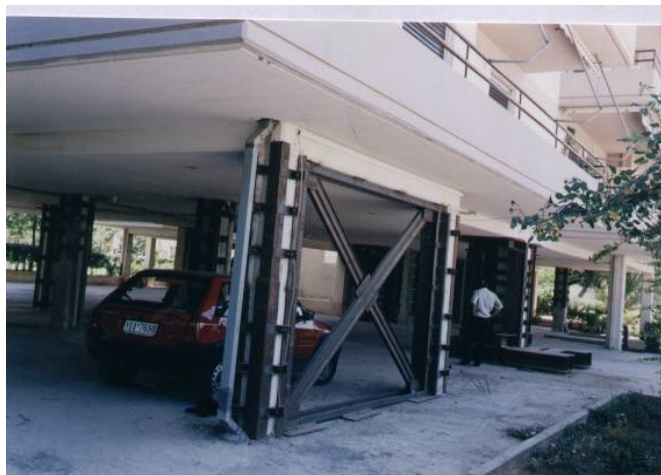
Fig. 18 Temporary strengthening of the damaged “Soft story” of the Metamorfosi building.

- Despite the experience gained during the last 30 years by post-earthquake immediate measures in temporary shoring of damaged structures in order to avoid partial or total collapse during subsequent strong aftershocks this was applied with considerable delay in the case of the Athens 1999 earthquake (Fig. 18 and [13, 27, 48]).

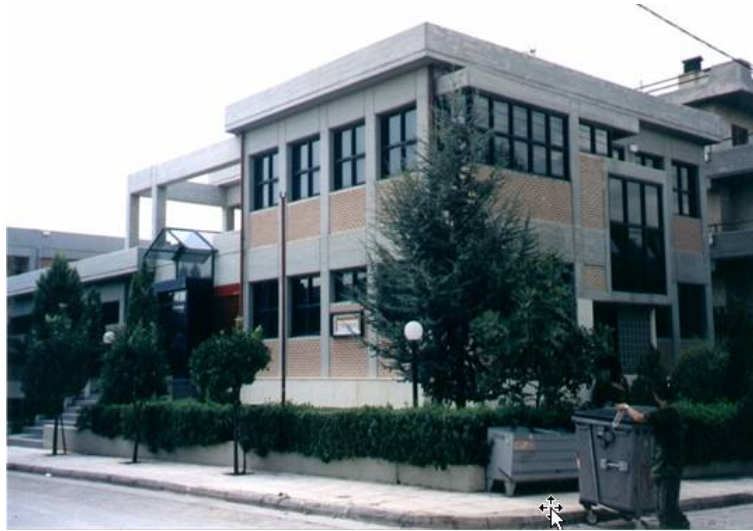
Fig. 19 Excellent performance of “Gnomon” building designed by the New Greek Seismic Code (epicentral region).

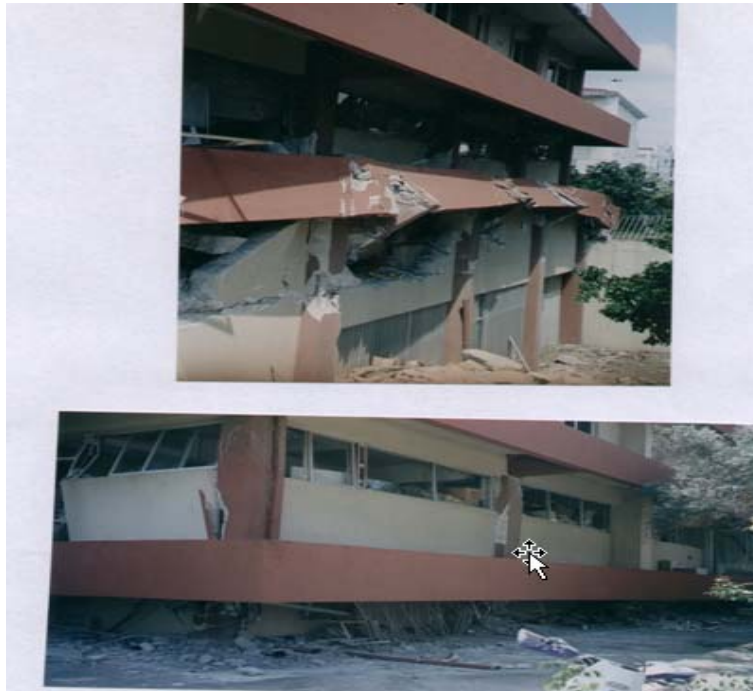
Fig. 20 Total collapse of ground floor with short columns—“Prokos” building (epicentral region).

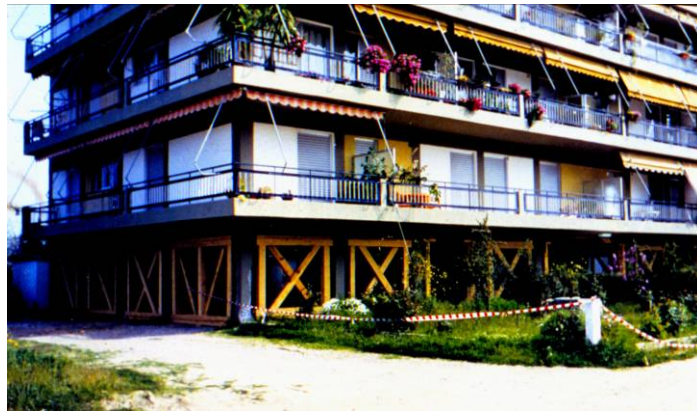
This building (Figs. 23-26) was designed and constructed in 1990 according to the provisions of the Old Greek Seismic Code [23, 40, 42]. It included at its ground floor a “soft-story” which was seriously damaged during the 1993 Pyrgos strong earthquake sequence (see section 2.3). As a case study, for the effect of the provisions of the New Greek Seismic Code, the earthquake (EQ) performance of this 5-story

Fig. 24 Temporary strengthening of the damaged “soft story” of the “Pyrgos Hardas” building.

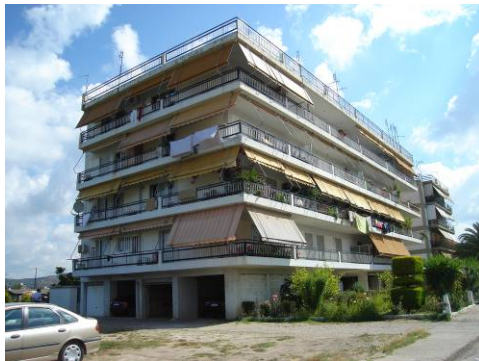
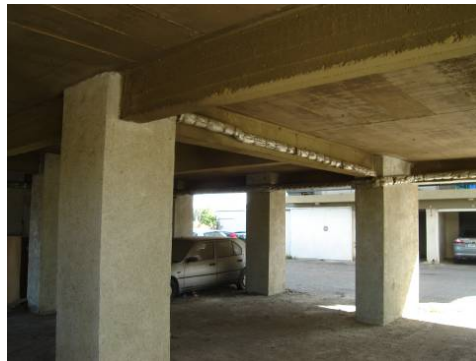
Fig. 25 Pyrgos Hardas building with columns at the ground floor “soft story” strengthened by R/C jacketing. The performance of this repaired building during the 2008 earthquake sequence was satisfactory without signs of any distress.

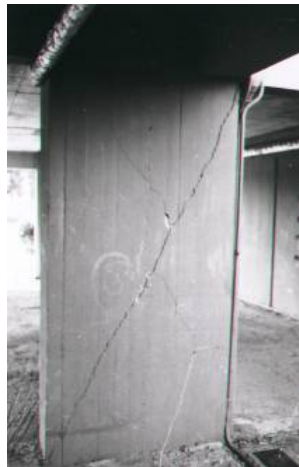
Fig. 26 Damaged column C35 of the Pyrgos Hardas Building.
