The Importance of the Damage's Map in Identifying Pathologies on Historical Buildings: A Study of the Carmo's Church – Olinda – PE

Based on what was said before, this article results from a master's research in progress and it aims to show the development process of a damage map based on the methodologies adopted by Iphan, seeking its implementation in a real case study, the facades the Carmo's Church in the city of Olinda – PE.

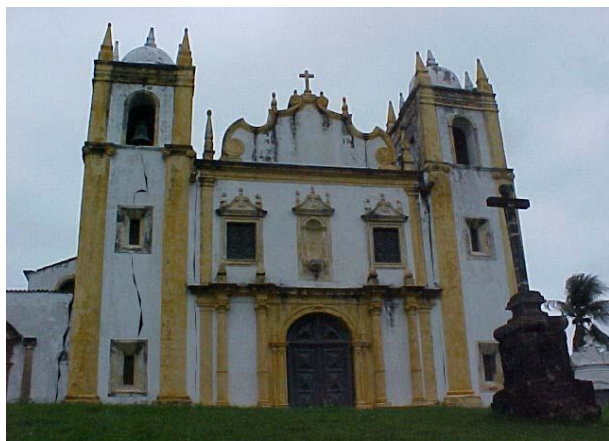
Fig. 3 Structural Damage in the Church of Carmo's in the middle of the year 2000.

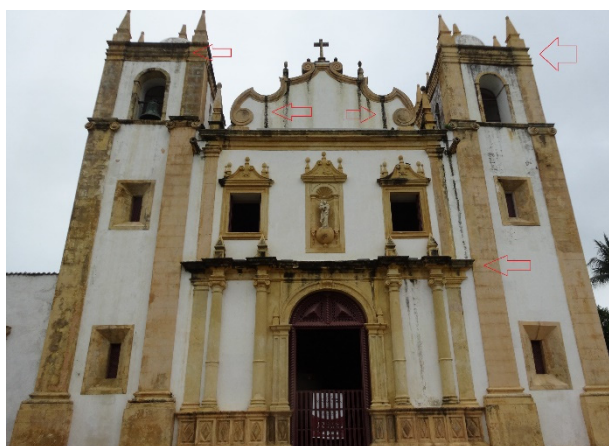
Fig. 4 Current damages in the Carmo's Church.

church was returned to the population. However, after only four years of restoration work, some anomalies in the facades can be observed.

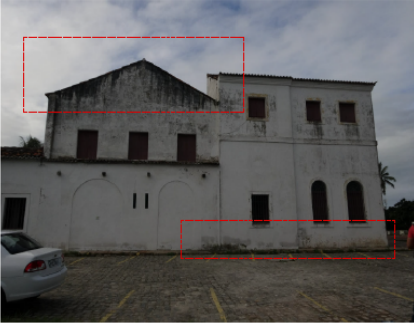
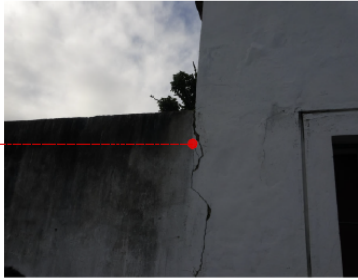
Fig. 8 DIF of Our Lady of Carmo's Church – South Facade.

In the south facade, there were also damp stains with dirt, including damp stains upward along the full length of the facade (see Figure 8).

Also, there were some changes to the initial design of the building, some door openings were sealed, and some windows could not be opened anymore. We did not get the information about the interventions implemented, which made it difficult to identify the material that was used to seal these elements. We believe that the material used was probably a high porosity and high permeability since there were some damp stains in areas where these changes were made.

Another issue identified is the appearance of a vertical crack with thickness ranging from 0.5mm to 2mm found near the tank wall (south facade). As the Carmo's Church has a history of structural problems arising from settlements, having gone through a strengthening of foundations in mid-2001, it is necessary to consider this problem by monitoring this fissure in order to identify their origin.

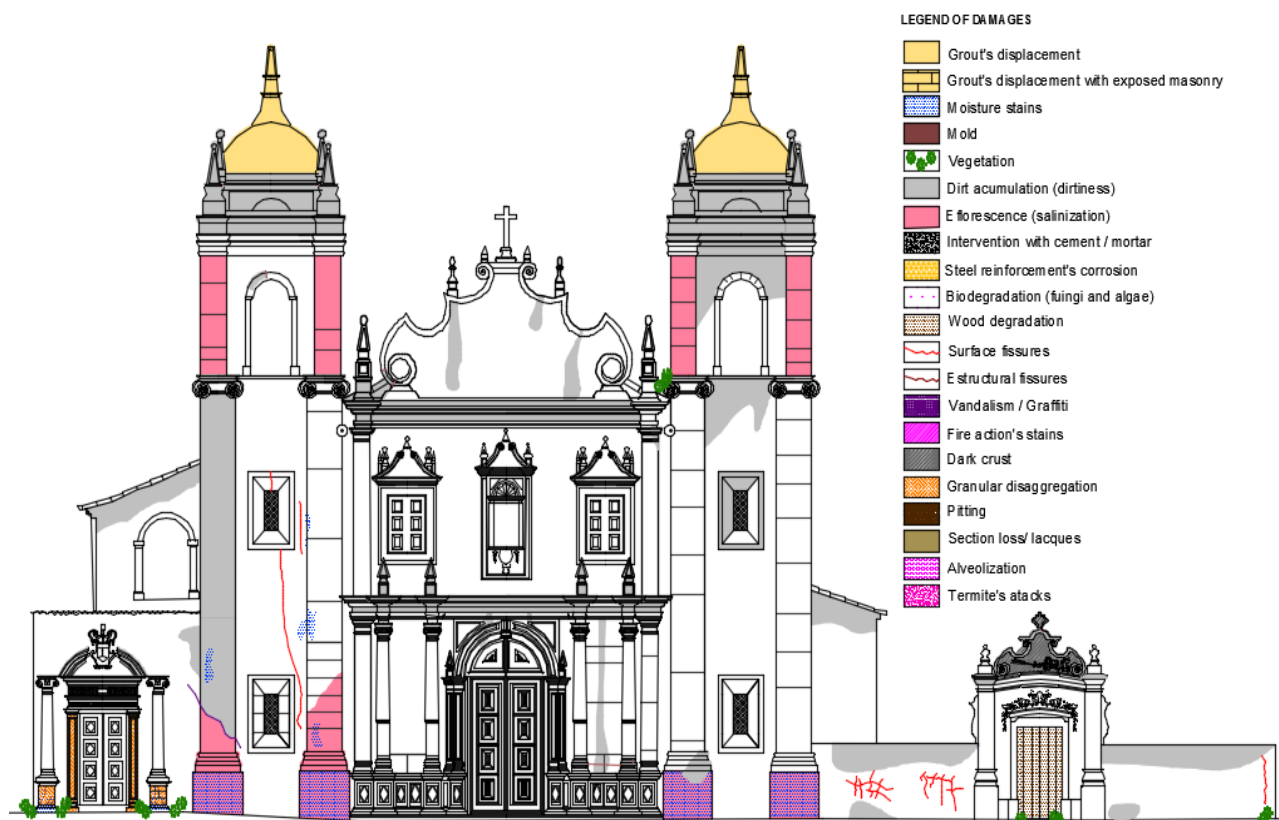
Fig. 10 Damage's Map of Our Lady of Carmo's Church – North Facade..

Thus, we can say that the pathological problems more observed in the facades of the Carmo's Church were dirt, vegetation, cracks and moisture. Also, it is found in the east facade, west and north, black crust recurrences. During the surveys were also found pieces of reinforced concrete with high state of reinforcement corrosion and wood rot in a northern front door. In the figures below are presents succinctly the Damage Identification Form of the pathological manifestations

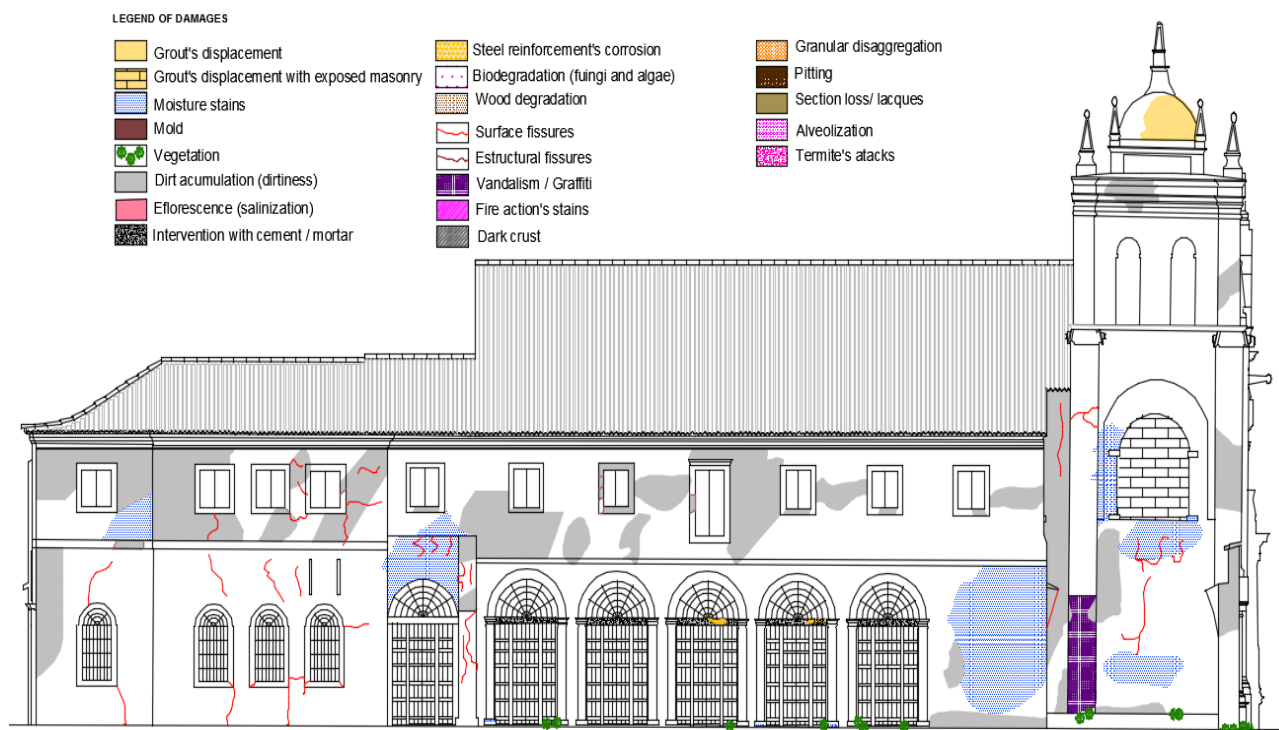
Fig.11 Damage's Map of Our Lady of Carmo's Church – East Facade..

The Figure 7 shows the East Facade's DIF, where it is observed that the pathological problems more incidents in this building are damp stains, dirt, cracks in the plaster, the presence of vegetation and corrosion of reinforcement.

The use of reinforced concrete, evidenced by the presence of reinforcement corrosion, indicates an intervention in the structure with the use of building technologies nonexistent at the time of construction of the temple. Thus, treatment of this pathological manifestation should be done as soon as possible and so as not to interfere with the safety preserving the architectural features of the facade.

It is noteworthy that the East facade of the building has a higher incidence of salt spray, given that Carmo's Church is located in a coastal area. Thus, the reinforced concrete structures are more likely to degenerative action of chlorides and cycles wetting and drying produced by the rains.

For example, we detected corrosion in the East facade of the Carmo's Church where there was an intervention with reinforced concrete. After analyzing the area, we observed that the East facade was nearest to the ocean where occurs salt mist. It confirms the importance of the knowledge of the environment which the building is located.

Thereby, the correction of corrosion points found in

the inspection of the East facade must be treated as soon as possible in order to avoid loss of steel section, stirrups breaking and peeling of more areas.

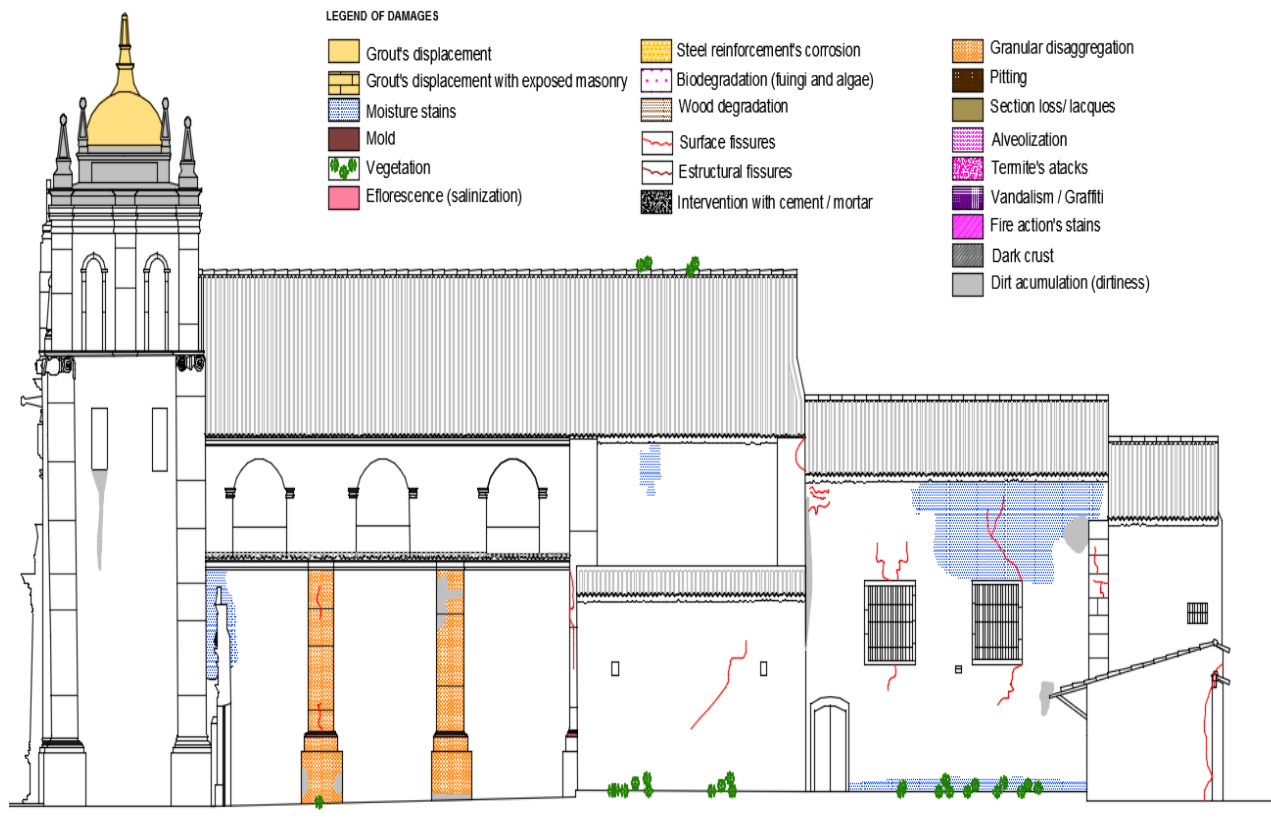
Fig. 13 Damage's Map of Our Lady of Carmo's Church – West Facade..

anomalies frame is similar to other facades. However, there was more damage in the structure of the masonry in this facade than the others with granular breakdown, pitting and section loss (gaps).

We can also see in the DIF of the west facade that the process of penetration from the soil capillary water was intensified by building metal ramp that, in the time of rain, splashes on the facade. Thus, it is observed at this point the development of molds and slime.
