Impact of Deterioration of Flare of an Offshore Oil Platform

2.1 Inspection of Corrosion, Cracks and Fissures in Flare System on Offshore Platform (FPSO)

2.2 Case Study Involving Corrosion Problems and Failures in a Flare of an FPSO

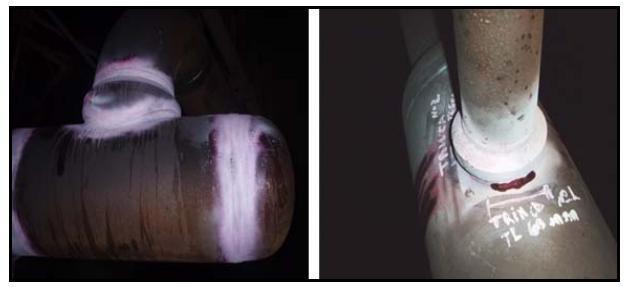
Fig. 5 presents two examples of observed cracks in the welded region and in the body of the tube in branching lines using collars that are thicker than the tubes creating thermal stresses. Such failures could compromise drastically the flare and force an emergency stop for repairs.

Fig. 5 Cracks and fissures identified by liquid penetrant in heater tubing.

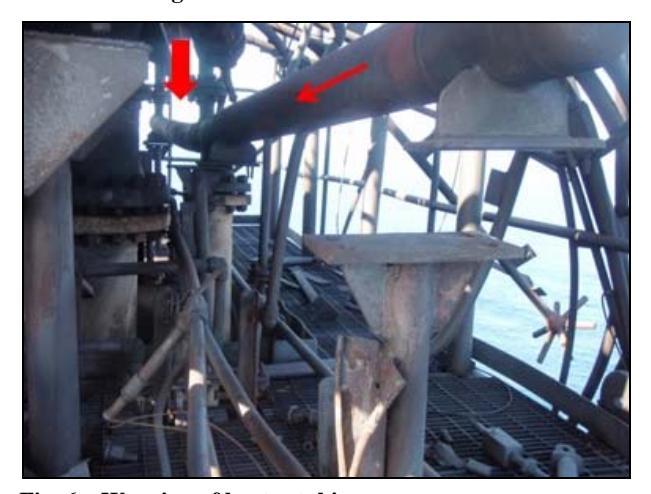
Operation of the system in high temperatures also favours the distortion of lines if they are not properly supported, since the material Yield Strength is reduced as the temperature increases and plastic deformation becomes easier. Fig. 6 illustrates the warping of a heater tubing line. In this case, the deformation is not in accordance with the standards, and may generate cracks.

Fig. 6 Warping of heater tubing.

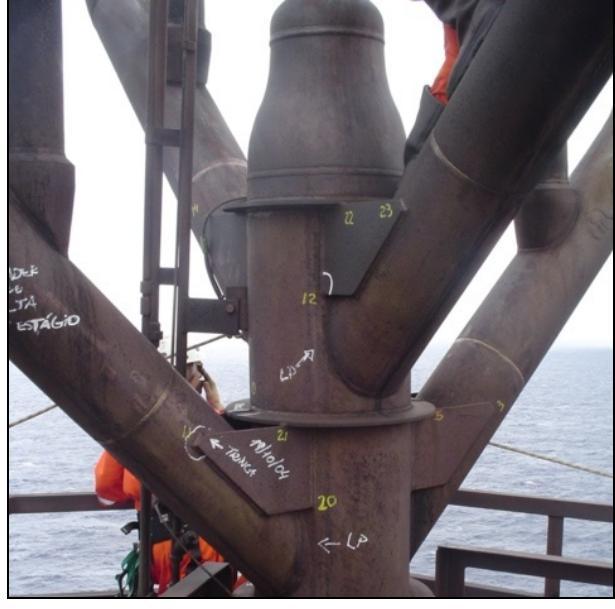
A good piping support is very important when operating in high temperature but highly restrictive conditions should also be avoided since the lack of freedom in material expansion generates thermal stresses. When heating and cooling cycles occur several times during the life of the system a thermal fatigue mechanism is generated and cracks appear, as illustrated in Fig. 7. When the support is directly welded to the process piping, without transition paddles, the cracks that appear due to relaxing of the

Fig. 7 Cracks in the welding of supports to the main tube.

thermal stresses may propagate by fatigue associated to other kind of generated stresses, like the FPSO movement, and if the cracks propagate through the process piping it may cause a critical condition.

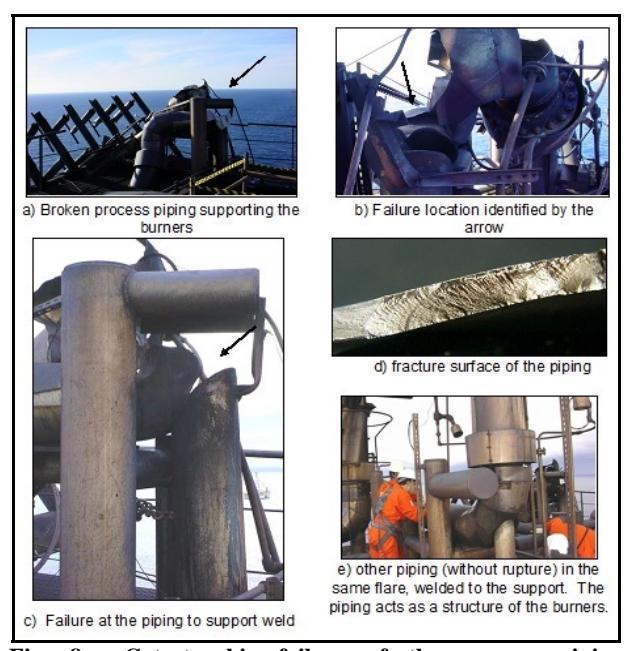
Fig. 8 Catastrophic failure of the process piping supporting the burners due to fatigue in the welded region of the support to the main tube.

A catastrophic mechanical failure occurred for the burner as in Fig. 8 due to the weld of the process piping directly to the trunnion support, in a condition that the piping was acting as a structure to support the burners. In the fracture surface of the process piping, it is possible to see the propagation of cracks by a fatigue mechanism. The arrow presents the failure region of a, b and c in Fig. 8. In Fig. 8d it is clear the fatigue beach marks in the fracture. In Fig. 8e, it is possible to see how the trunnion was directly welded to the main process piping and the structural condition of the process piping. To restore this equipment to operation a long time is required since a new part (piping and burners) had to be acquired.

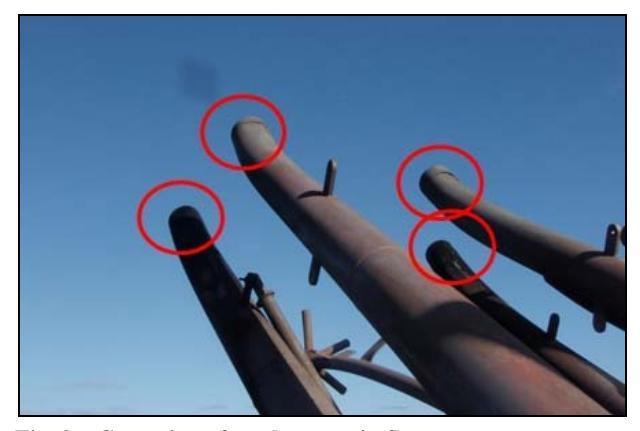
The flare operating conditions, with which the deterioration is associated, are high-temperature corrosion, which results in the collapse and loss of metallic material, as shown in the destruction of the gas outlet nozzle in Figs. 9 and 10.

Fig. 9 Corrosion of gas burners in flare.

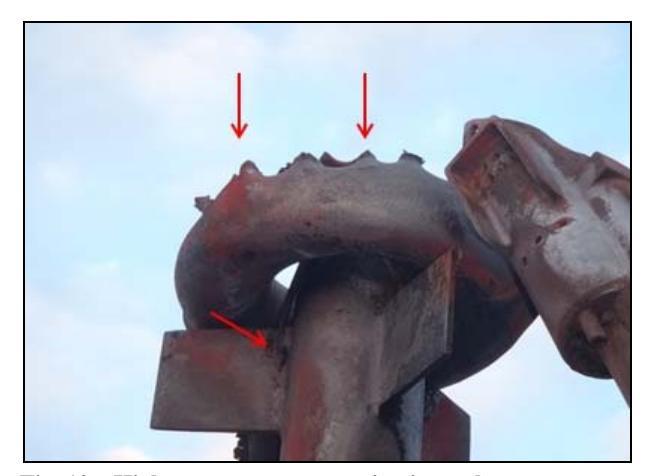
Fig. 10 High-temperature corrosion in gas burners.

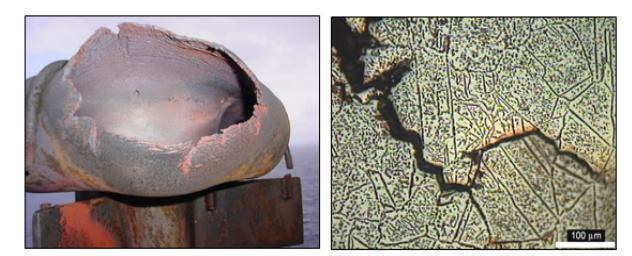
Fig. 11 Flare tip carburized and cracked due to high temperature corrosion. Austenitic structure presenting carbides. Electrolytic etch.

Additionally if the tips are exposed to a carburizing condition (by the flame) the material degradation is quickly, as evidenced in Fig. 11. The metallographic replication technique adopted for the tips help to understand if the material is suffering the carburization, clearly revealed by a carbide precipitation in the structure.

The carbide precipitation makes the SS less corrosion resistant since the chromium in solution precipitates as carbides and depletes the material in chromium, responsible for the surface passive layer. When the material is carburized (carbon was introduced in the alloy composition from the surface) and operates in high temperature the life is strongly reduced. This condition may be monitored by metallurgical inspection using replication technique.

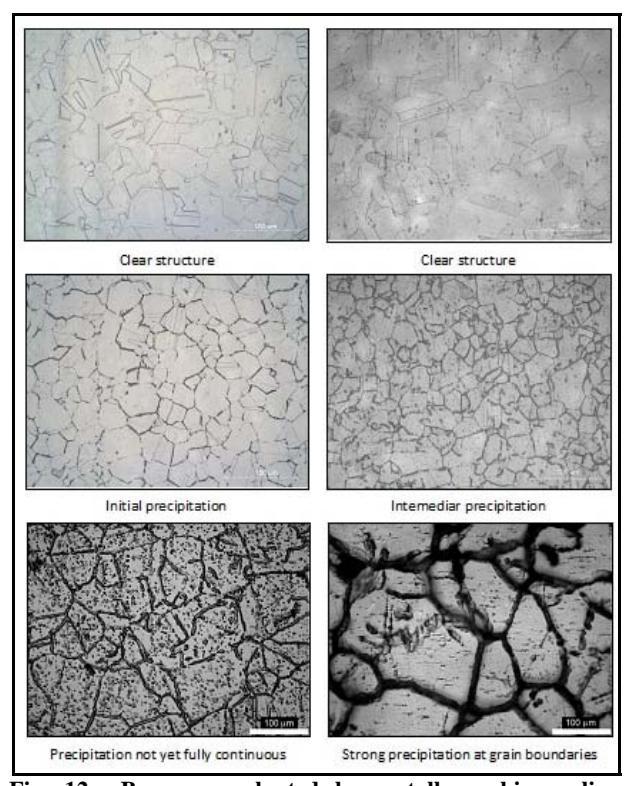
When the material works in temperatures higher than 400 °C, but not directly exposed to the flame (i.e. no carburizing conditions), it is still possible to occur carbide precipitation due to the carbon content of the steel. The carbon precipitates at austenitic grain boundaries and depletes the adjacent region. This condition, called sensitization, creates a condition for intergranular corrosion to occur [22]. Fig. 12 presents several examples of austenitic structures with different levels of carbide precipitation, evaluated by replica in flare systems.

Fig. 12 Burners evaluated by metallographic replica, presenting different levels of precipitation at grain boundaries due to high temperature effects. Electrolytic oxalic acid etch.

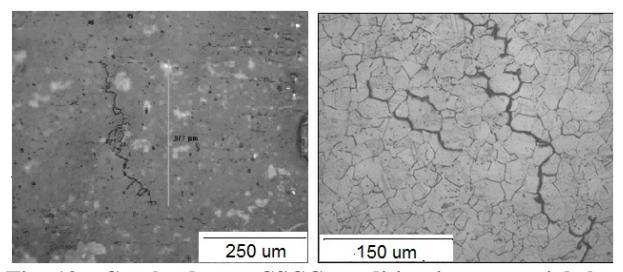
The worst condition for intergranular corrosion to be critical is not at high temperature but it is when there is a wet and warm condition, as the sensitized steel is very susceptible to CSCC. Fig. 13 shows a crack in a location a little far from the tip where the material undergone a carbide precipitation and generate a crack due to CSCC.

Fig. 13 Cracks due to CSCC condition in a material that is slight sensitized by the high temperature.

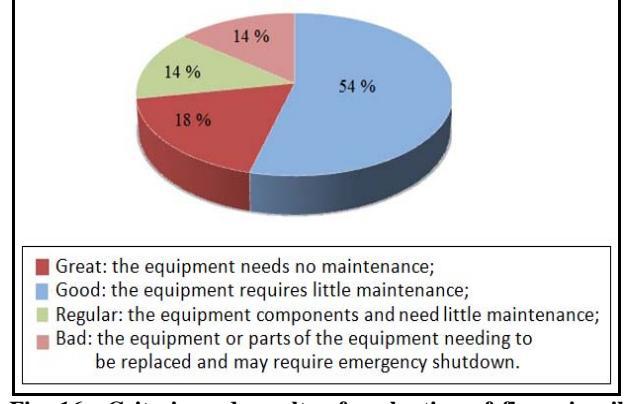
Based on reports from 30 inspections of oil rigs operating in the world, relating to the flare system, are considered the following classification criteria for the scheduled maintenance shutdown program of 15-20 days, or an emergency shutdown program of up to seven days. The results of this assessment are presented in Fig. 16.

Fig. 16 Criteria and results of evaluation of flares in oil and gas offshore rigs.
