Lead and Cadmium Distribution in Tubes of Galvanized Steel by Hot-Dip Used for Drinking Water Supply

Abstract: The main objective of this work was to evaluate the presence of lead and cadmium in galvanized steel tubes by hot-dip used exclusively for drinking water supply. In this research, samples of galvanized tubes were removed from walls of residential buildings with 30 years of use. In the process of hot galvanizing, the manufacturing standards allow or for low cost conveniences, and the use of primary zinc ingot with 1.6% metallic impurities, such as lead and cadmium, is allowed, enabling the incorporation of these metals into the zinc coating deposited on the carbon steel. The associated corrosion of these tubes can release these toxic metals, contaminating the drinking water used by residents. The samples taken from the tubes were evaluated by a square-wave anodic stripping voltammetry technique, and the results for lead and cadmium suggested randomly distributed levels, indicating that the contents of these contaminants depend mainly on the quality of the added primary zinc and the operational conditions of the immersion bath. The metallographic evaluations performed on th

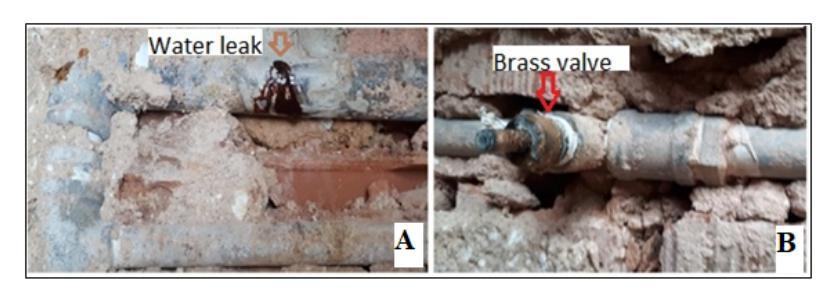
(potable) water to the bathrooms, kitchens, and service areas of two residential buildings that were built 30 years ago. Fig. 3 highlights a water leak and valve made of brass, illustrating galvanic corrosion. In Figs. 4 and 5, the tubes used as specimens for chemical and metallographic analyses are presented. Corrosion is noted from the inside out, and in some cases, crevice corrosion and galvanic corrosion caused by iron (carbon steel)-brass or iron (carbon steel)-bronze connections are observed under the deposit.

Fig. 3 Galvanized tubes and connections in a residential building.

Based on this premise, the condition of these samples taken can be considered as being intact on these walls for 30 years, as they are completely dry (Figs. 3a and 3b). However, in Fig. 3a, there is a leakage point from the inside out. This occurrence corroborates the fact that this water leakage migrates to the walls, making them moist and, consequently, favoring external corrosion of the tubes, as shown in Figs. 4b and 4c. Another premise, based on the presented micrographs (Figs. 8 and 9), suggests that the low thickness and defects may also happen inside of the tubes, favoring localized and generalized corrosion.

Based on Fig. 3b, it can be assumed that a brass valve connected to the galvanized pipe can internally accelerate the corrosive process by galvanic corrosion, which is defined by the connection of two different metals immersed in drinking water. These facts can be substantiated by works presented in the referenced literature [14-15].

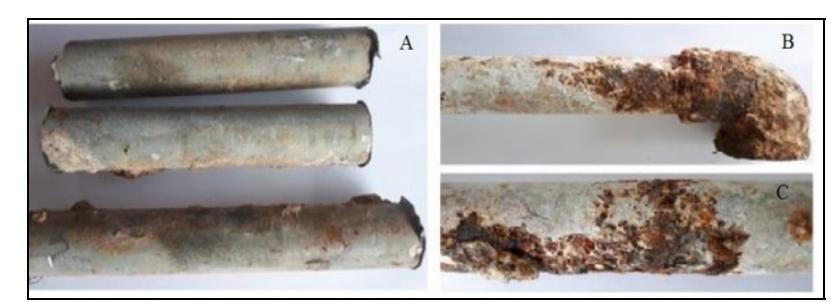
Fig. 4 (a) Galvanized tubes removed from dry walls and (b and c) tubes and connections removed from wet walls in a residential building.

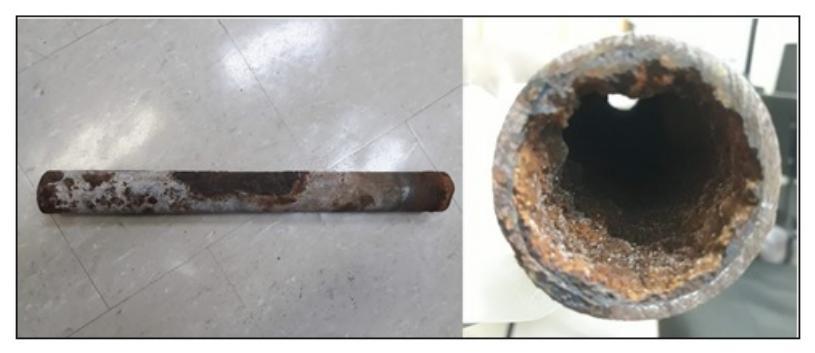
Fig. 5 Internal and external corrosion in galvanized tubes.

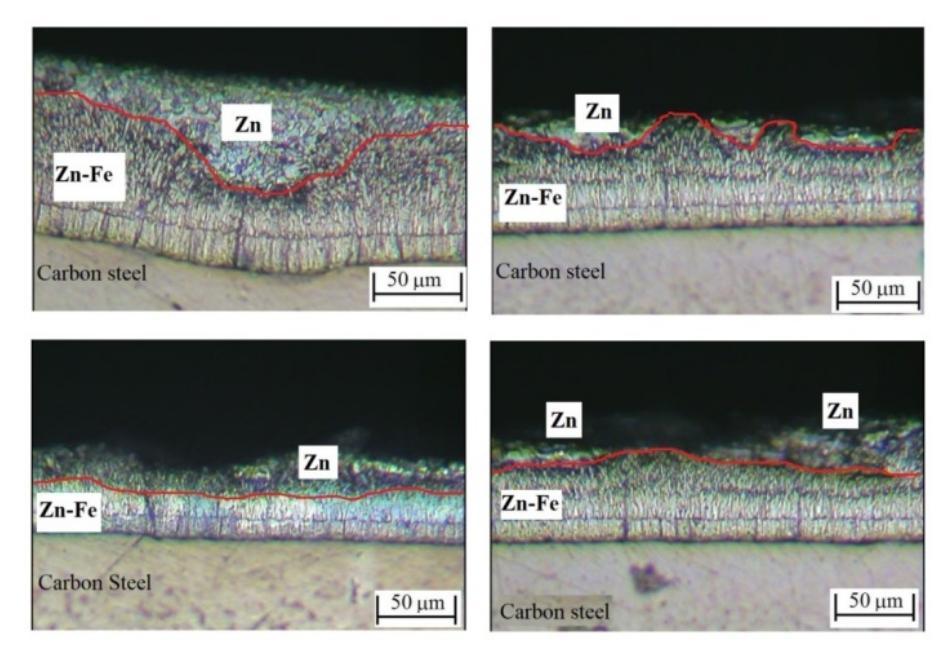
The micrographs shown in Fig. 8 show the outside of the tube. The Zn-Fe layers formed by immersing carbon steel (Fe) in molten zinc are made up of the four phases, as shown in Fig. 2. The three Fe-Zn

Fig. 8 Micrographs illustrating irregularities in the zinc layer.

phases are (γ) FeZn₃ phase containing 21-27% iron, (δ) FeZn₇ containing 7-12% iron, and (ξ) FeZn₁₃ containing 2-6% iron. The layer of nearly pure zinc (η) is irregular and discontinuous, ranging from 5 to 80 μ m thick. The micrographs shown in Fig. 9 also show the outside of the tube where defects and discontinuities of the coating are observed, favoring the corrosive process [2-4].

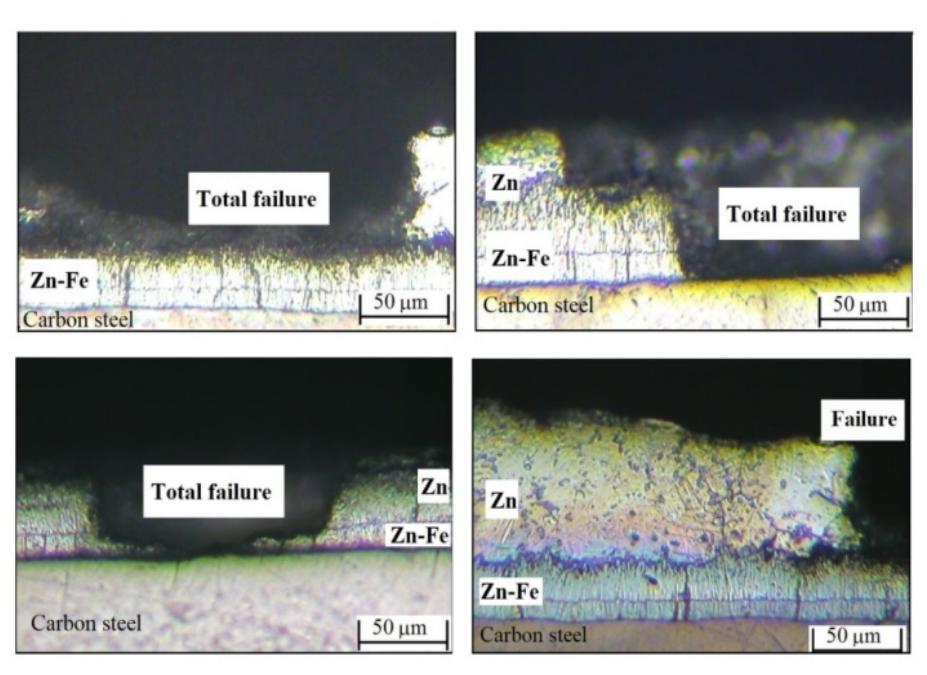
Fig. 9 Micrographs illustrating zinc coating failures.

• Metallographic analyses, carried out on the outside of the galvanized tubes removed from the dry walls (where there was no corrosion), showed irregularities, discontinuities, and failures in the zinc coating on the carbon steel.

• Finally, considering both paths of lead absorption (oral and cutaneous), in addition to being a bioaccumulative metal, where concentration levels are more sensitive in children, pregnant women, and the elderly, compared to adults, tubes coated with zinc by the hot-dip process must be banned for drinking water installations.
