# Workshops of the Paulista Company in Jundiaí, São Paulo: A Threatened Railway Heritage

**Abstract:** The workshops built by the *Companhia Paulista de Estradas de Ferro* in Jundiaí can be considered among the most significant Brazilian railway assets, both for their aesthetic and deployment qualities, and for the industrial activities carried out on the premises, since their spaces preserve the memory of the work of generations of railway personnel who performed their various functions there between 1893—the year they opened, and 1990 when they were permanently decommissioned. This complex, during its almost 100 years of operation, has undergone significant modifications and enhancements mainly due to technological changes driven by the replacement of steam traction by electric traction, and then by diesel-electric traction. Despite this, the complex maintained an impressive architectural consistency. Unfortunately, most of the buildings of this complex are unused and in disrepair, being the target of invasions, vandalism and theft of materials that if not stopped will cause irreparable damage to its structure and to the local ambience. The question that appears most urgent, the

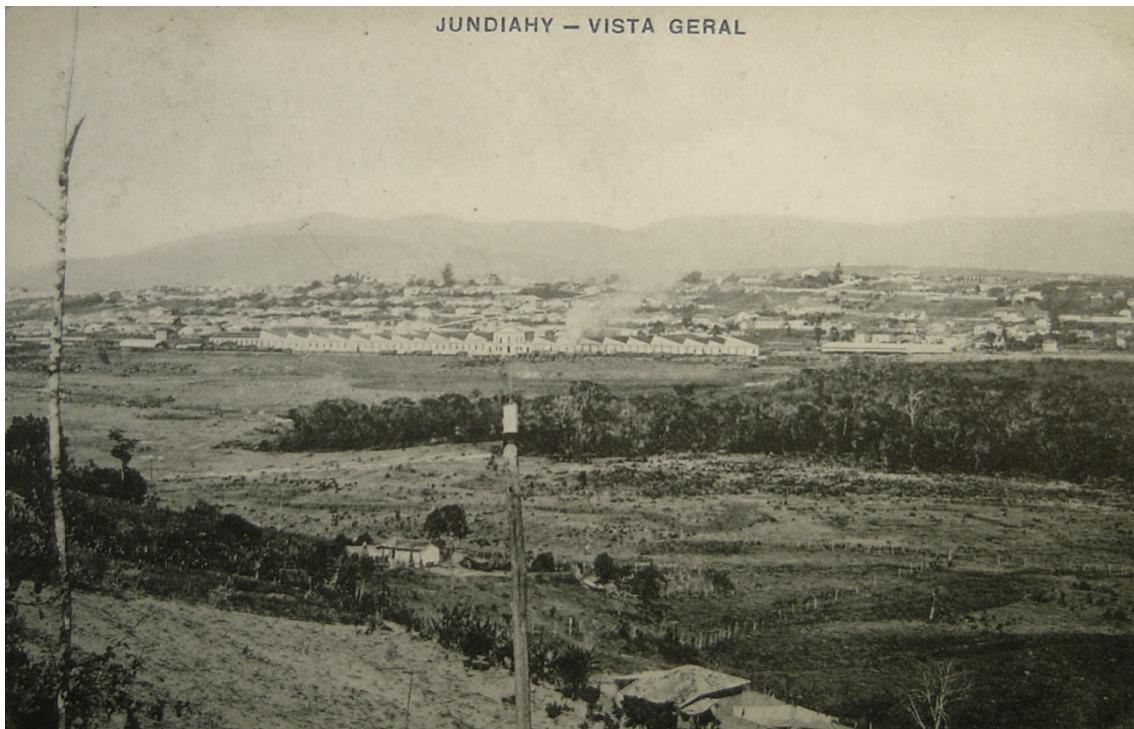
**Fig. 1** 1908 postcard showing the Paulista Company's workshops in Jundiaí, note their size in relation to the city.  
Source: collection of Historical Museum of Jundiaí.

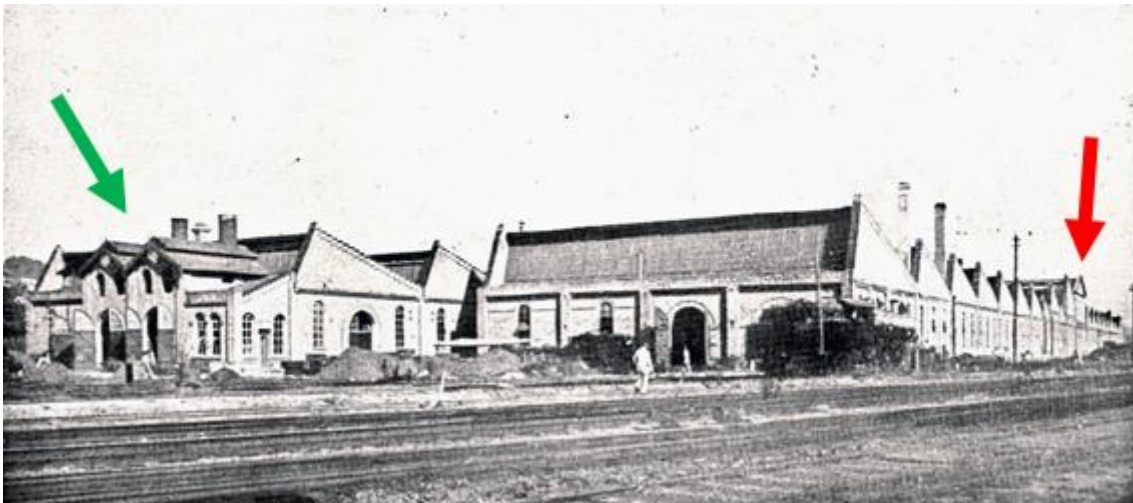
**Fig. 3** View of Jundiaí workshops from the railway line. The red arrow indicates where the Inspection Department of the company worked. The green arrow shows the original features of the workshops before the expansion taking place in the 1950s.

In locations intended for accounts and inspection, the finishing is more elaborate, moving away from the recommendations of the treaties, especially in the composition of the facades in which are used ornamental elements originating from the classical vocabulary in addition to Masonic symbols (Figs. 3 and 4).

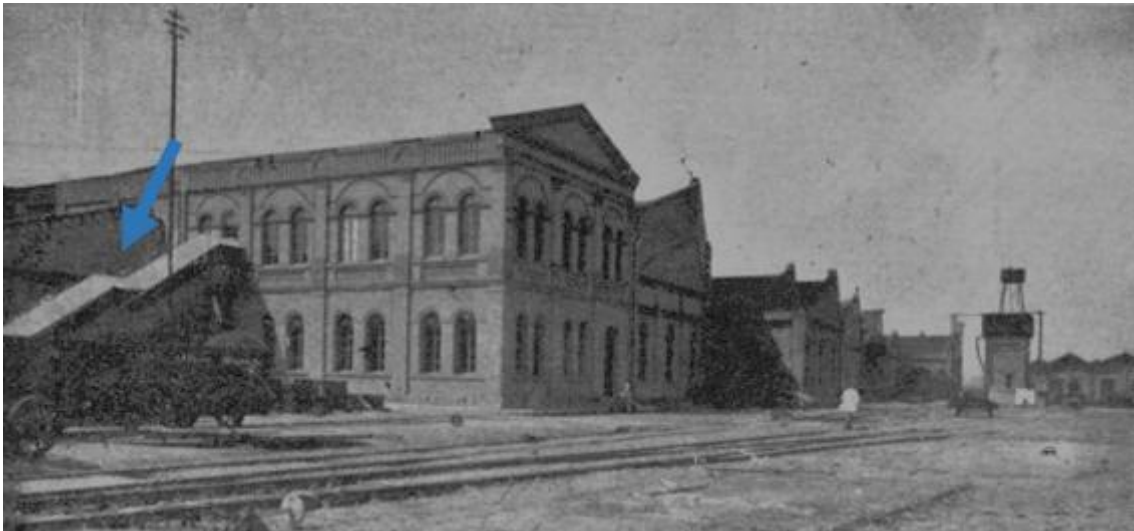
**Fig. 4** Former Accounts Department. The blue arrow shows where the stockrooms used to be. Note that the building had only one floor and had sawtooth finishing, as did the other sectors of the workshops. There would later be added a second floor for use as offices. At the front, one can see the covered stairway that led to the reception. This stretch is one of those that suffered the most profound changes of the whole group, compared with the Figs. 5 and 6.

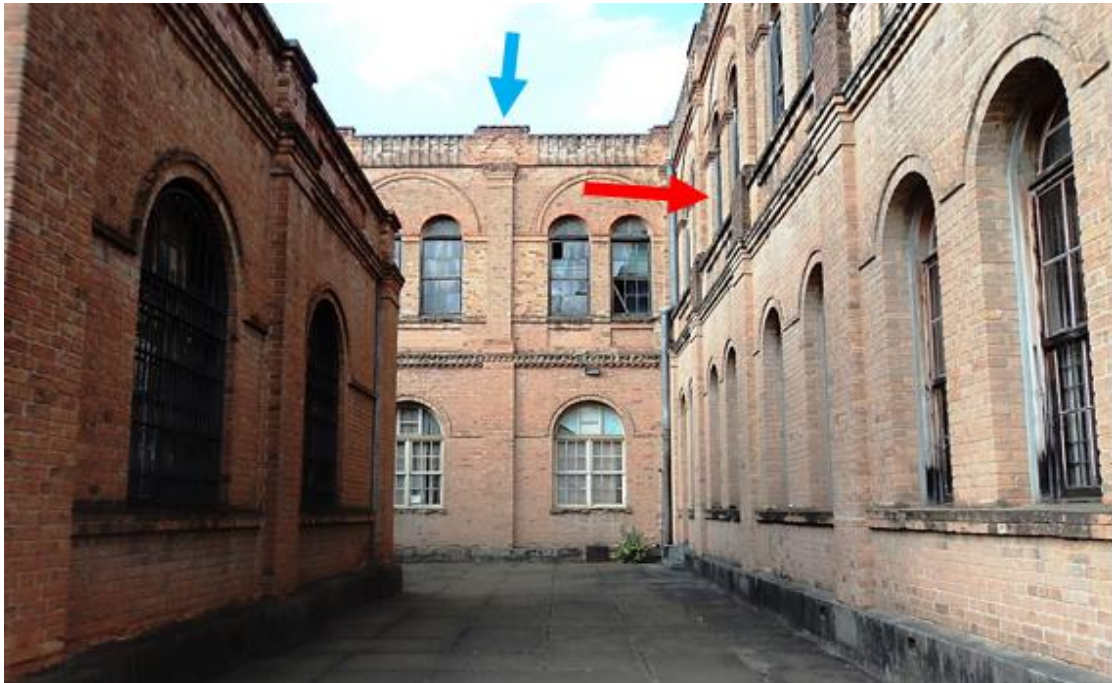
Fig. 5 The blue arrow indicates the stretch where the stockroom stood that was expanded in the 1950s. The red arrow indicates the location of stairs to the second floor, compared with Fig. 4.

In the extension of this second building, at the end of the stretch in U, we have three more modules with sawtooth finishing, probably built during the same period. There are, however, differences in the finish (an oculus in the centre of the first gable, for example). The frames, apparently of the same design as the remainder, were at some point replaced by others of a distinct modulation (Figs. 5, 6, 8, 9).

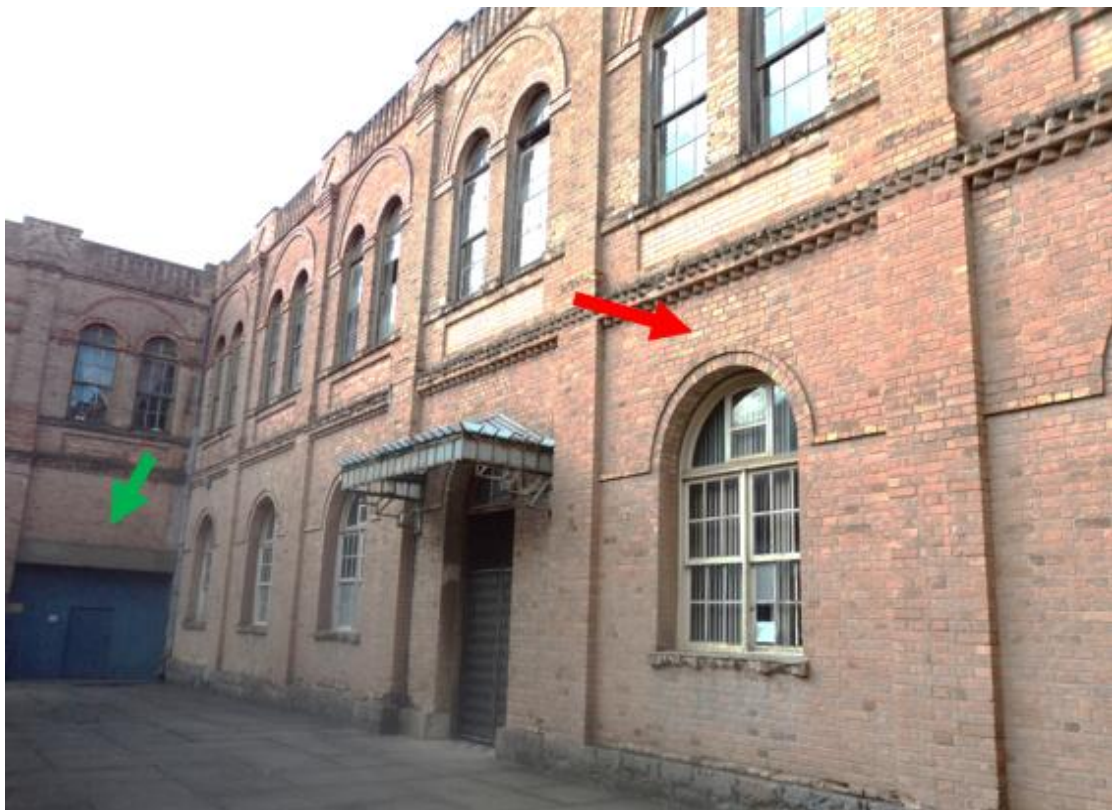
Fig. 6 Continuation of the stretch extended in the 1950s. Note the mark of the extension from the difference of the colour of the bricks (red arrow). The green arrow indicates the beginning of last segment that ends the stretch extended in the 1950s. Note the mark of the expansion in the bricks above the introduced girder.

Even today, the changes made can be detected by observing the difference between the bricks of the earlier setup and the new. The bricklaying, even though it was carefully performed by skilled workmen, shows the differences in composition and colouring of the material. Another detail that differentiates the time of construction is the foundations in mortar in the older buildings and masonry in the more recent.

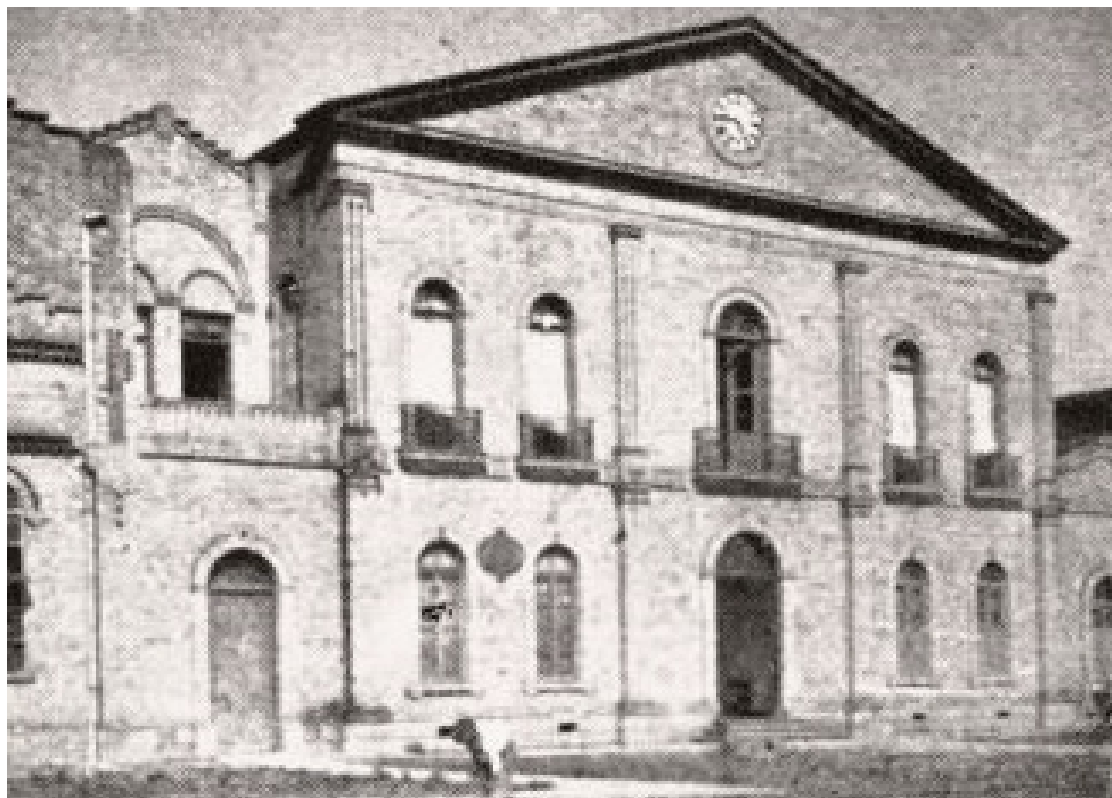
**Fig. 7** Entrance to the Inspector's Office. Note the decoration based on classical motifs.

In the existing part, the entire stretch following the Accounts Department (Fig. 7) was modified with the space where the stockroom functioned being transformed into offices. Outside, the sawtooth profiles were eliminated for the construction of a second floor that would follow the same architectural pattern as the remainder. The new configuration would take the form of an U, involving the Retirements and Pensions Fund building, being finished off with a similar construction to the Accounts Department. The area on the ground floor, comprising the inspector's offices (beside the

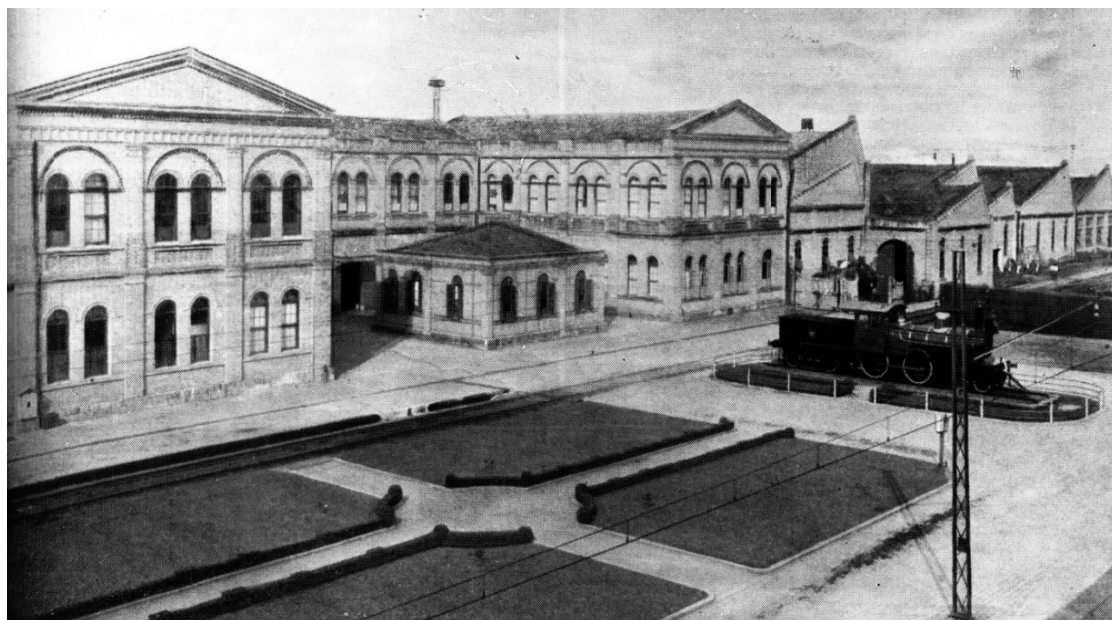
**Fig. 8** Portions of the workshops where the administrative activities were concentrated after completion of the expansion works. Note the concern of the authors to reproduce in the building on the right, the same details as the existing building. In the center, one can see the building of the former Retirement and Pension Fund, built between 1920 and 1930.

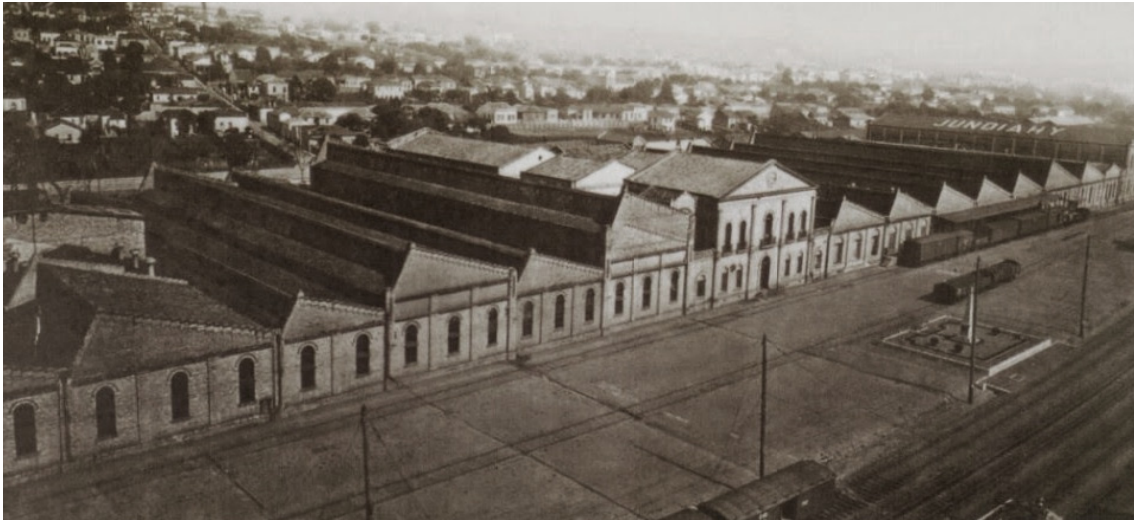
**Fig. 9** General view of the workshops in the 1950s from the rail bed. In the center, one can see the entrance to the Inspector's Office and in the background right, the workshops for the maintenance of diesel-electric locomotives.

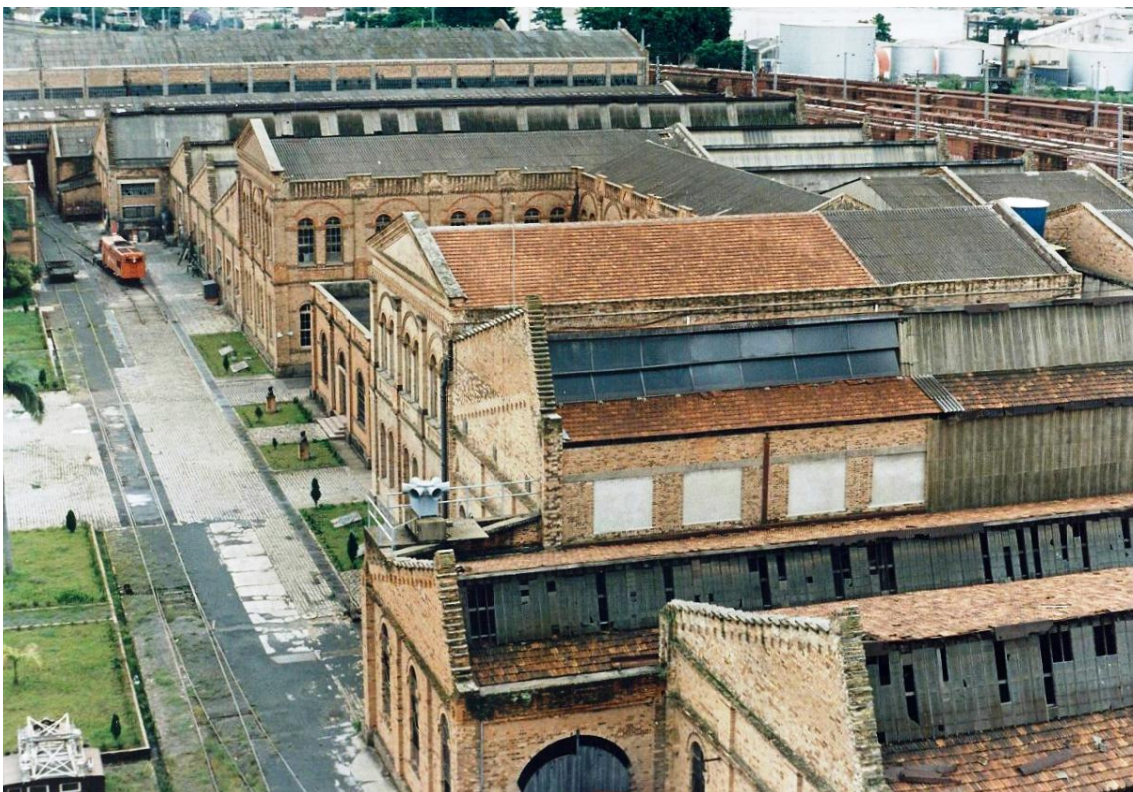
**Fig. 10** Aerial view showing the stretch expanded in the 1950s. Note the change in roofing, originally in French tile. Changes like this were probably made during the buildings maintenance work. At the back, the rear view of the workshop built to deal with the diesel-electric units (photo 1999).

Next were built new facilities for the maintenance of the electric and diesel-electric locomotives. The new building, although it had sidewalls in visible brickwork, did not follow the typology of the previous buildings, being constructed in concrete and steel, because of the increased weight of the new compositions (Figs. 10 and 11).

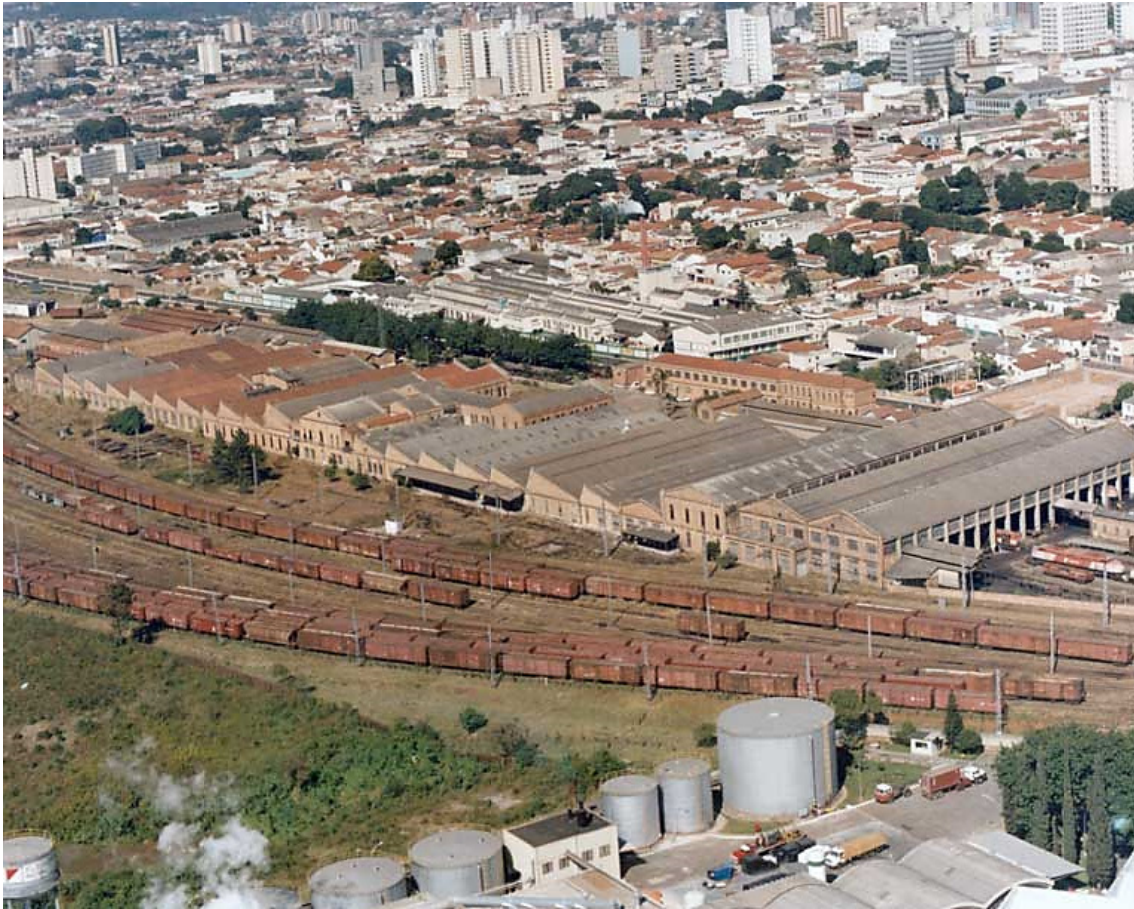
**Fig. 11** Complex of the Jundiaí workshops in 1992.

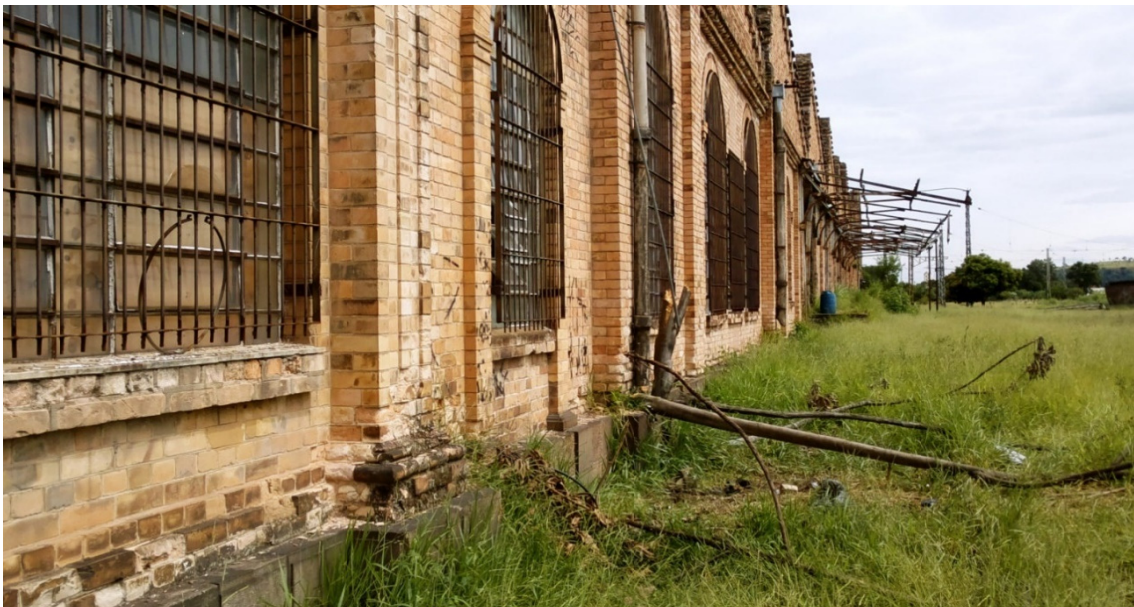
**Fig. 12** Current situation of the old entrance to the Inspector's Office, Companhia Paulista.

In the 1990s, the process of privatization of Brazilian railways began, including the FEPASA, effective in 1999. This marked the final deactivation of the Paulista Company's workshops in Jundiaí (Fig. 12).
