History of Church Design in Olszyna Lubańska

Abstract: The history of the design of St. Joseph the Betrothed church in Olszyna Lubańska is presented in the paper. The first design of the church was drawn up by a local master builder in 1889 but was given such a poor evaluation by a firm of architects in Berlin that a new project had to be commissioned. The technical opinion on the design is analysed in the paper: both projects are discussed and some of the drawings from the projects are presented. The text of the expert evaluation and the draft of the church have never been published yet.

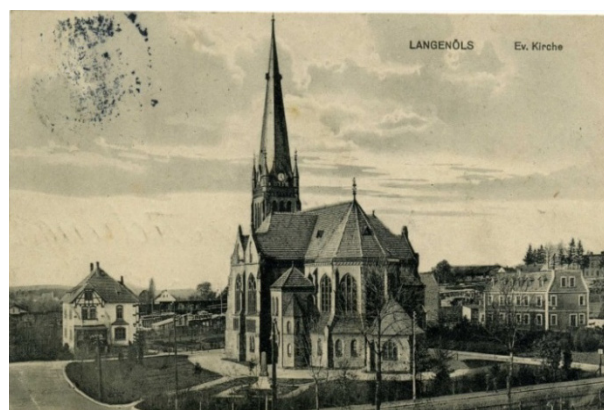
Fig. 5 The church in Olszyna Lubańska from an old postcard.

The building was designed in a neo-Gothic style (Figs. 5 and 6), on a cruciform plan, with an indoor shape of hall and vaulted annexes that imitate lateral naves (Fig. 7).

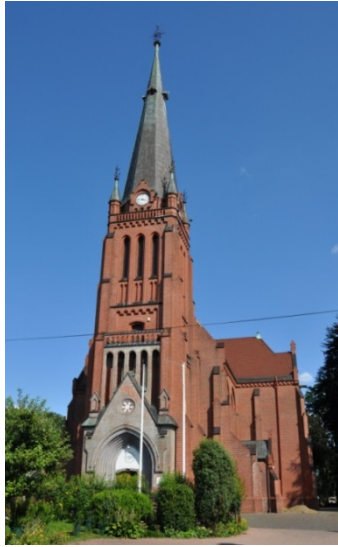
Fig. 6 Contemporary view of the church in Olszyna Lubańska.

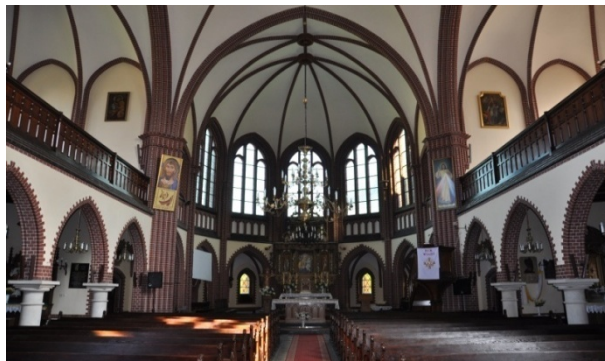
Fig. 7 Interior of the church in Olszyna Lubańska.
