# Marine Environment around Taiwan Coast

**Abstract:** Coastal erosion is an island-wide problem in Taiwan; about 80% of the island's sandy coastline had suffered from erosion over the past few decades. Historically, with the specific tectonic environment and rapid uplifting rate, lots of sediment had been yielded and transported to the coastal area that resulted in an advancing shoreline. Taiwan economically moved from a developing country to a developed one; a lot of human intervention had been made along the island coast. These are the major factors on recent coastal erosion. Even actions such as building of stabilization structures may inadvertently increase erosion. Some intervention examples are chosen to address how human-induced change made the profound impact on coastal erosion in Taiwan. All the information serves to provide a better understanding of the coastal processes, and a better response to the erosion problem.

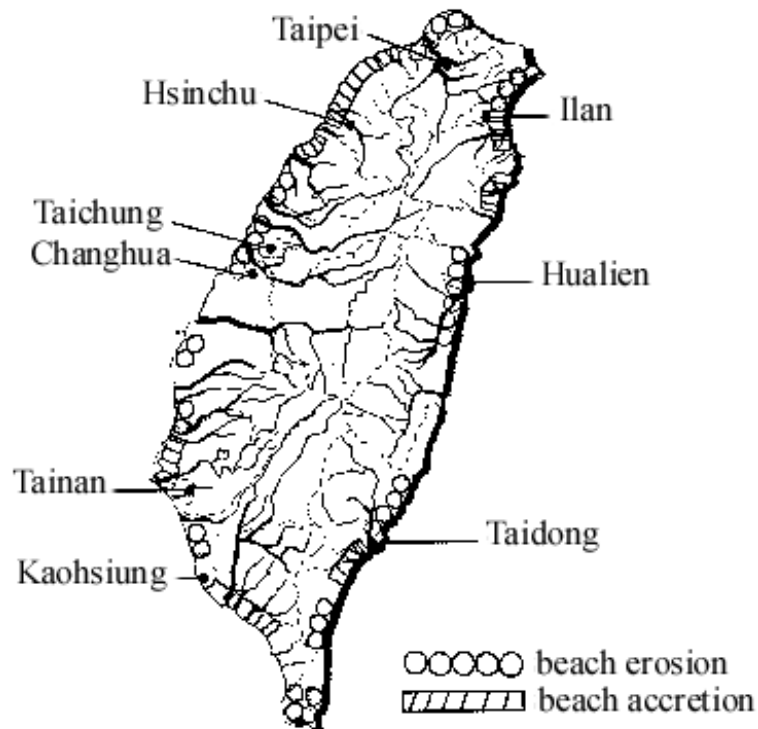
**Fig. 1** Spatial diversity of beach erosion along Taiwan Coast.  
Source: Refs. [4, 5].

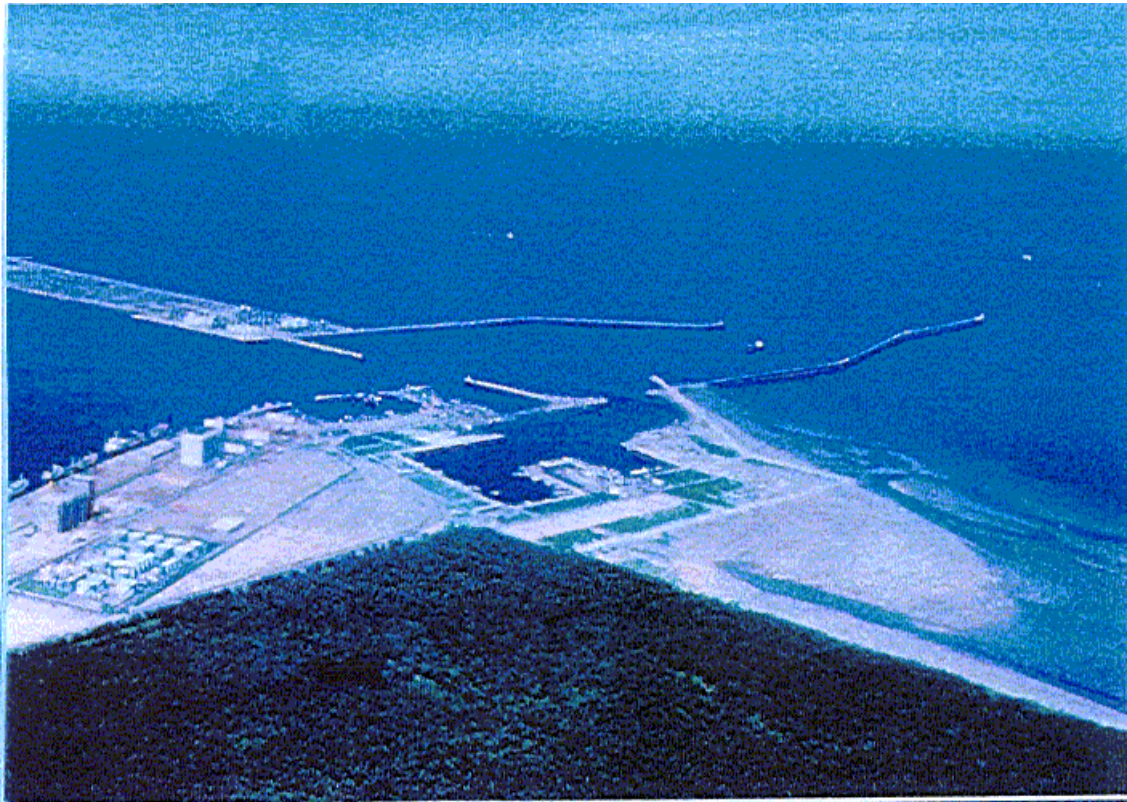
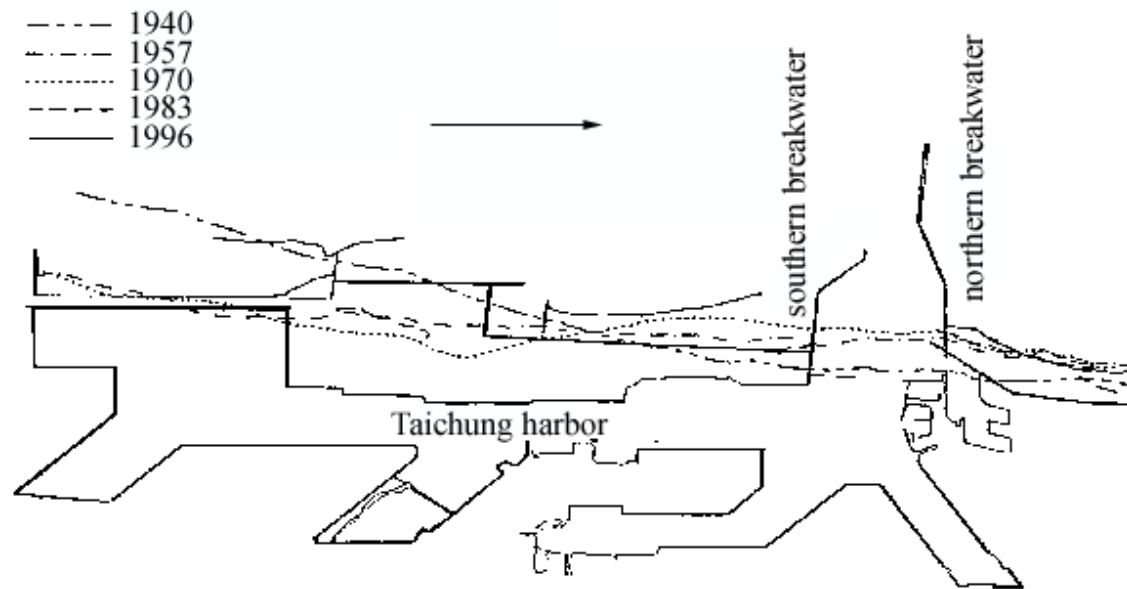
**Fig. 3** Littoral drift deposit along north breakwater: (a) the northern breakwater at Taichung harbor, with sand accretion on the updrift side and erosion on the downdrift side; (b) shoreline changes resulting from the construction of the northern breakwater at Taichung harbor, with extreme erosion on the downdrift side.

One example here is the construction of Taichung commercial harbor along the Wuchi Coast. The far extension of the northern breakwater at Taichung harbor had blocked the longshore sediment transport that moved sediments from north to the south. This interruption of longshore sediment transport has caused sediment accumulation on the updrift side of the breakwater and led to severe coastal erosion on the downdrift side 1,500 m south (Figs. 3a and 3b).

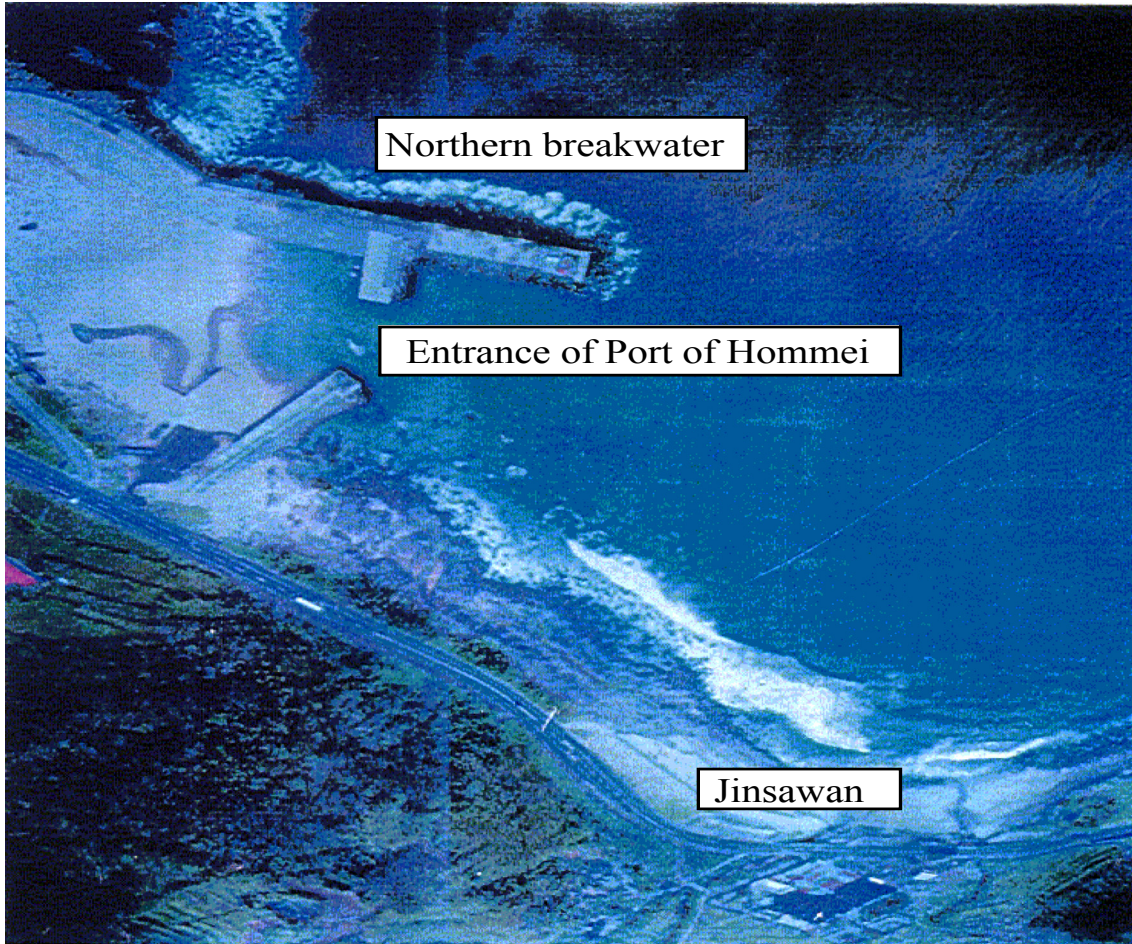
Fig. 4 Sand deposition in the sheltered lee of the extended northern breakwater at port of Hommei and erosion of Jinsawan Coast.

The extended breakwater could reduce the wave heights in the harbor's lee marine area by providing effective sheltering protection as it was designed for. However, it also results in changes of the nearshore current system and sediment transport. Hommei fishery port at Taipei County is another example that had its northern breakwater extended to about 200 m long in 1984 to protect the port from wave attacks. However, the extension of breakwater had caused the siltation (accumulation of fine sediments) in the lee side of the port and the rapid beach erosion along the Jinsawan Coast, a beautiful recreation beach that was just next to the port at the south (Fig. 4). However, the reversed currents induced by the sheltering of the

extended breakwater carry the sediments from Jinsawan towards the entrance of the port. It is noticed that an additional northern current is generated along the Jinsawan Coast due to changes of radiation stresses and wave patterns.
