The Profile of Umalad Watershed in Roxas, Palawan

Frank Joe Mojica and Flornita Nangit Ferrer

Faculty of Education Department, Palawan State University-Roxas Campus, Roxas, Palawan 5308, Philippines

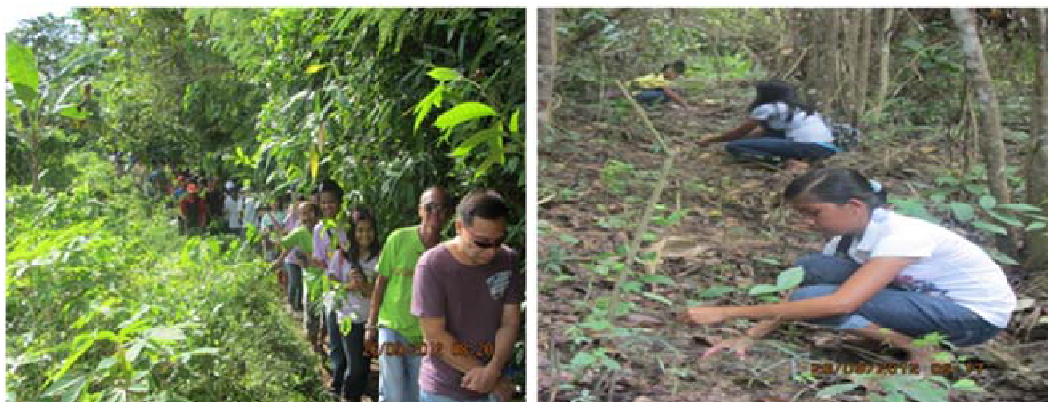
Fig. 2 Trees recommended for watershed.

There are, however, plants/trees recommended for water shed due to its capacity to hold water which are found abundant in the area (Fig. 2) such as Bangkal (*Nauclea orientalis*), Mahogany (*Swietenia mahogany*), Ifil (*Intsia bijuga*), Paper tree (*Gmelina arborea*), Narra (*Pterocarpus indicus* Willd.), Pandan (*Pandanus tectorius*), and Acacia (*Acacia confuse*).

Of the plants/trees recommended for planting in watershed areas due to its capacity to hold water, seven species are found in the area such as Bangkal, Mahogany, Ipil, Paper Tree, Pandan, Narra and Acacia.

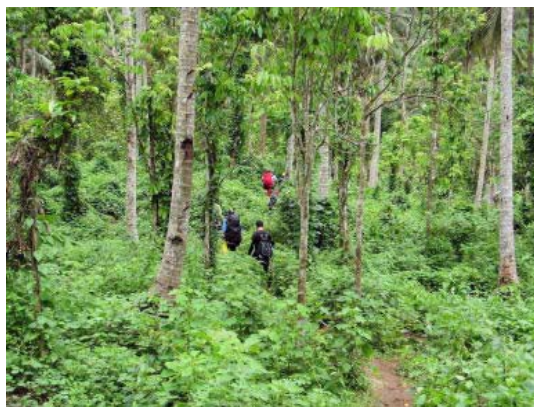
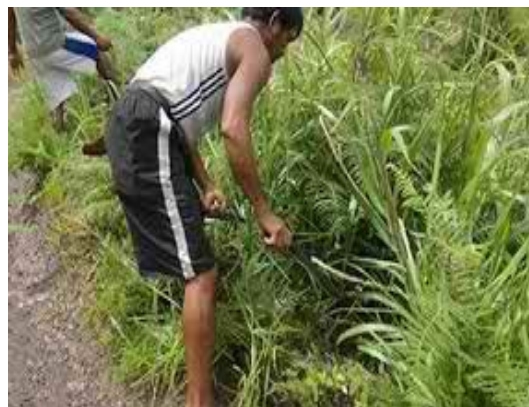
Fig. 4 The Roxas Water District (RWD) Management assigned laborers for Ring Weeding.

As part of the monitoring of the planted trees, a quarterly “Ring Weeding” is conducted by cleaning around new planted trees. It is a follow up to tree planting activity participated by the Non-governmental Organizations (NGOs). This is to ensure that the newly planted trees are able to thrive in the new habitat and were not outgrown by other plants. The weeding was done by hired laborers under the supervision of the RWD.

implementation of the annual tree planting in the area. A quarterly “Ring Weeding” (Fig. 4) is conducted as part of the monitoring of the planted trees.

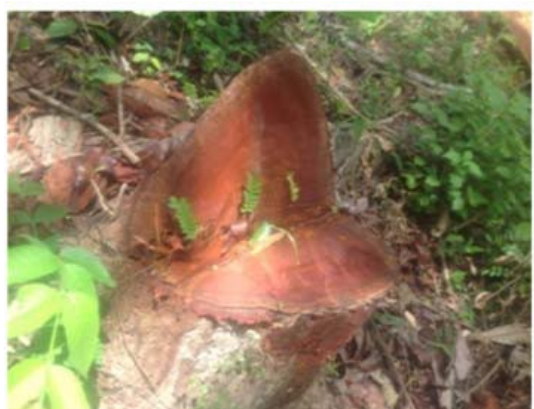
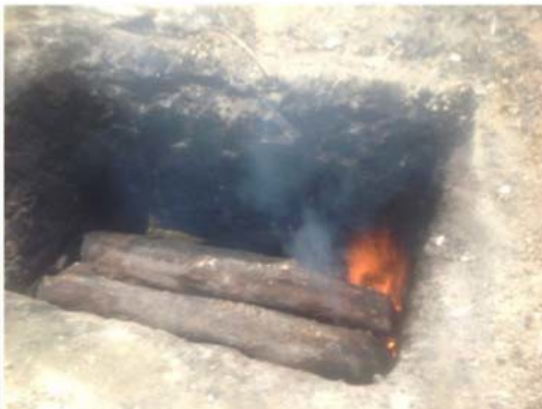
Fig. 5 Stressors present in the Umalad watershed.

Stressors (Fig. 5) are found in the area such as charcoal making, slash and burn activities, presence of residents and logging. Despite the benefits charcoal making and slash and burn activities have contributed to the residents, still, they affect the watershed since it takes years for a tree to be fully grown. The residents have lived in the area for decades and some claim ownership of the land. Loggings activities are conducted as a source of livelihood.

The RWD BOD believed that there are still settlers within the declared watershed who engaged in “Kaingin” slash and burn activities every year, charcoal making, logging and quarrying along the riverbanks which affects the ecosystem of Umalad watershed, thus making the tree planting efforts of the community every year less effective.
