Influence of Local Weather Conditions on Ventilation of a Pitched Wooden Roof

Nora Schjøth Bunkholt¹, Lars Gullbrekken¹ and Tore Kvande²

1. SINTEF Community, Trondheim 7046, Norway

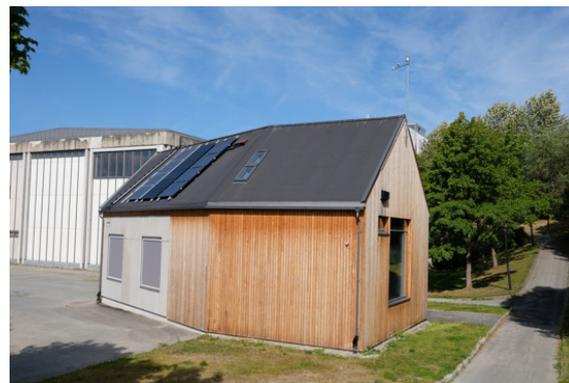
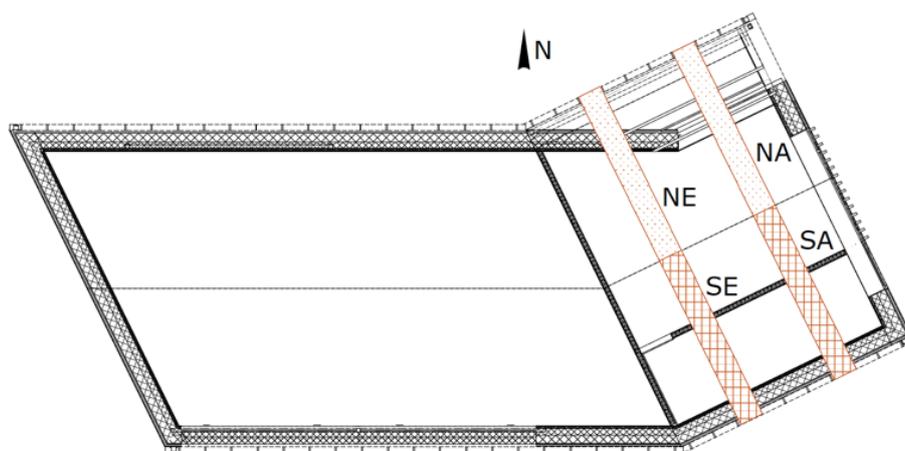
Fig. 1 (a) The ZEB Test Cell Laboratory; (b) position of the air cavities included in the study.

The study was carried out on a full-scale experimental laboratory building, ZEB Test Cell Laboratory, situated in Trondheim, Norway (see Fig. 1). The building has a wooden roof construction with a roof angle of 40° . The roof has eaves-to-eaves ventilated air cavities below the roofing, with 48 mm wide inlets and outlets along the eaves. The air cavities are 10.8 m long, 552 mm wide and 48 mm high. The lower surface of the cavities consists of a flexible roof underlay mounted on an oriented strand board (OSB). The upper surface is an OSB covered by a bitumen-based roofing membrane on the weather exposed side (see Fig. 2).

Four of the cavities on the roof were studied, described in the plan drawing in Fig. 1, showing the building from above. Two cavities on the southern side of the roof, denoted as SA and SE, and two cavities on the northern side of the roof, denoted as NA and NE, were included in the study.

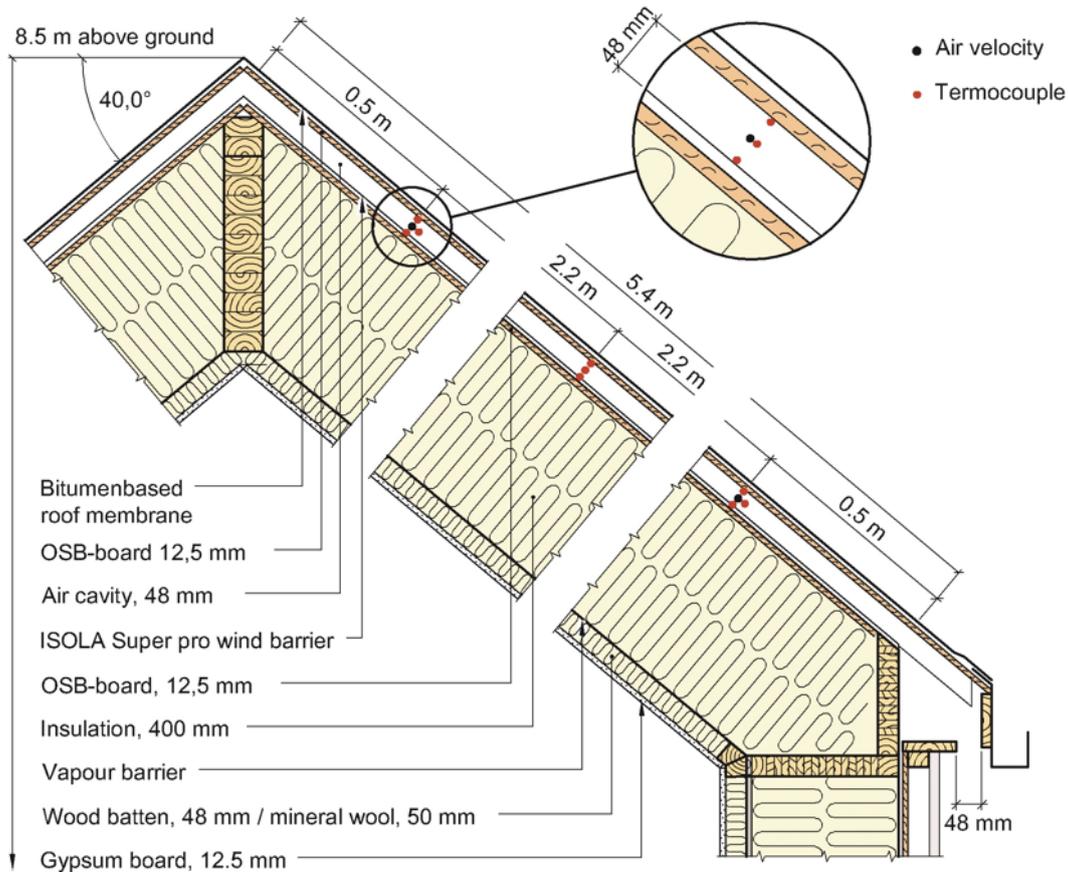
Fig. 2 ZEB Test Cell Laboratory roof structure.

The air cavities of the roof are equipped with instrumentation for temperature and air velocity measurements (Fig. 2). Eighty-one (81) thermocouples are shared evenly on nine parallel cavities. In each cavity, three thermocouples are located 0.5 m above the eaves, three are found between the eaves and ridge, and three are located 0.5 m below the ridge. In each triplet, one sensor is installed on the roof underlay, one is installed in the middle of the air cavity, and one is mounted on the rear surface of the roofing. In two of the air cavities, two air velocity measurement probes are installed. The accuracy and range of the sensors are $\pm 0.10^\circ\text{C}$ and -20°C - 60°C for the thermocouples, and 0.05 m/s and 0.05-5 m/s for the air velocity probes.

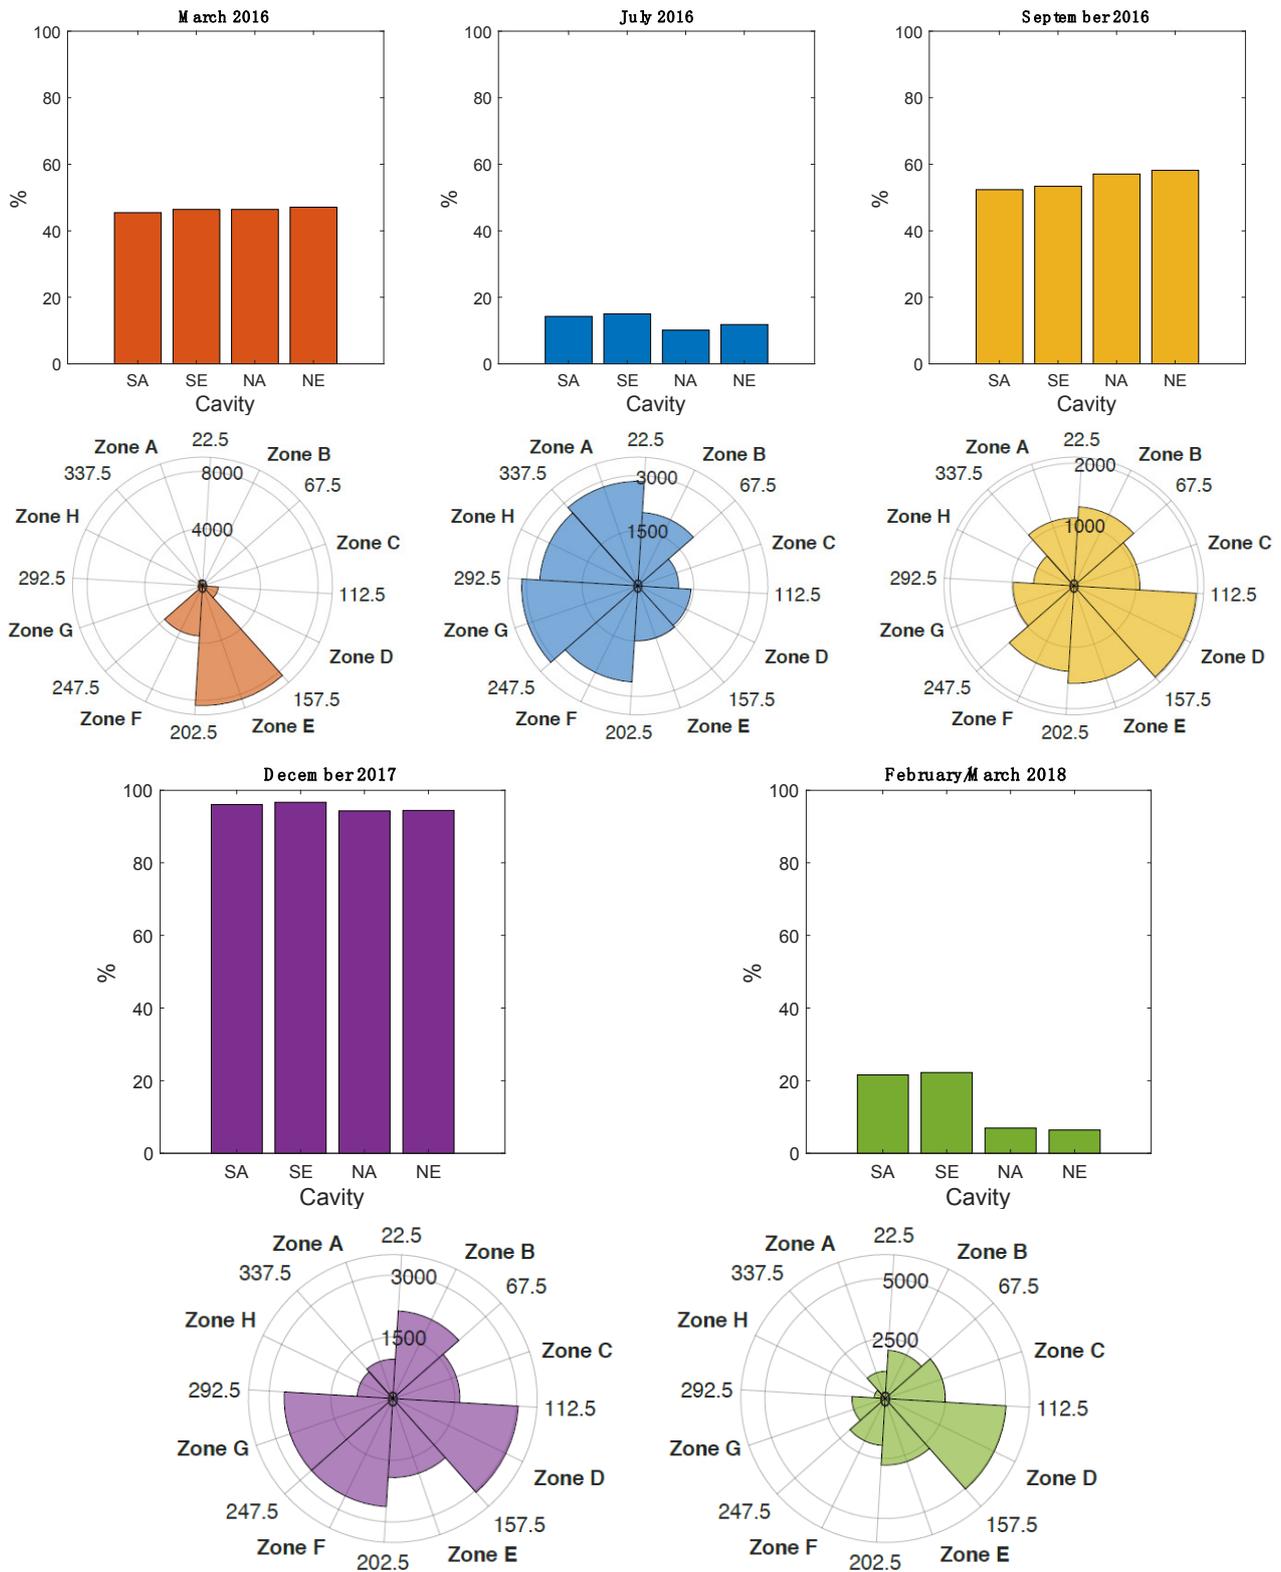
Fig. 3 The bar charts present the percentage of each period with lower temperature on the rear side of the roofing than in the outdoor air. The polar charts show the occurrence of wind from different directions towards the house. The radial axes in the polar charts represent the number of measurements within a zone. Note that the scale of the radial axes varies between the different periods.

In this paper, the temperature and condensation conditions in the ventilated air cavity of a full-scale pitched wooden roof have been investigated. Five periods between 2016 and 2018 were included in the study. How the temperature in the air cavity depends on the outdoor temperature and wind is presented in Fig. 3. The subsequent CP_i in periods with below-ambient temperature in the air cavity is examined in Figs. 4 and 5.

The measurements from the roof at ZEB Test Cell Laboratory demonstrated long periods of below-ambient temperature in the ventilated air cavity beneath the roofing. During the spring and autumn periods, the measurements at the rear side of the roofing showed temperatures below the ambient temperature for approximately 50% of the time. This is in line with the results found by Gullbrekken et al. [10]. In the December period, below-ambient temperature was measured close to 100% of the time. There was no snow on the roof in this period. Low outdoor temperatures and periods with clear sky may have contributed to large cooling of the roof and the subsequent low temperatures at the rear side of the roofing. During the second winter period, in February/March 2018, comparatively small intervals with below-ambient temperature were measured. Snow,

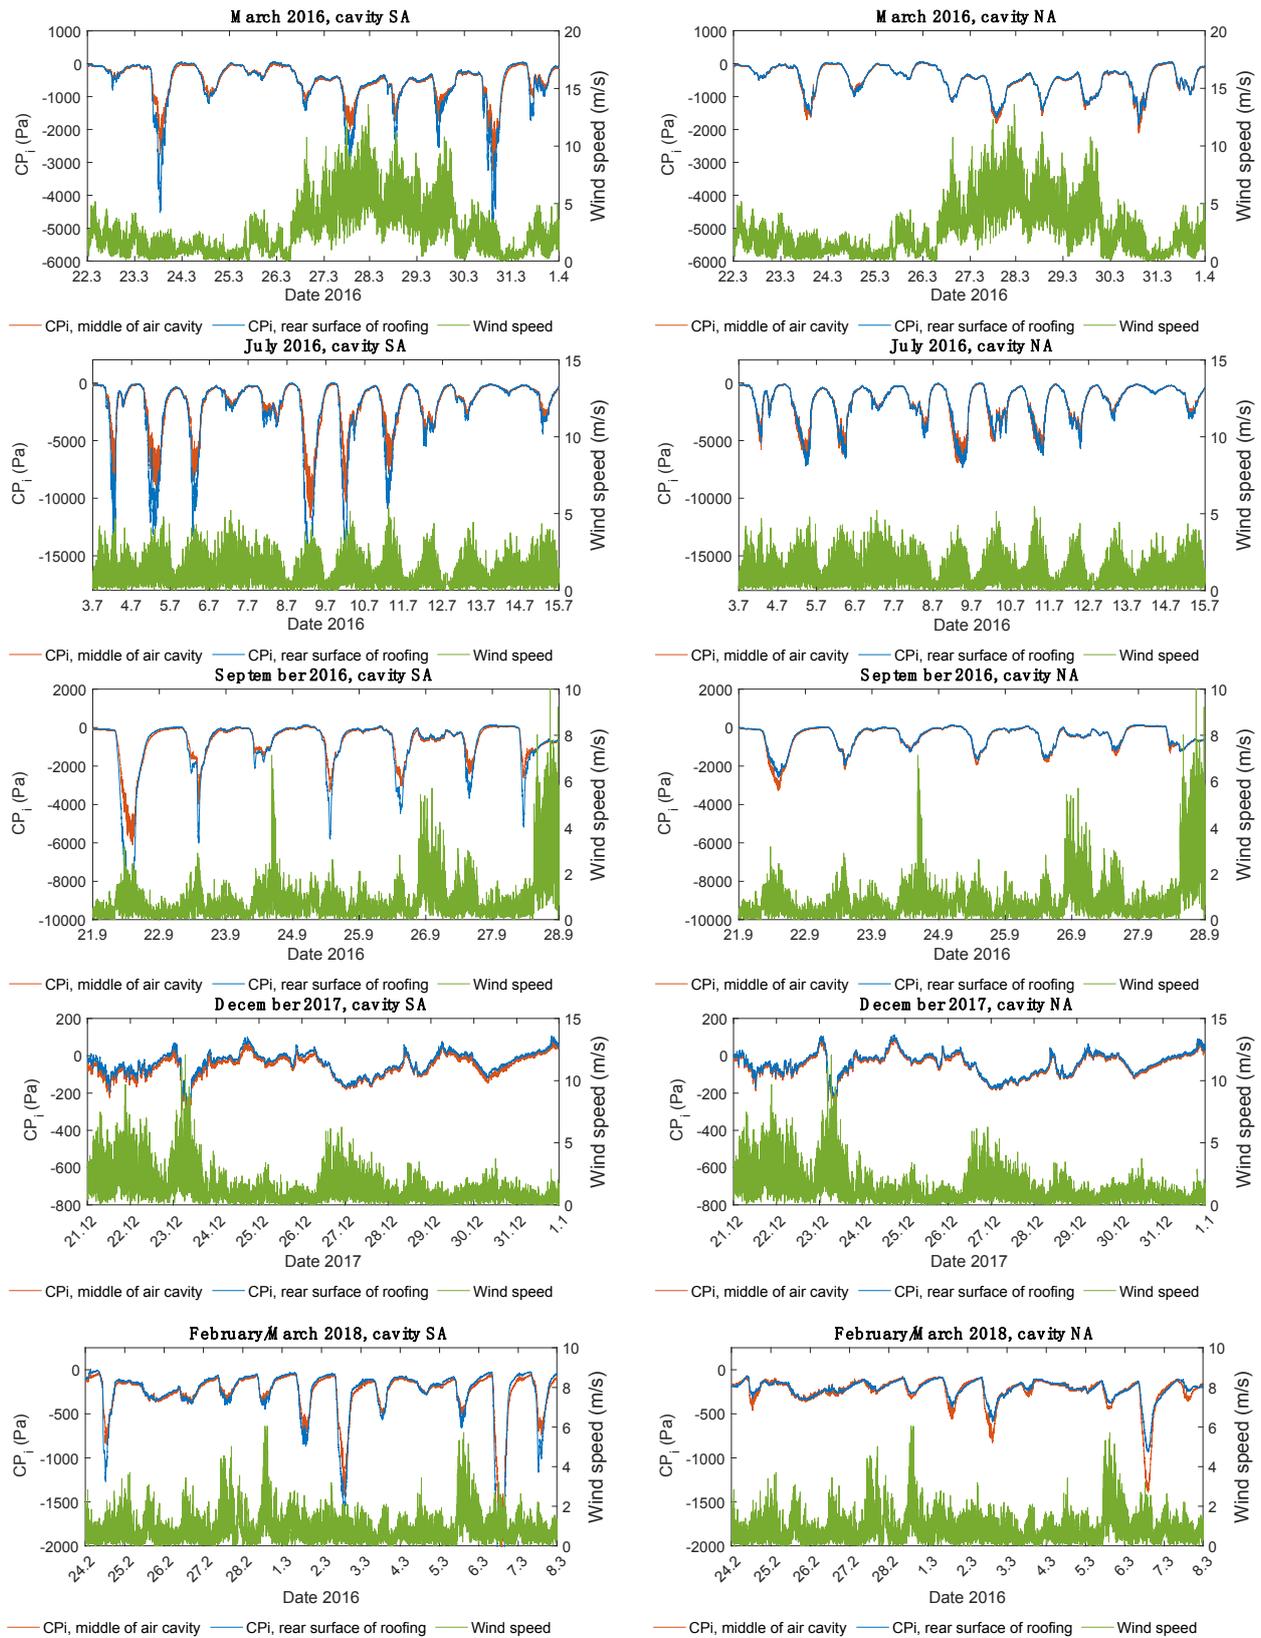
Fig. 4 Variation in CP_i and wind speed in the five periods. Results for cavities SA (left) and NA (right) are presented. Note different axes scales.

180°, 225°, 270°, 315° ± 22.5°. The angle of 0° corresponds to wind approaching perpendicular to the wall on the northern side of the building (zone A). Fig. 4 shows CP_i in the air cavity and wind speed as a function of time. Fig. 5 compares the risk of condensation in the different periods. In Fig. 5 results are not given for February/March 2018, as no positive CP_i was found in this period.

As recorded in Fig. 4, differences in CP_i were found when comparing the southern and the northern side of the roof. Due to heating by the sun, the negative peaks in CP_i were much larger on the southern side. The large negative peaks in CP_i correspond to the points of time with high temperatures in the air cavity found by Gullbrekken et al. [10]. The periods of positive CP_i were larger on the northern side of the roof. Together with the smaller size of negative peaks, this implies that the risk of condensation is higher at the northern side. A larger CP_i was also observed for the rear side of the roofing than for the middle of the air cavity. However, the rear side of the roofing also had a larger dry-out potential because of greater heating of the roofing during the day. This decreases the risk of long-term

A relationship was also shown between variation in wind and CP_i . Periods with larger wind speed corresponded to periods with low CP_i , and the opposite. However, it is not unambiguous that high wind speed leads to small CP_i , as large negative CP_i to a great extent is influenced by the temperature conditions in the air cavity. Yet, Fig. 4 shows that the positive peaks

of the CP_i decreased when the wind speed increased, and the opposite. It was also found that the wind speed was very low, i.e. below 1 m/s, during most of time when the CP_i was positive. This implies that wind speed is of importance for the condensation situation in the air cavity. Gullbrekken [14] showed that most weather stations in Norway had a daily average wind speed larger than 1 m/s more than 250 days of the year. This indicates good conditions for ventilation of roofs. However, the present paper found that the studied periods had wind speeds less than 1 m/s during 27-75% of the time. Accordingly, in cases with condensation risk it is important to study the local climate conditions in order to make sure ventilation of the air cavity is satisfactory.

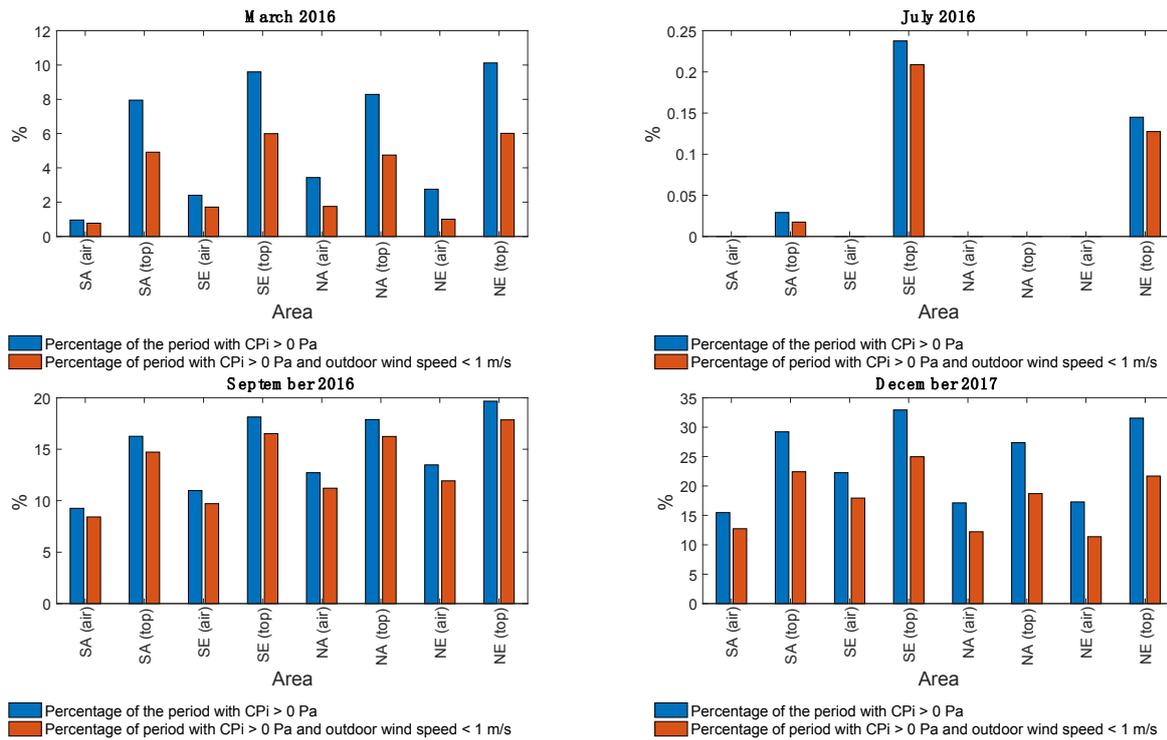
Fig. 5 Percentage of each period with positive CP_i , and percentage of each period with positive CP_i at the same time as the wind speed is < 1 m/s. Note different axes scales.
