Experimental and Numerical Analysis of Delamination Repair Plaster Applied to Historical Masonry Building

Abstract: Often masonry walls of historical buildings are subject to rising damp effects due to capillary or rain infiltrations. In the time, their cyclic action produces decay and delamination of historical plasters. An experimental laboratory procedure for the pre-qualification of repair mortars is described. Long-term plaster delamination frequently occurs because of the mechanical incompatibility of new repair mortars. The tested mortars are suitable for new dehumidified plasters applied to historical masonry walls. Compression static tests were carried out on composite specimens of stone block-repair mortar, which specific geometry can test the de-bonding process of mortar in adherence with historical masonry structure. A numerical simulation based on the cohesive crack model was used to follow the experimental data, in order to describe the evolutionary phenomenon of de-bonding as a function of a small number of parameters. This method supplies useful indication for selecting the product that is best in keeping with the mechanical characteristics of the historical materi

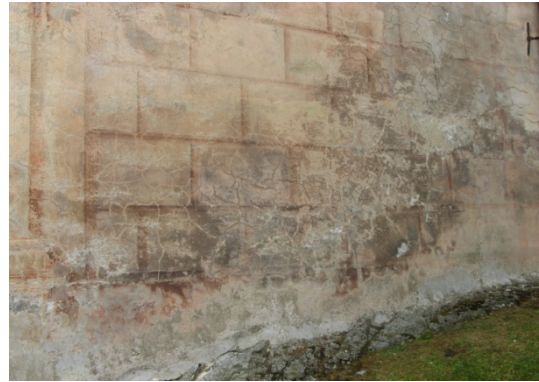
Fig. 3 Delamination and detachment of artistic plasters because of the rising damp effects due to capillary action or rain infiltration (Chapel n. 23—Jesus is taken).

Because of the rising capillary damp, the freeze-thaw cycles and the abundant rain and snow precipitations that characterize this mountain area, the historical plaster of the chapels has been subjected to progressive material decay over a long period of time (Figs. 3 and 4).

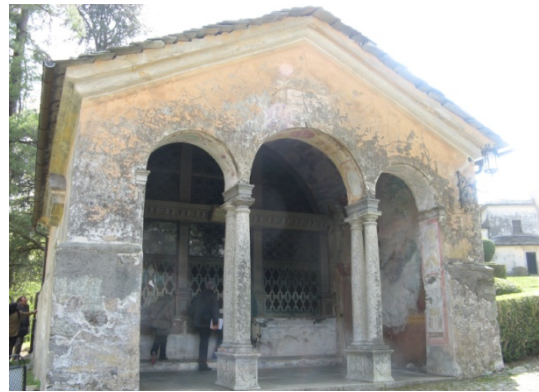
Fig. 4 Decay of historical plasters because of the rain infiltrations (Chapel n. 13—The Temptations).

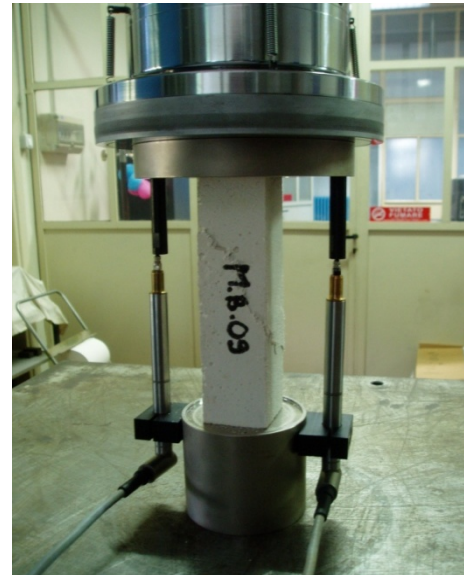
Fig. 5 Compression test on single mortar specimen.

The mechanical and hygrometric characteristics of single materials have been investigated by means of 10 test pieces $40 \text{ mm} \times 40 \text{ mm} \times 160 \text{ mm}$ for each mortar typology. All tests were carried out 28 days after the casting of repair mortar. The single specimens were labelled “M.A.” for mortar A and “M.B.” for mortar B, following the number code (Fig. 5).

Static tests, according to UNI EN 1015-11 and UNI 6556, were performed by means of a 250 kN model 810 M.T.S. (material testing system). In particular 3 specimens for each repair mortar were employed for bending test and 4 specimens for compressive and elastic modulus test.

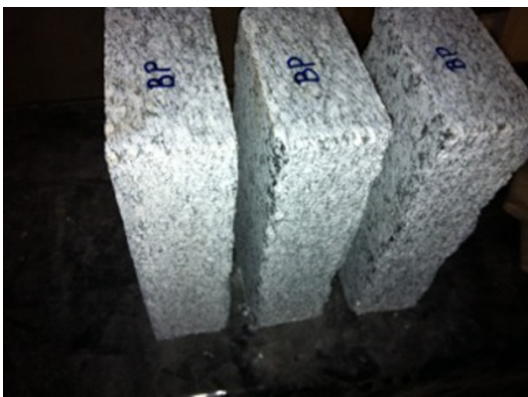
Fig. 8 Adherence surface of stone treated by pneumatic drill.

From the results of point 2.1, a typology of mortar was chosen and the experimental study was carried on with tests on composite stone block-repair mortar specimens. Compressive static tests were carried out on 4 specimens after 28 days of maturation. This mixed specimens were made by 30 mm thick layer of chosen repair mortar joining to the two shorter vertical sides of the stone block, selected similar to that of the Sacro Monti masonries (Fig. 7). The stone surfaces to contact with the mortar were treated by a specific pneumatic drill in order to improve the adherence of the strengthening product (Fig. 8).

Because of the wedges (Fig. 14), the cracks starting from the specimen bottom show a growing velocity larger than the cracks starting from the specimen top. Therefore, the second couple of cracks plays the role of main cracks. The surface treatment shown in Fig. 8 increases the values of w_{nc} and w_{lc} in comparison to the case of the interface between the same type of mortar and brick [14].

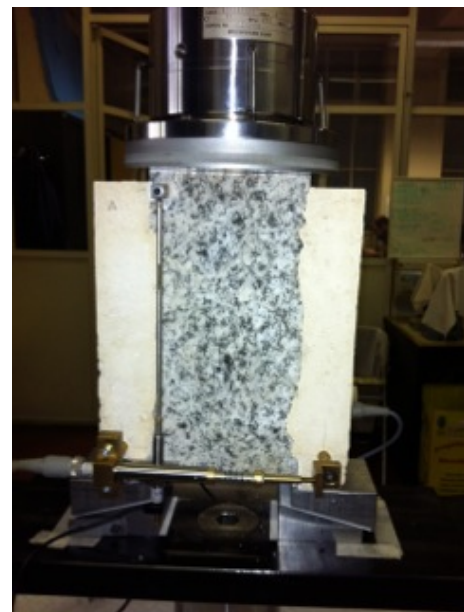
Fig. 10 Composite specimen stone-repair mortar.

The mixed pieces were instrumented with two symmetrical couples of inductive displacement transducers (Fig. 10). One transducer per side was arranged horizontally in the lower part of the specimen and connected between the two opposite mortar layers, measuring the displacements due to bulging. The other transducers, one per side, were placed vertically on the stone block.
