Japanese Cooperation for Urban Planning in the Old Capital of Damascus

Kosuke Matsubara

Faculty of Engineering, Information and Systems, Urban Planning Studies, University of Tsukuba, Ibaraki 305-8577, Japan

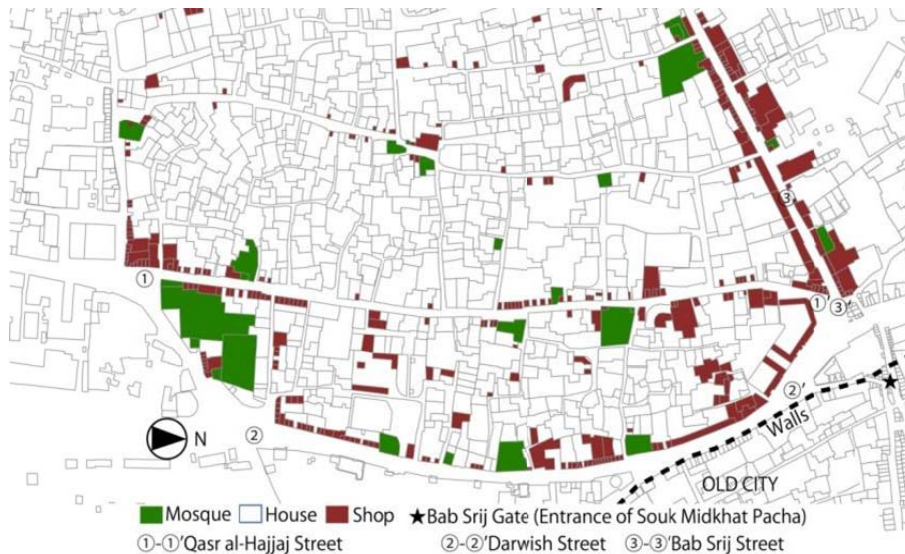
Fig. 1 Actual land use along the street.

Basic actual land use is for housing but some houses have small shops in the front (Fig. 1). The street, which is 514 m in length and between 4 m and 6 m in width, is a one-way street but traffic is heavy and it is not safe for pedestrians.

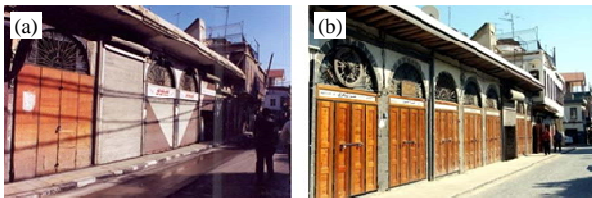
Fig. 2 Case of Souk Midkhat Pacha: (a) before improvement; (b) after improvement.

In fact, the situation on Qasr al-Hajjaj Street is quite different from that of Souk Midkhat Pacha which was the object of a facade improvement project in the past (Fig. 2) [9]. Past projects included some radical methods such as replacing shutters with neo-traditional wooden doors or apparent unification of building heights and wall finish. However, these radical methods are still debatable since one of reasons that the old city is attractive stems from its spatial variety.

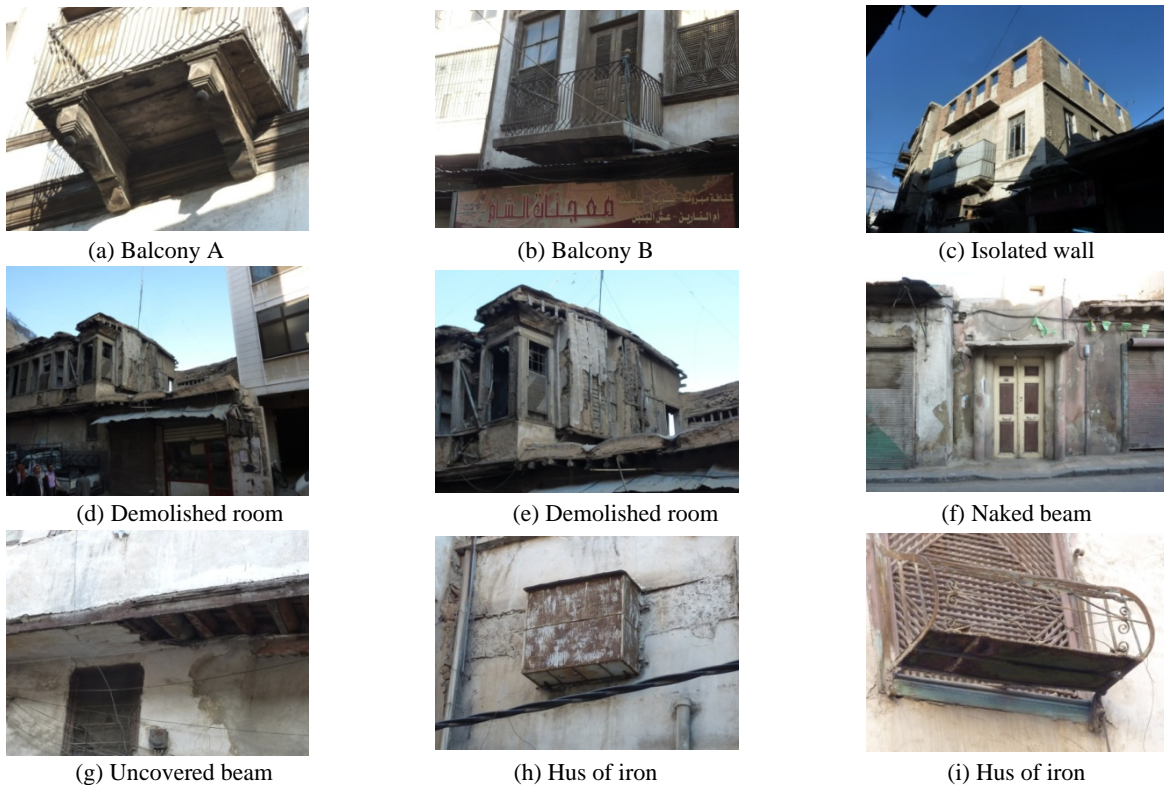
Fig. 4 An overview of the Qasr al-Hajjaji Street.

For example, Figs. 4a and 4b show two balconies. The bases of the balconies are considered to have originally been made of wood but these days some are made of concrete as shown in Fig. 4b. In such cases,

should this be replaced with a wooden base? Fig. 4c shows the entrance to Qasr al-Hajjaj. Why was the wall built like this? It was probably so that it followed the original height of the buildings, at least for walls. In this case, what should people do to improve the facade?

Figs. 4d and 4e give the impression that there used to be a room here but that it was demolished when a modern apartment was built alongside. In this case, should people restore or reproduce the room to its original state? Fig. 4f shows that naked beams were visible in the facade. This is a typical townscape element. People should accurately distinguish whether they were originally uncovered or covered as shown in Fig. 4g. In addition, Fig. 4h shows a traditional kind of bay window called a Hus. However, it seems made of iron. This is the same in Fig. 4i. Should people accept Hus that is made of iron?

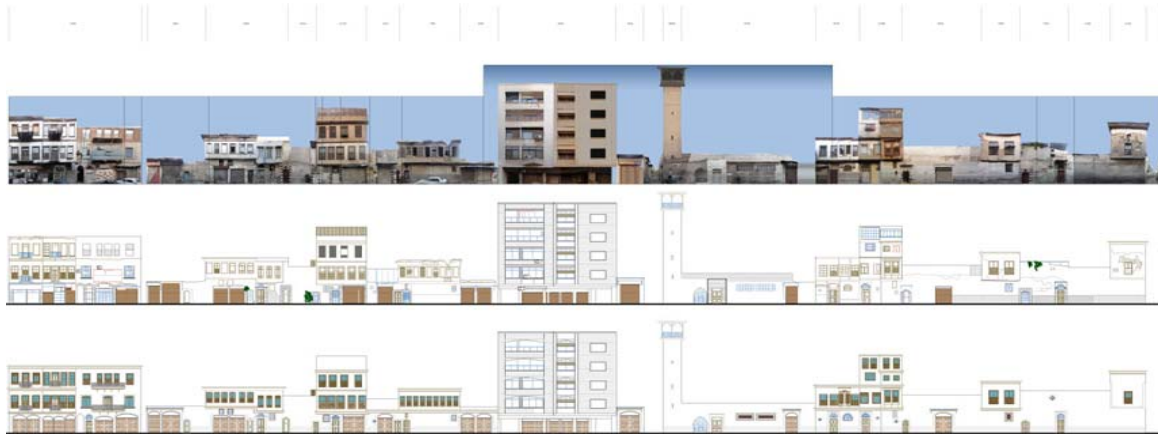
Fig. 5 A part of the first set of plans created in the JICA project (in collaboration with Dr. Sacka).

In January 2011, the first set of plans was created by a JICA team in cooperation with Dr. Sacka’s local architectural office. They comprised three plans: (1) facade photos; (2) plan of the actual situation; and (3) proposal plan. Fig. 5 shows an example of the plans for the east side of Qasr al-Hajjaj Street.

In order to roughly estimate the quality of the plans, the author needs to examine the integrity of the facade photos, the accuracy of the plan of the actual situation, and the validity of the proposal plan.

The integrity of the facade photos seems good enough on a technical level but some issues can be pointed out such as the fact that the photos were taken early in the morning in order to avoid people and cars in the images. However, some cars are presented in the photos even though efforts were made to avoid this. Also, because it was early morning, almost all the shops have their shutters closed so it is difficult to judge what kind of shops they are. It was necessary to visit the street and confirm the situation in order to resolve these issues.

The accuracy of the plan of the actual situation is quite important because it may be used not only as a base on which to elaborate the proposal plan but also as a database of knowledge and understanding of the characteristics of the facade that will be shared by all those involved and to which the author can repeatedly refer during the project as a whole. From this point of view, this Auto Cad plan seems to describe each traditional facade element well and in detail, for example, Shurfa, Hus or other structural elements such as wooden beams under bay windows and roofs. It also identifies materials. The plans are layered corresponding to standard elements such as a wooden materials layer, an iron materials layer, a shutter layer and a green layer, etc.. In addition, some of these traditional elements have deteriorated so the plan also describes some damaged parts of Klusa, twisted beams, and abandoned Hus. This information suggests serious issues the actual situations are as following: some houses need not only superficial repairs but also structural restoration. The plan also accurately shows the other facade issue which is the disorderly installment of modern equipment such as air conditioners, electricity cables and shutters.

The provisional proposal plan contains various and important suggestions for facade improvement. Based on the principle of preserving traditional architectural features such as arches and balconies, the proposal plan indicates many tasks such as the restoration of

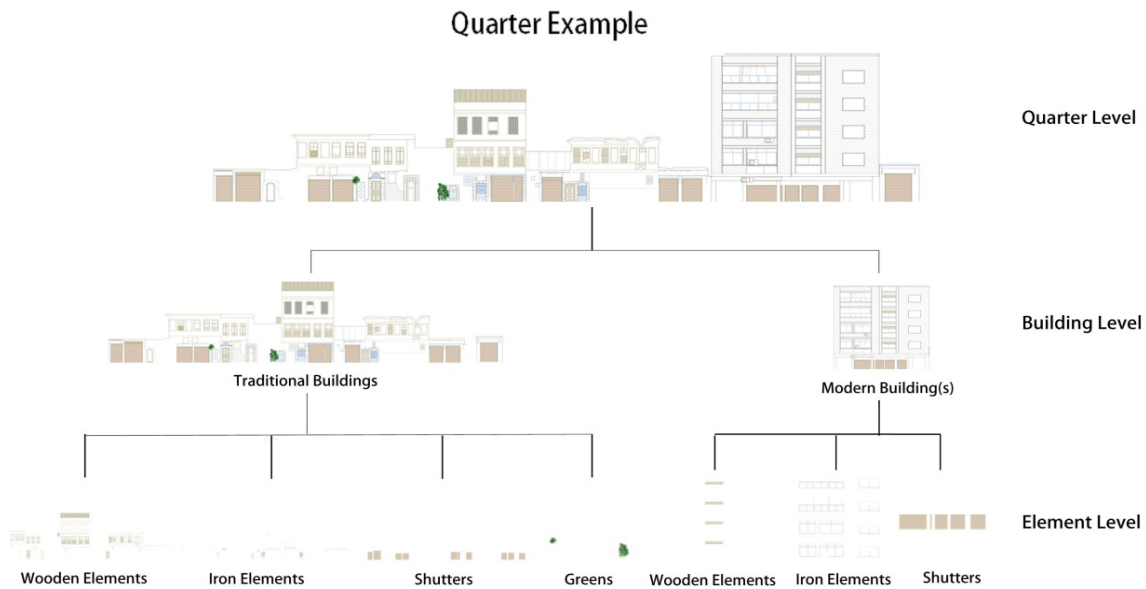
Fig. 6 Example of clustering analysis of facades at quarter level, building level and element level.

Fig. 6 shows further clustering analysis of the facade for quarter level, building level, and element level and that townscape elements in each level compose the whole facade. Fig. 6 is an example of a quarter.

In this quarter, there are some traditional houses and a five storey modern apartment. On the building level, it is possible to make two clusters: one of traditional buildings and one of modern buildings. For the traditional buildings cluster, it is not easy to count the exact number of traditional houses because they are joined by common walls. However, it is clear that these buildings have some doors to houses and shutters of small shops on the ground floor. As mentioned above, this area was built as a housing area when the Ottoman Empire occupied Damascus in the 16th century. This example suggests that this was originally a housing area then some houses were converted into shops over time. The shops are small and it may be that there are no shops on the first floor or above. These floors seem to have remained as houses at least by appearance, but some of them may be abandoned or used as storage for the shops.

On the other hand, the apartment building is a typical modern architectural structure constructed in the 1970s or 1980s according to district plans influenced by Ecochard-Banshoya. The building line is set back according to the rules in order to widen the street to accommodate cars. In the frontage of the ground floor, there is a sidewalk designed as a corridor with columns. This corridor contains some shop shutters. The district plan was intending to destroy all the historic facade of Qasr al-Hajjaj Street to create a wide street with a shopping corridor with columns. Needless to say, this plan is out of date and fortunately the area has been registered as a protected historical area. However, this apartment building is also an ineluctable element of the facade since it can not be easily demolished. On the whole, the facade of this quarter has at least two different types of facade on the building level.

For the element level, take the example of the traditional buildings in Fig. 6. The plan is made up of several layers and some of these indicate facade elements. In fact, the definition of elements is still vague, sometimes it means materials such as wood or iron in general and other times it means specific parts such as shutters or greenery.

Wooden elements are mainly groups of window frames and covers including Hus. These are particularly concentrated on the first floor and above. Windows are basically rectangular and size and design are uniform. This may be one of the reasons why the whole facade seems quite well arranged and regulated in a traditional manner. However, each window may have slightly different and original characteristics in their composition or design. In contrast, uniformity is less obvious on the ground floor. It appears that windows tend to be relatively small, square in shape and located higher than the doors. This tendency can be explained by the traditional discipline of Islamic urbanism in which is standard not to permit people to look in from the street. According to this same traditional discipline, house entrances should not be located on the main street but on narrow lanes. In the

case of Fig. 6, there are some doors on the facade showing that the discipline is not clearly adopted here. It is necessary to check all the houses on the corner in order to examine this in more detail.

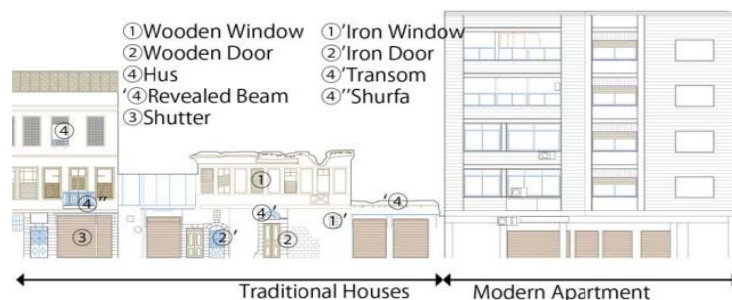
Fig. 9 Examples of facade elements.

Four categories of essential elements to be analysed have been pinpointed on the facade plan as follows (Fig. 9): (1) doors; (2) windows; (3) shop shutters; and (4) decoration (including traditional balconies called *Shurfa*, revealed beams etc.). Small and optional elements such as individual tiles, materials for finishing walls that are not part of the structure, modern equipment such as electric cables or exterior parts of air conditioners and greenery are excluded from the analysis. The elements of the four categories are subdivided into wood/iron and 1st/2nd/3rd floor, etc., in order to understand the number, surface and percentage of the elements as essential information for facade evaluation (Tables 1 and 2).

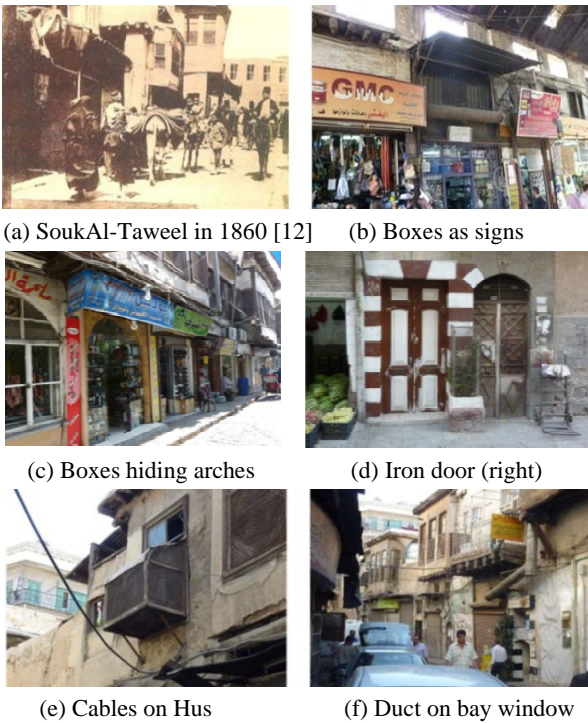
Fig. 14 Some photos about Souk al-Taweel City.

Decrepitude causes materials to change. Doors and window frames that were originally made of wood tend to be replaced by iron (Fig. 14d). Makeshift

repairs of collapsed walls using zinc or haphazard brick-laying is also regarded as an obstruction to the original facade. Even some traditional elements such as Shurfa and Hus have been replaced with iron or concrete materials. This change of materials must be based on demands for strength because these decorations have an aspect of practical use. However, these synthetic materials are an obstruction that do not match the wooden elements.

There are other obstructions excluded from the analysis in Section 4: the jumble of electricity cables on the walls of houses (Fig. 14e) and electricity boxes and exterior parts of air conditioners. Thick ducts on the walls of bakeries also obstruct the original facades (Fig. 14f).
