Interactive Model Used in Maintenance Planning of Facades Based on Virtual Reality Technology

Abstract: A virtual reality model was created in order to help in the maintenance of exterior closures and interior finishes of walls in a building. It allows the visual and interactive transmission of information related to the physical behavior of the elements, defined as a function of the time variable. To this end, the basic knowledge of material most often used in walls, anomaly surveillance, techniques of rehabilitation, and inspection planning were studied. This information was included in a database that supports the periodic inspection needed in a program of preventive maintenance. The results are obtained interactively and visualized in the virtual environment itself. This work brings an innovative contribution to the field of maintenance supported by emergent technology.

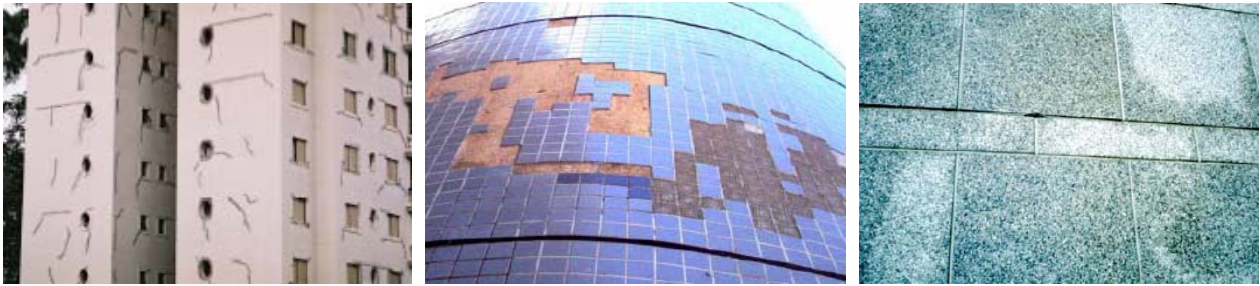
Fig. 2 Different type of materials applied as facade coatings.

In order to better understand the operation of facade coating, bibliographic research of materials usually applied to facade coatings was carried out and a table of characteristics of these was drawn up. Subsequently, a survey was made of anomalies, probable causes, solutions and methods of repair for each of the coatings studied. The visualization of the maintenance data of a building and the impact of time on the performance of these exterior closure materials require an understanding of their characteristics [13] (Fig. 2).

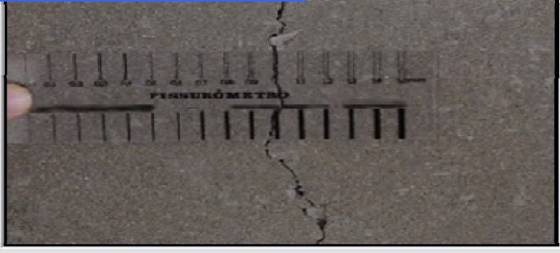
Fig. 4 Inspection sheet interface.

characterized, several inspection reports can be defined and recorded and thereafter consulted when needed. An inspection sheet is accessed by the main interface (Fig. 4).

Using the drop-down menus allowed by the interface, the user can associate the characteristics of the observed anomaly to: a facade element; the type of anomaly, the specification, details and the probable cause of the anomaly, an adequate repair solution and pictures taken in the building. After completing all fields relating to an anomaly, the user can present the report as a PDF (portable document file) file.

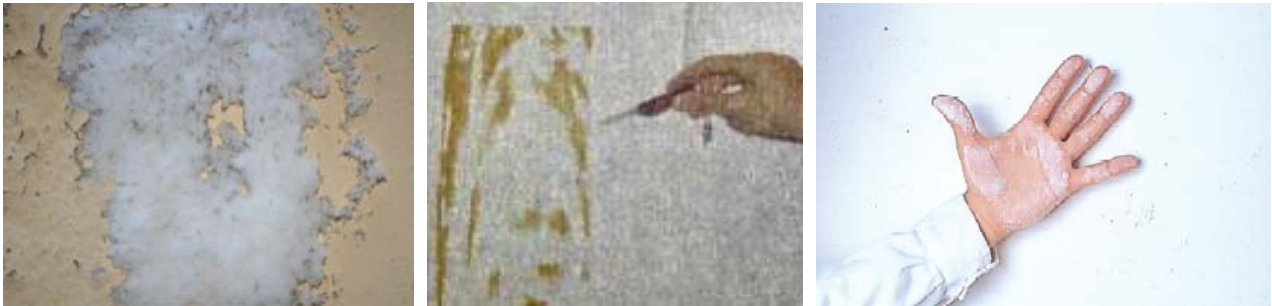
Fig. 8 Anomalies in painted walls.

An identical analysis of the characteristics, anomalies and repair works concerning the interior finish materials was carried out. With this information a data base was created (Fig. 8).
