Assessment of the Presence of Chlorides in Mortar through the Silver Nitrate Colorimetric Spraying Method

Abstract: This study aims to evaluate the presence of free chlorides by the silver nitrate colorimetric spraying method in mortars made with Portland cement CP II Z-32. In order to make an assessment beyond the qualitative analysis, a calculation of the contaminated areas by free chlorides was performed by measuring the regions using a computer image analysis software (IMAGEJ). The experimental part of the research involved samples of 5 cm × 10 cm of mortar and 0.1 M solution of silver nitrate in distilled water. The mortar samples were made with cement CP II Z-32 with the following concentrations of chloride incorporated into the mixing water: 0%, 0.4%, 0.6%, 0.8%, 1.0% and 2.0%, in relation to the mass of cement, totaling 108 samples. The average of percentage results from the contaminated area of the series of samples was respectively 0%, 14.9694%, 19.7444%, 46.0239%, 62.3311% and 96.0083% in relation to the total area, concluding that the method of silver nitrate spraying is applicable and that the white color indicates the presence of chloride ions and other possible aggr

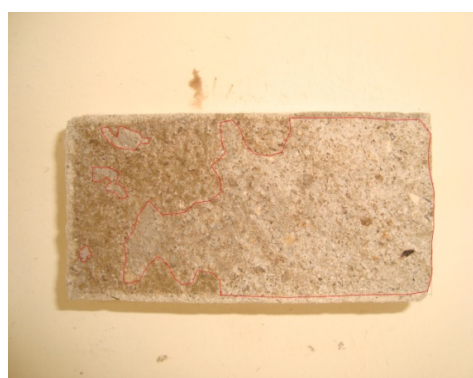
Fig. 5 Part of the whitish surface indicating contamination by free chlorides.

The samples were broken in the respective days (7, 28 and 56 days). The solution of 0.1 M silver nitrate was sprayed on the cracked faces (Fig. 4). A maximum of 15 min was awaited at environment light for the photosynthesis reaction to occur, showing contaminated regions by free chlorides with silver coloration (Fig. 5).

- The method of silver nitrate spraying proved to be applicable in the evaluation of the presence of free chlorides in the samples used in this research. It can be said that the whitish coloration presented by the method indicates the presence of chlorides salts, carbonates or sulphates, among other possible salts aggressive to the structure or to the concrete;
