# Analysis of Vehicle Modification Practice in Bangladesh

**Abstract:** With the shocking present vehicle growth over 10%, many vehicles are found to operate within urban areas and national highways of Bangladesh without having necessary registration and fitness papers. Uncontrolled vehicle modification practice has become a serious concern particularly for large vehicles, which leads the vehicle owners not to properly adhere to the vehicle fitness rules. The primary objective of this research is to reveal the extent of vehicle modification of different categories of vehicle. In this regard, field survey is conducted in major bus terminals and truck depots of Dhaka city to find out the issues related to rampant vehicle modification. Later statistical analysis is performed to obtain the most observed vehicle dimensions followed by local body workers. Finally, detailed questionnaire survey is performed on vehicle owners as well as the body makers as an attempt to reveal the poor quality of work performed by unskilled local workers. This paper would describe the findings of this research work along with appropriate remedial measures to control the unsafe modification of vehicles.

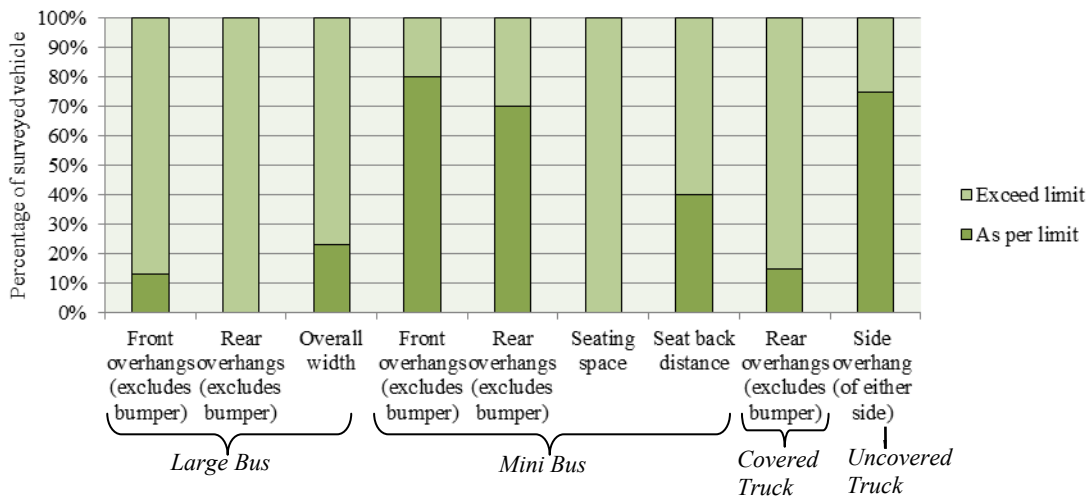
Furthermore, Fig. 2 shows the summary of collected field data from the year 2011 to 2012. Close observation of Fig. 2 reveals the unexpected degree of poor local vehicle modification. It shows that 86.7% of the 30 large buses exceed length of front overhang while all large buses surpass the limit of rear overhang. Also, for more than three-fourth of overall sample of large buses (76.7%) the overall width of large vehicle is found to exceed permitted dimension. However, intension of squeezing maximum number of seats is clearly perceived with limited space for legroom between seats in 60% of the 20 minibuses. For goods vehicle, 85% of the 20 covered trucks are reported to exceed allowable length of rear overhang. On the other hand, the back carrier of uncovered trucks has offset on both sides beyond truck cabin. For this research, this offset for carrier side is found to exceed limit of side overhang for 25% of the 20 uncovered trucks. All these are nothing but inevitable indicator

Fig. 2 Summary of measured vehicle data analysis (for the year 2011 and 2012).

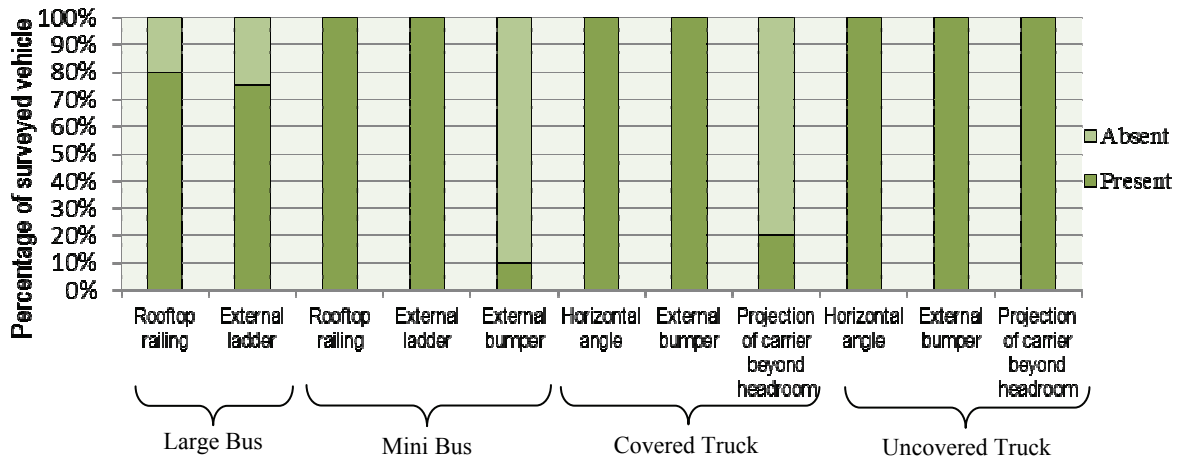
Fig. 3 Summary of vehicle condition survey result (for the year 2011 and 2012).

It is mentioned earlier that local road safety is primarily threatened by risky modification feature, like side projection of truck carrier beyond head-room and lateral angles fixed externally with truck carrier or bus. Large vehicle condition survey from local field investigation is accomplished with a view to find the extent of modification practices which rise questions regarding this safety issues and the detailed analysis is presented in Fig. 3. It is found from Fig. 3 that 20% of total surveyed 20 covered trucks and 80% of total 20 uncovered trucks are dangerously projected beyond front headroom, although any unsafe alteration of vehicle is restricted by local constitution [5]. Such projection has a direct effect on safety issue by inducing side blind spots of local trucks. According to a research conducted in United States for the period of 2003-2007, although highest number of impact for trucks occur in front side (62.5%), side collision rate is also significant. Almost 15.5% of the total impact occurs in left hand side of the driver and 6.5% of them occur in right hand side of the driver [12]. Such impacts are more serious in developing countries like Bangladesh, as locally modified truck drivers cannot

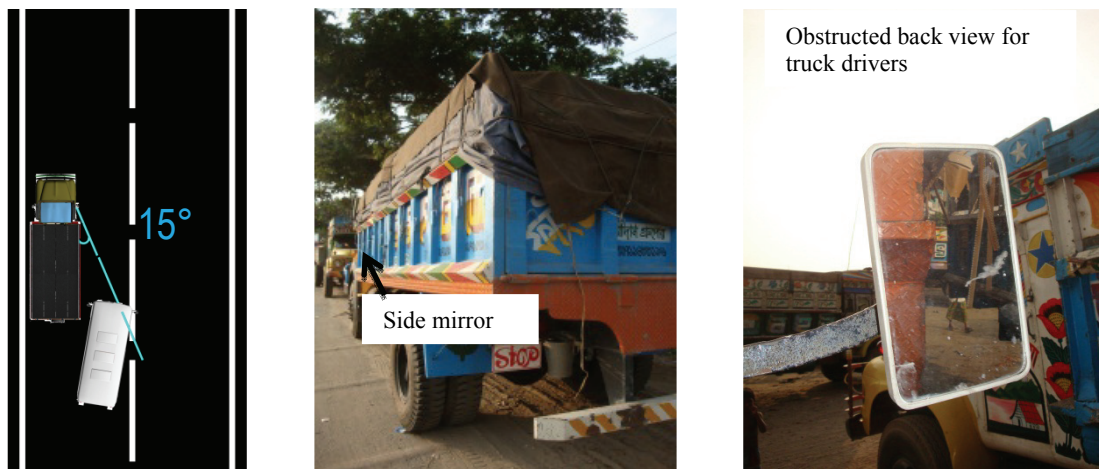
identify objects at an angle of 15° made with the side of truck headroom or cabinet. Here Fig. 4 shows this situation for a locally operational uncovered truck which was taken during the field investigation from Gabtoli area. Besides presence of sharp edged bumper and risky steel angles in all uncovered trucks reflect the shocking extent of illegal modification. For buses, it is believed that extra features like rooftop railing encourage overloading of goods or passenger and increase potential risk of passenger falling from roof at critical locations like sharp turn or frequent undulation. According to a research on accident analysis, out of total 1,011 accidents occurred near Jamuna Multipurpose Bridge, 50 passengers' fall-down incidents happened from rooftop and most are recorded as fatal or severely injured [13]. Majority

Fig. 4 Side black spot induced by projected local truck carriers.

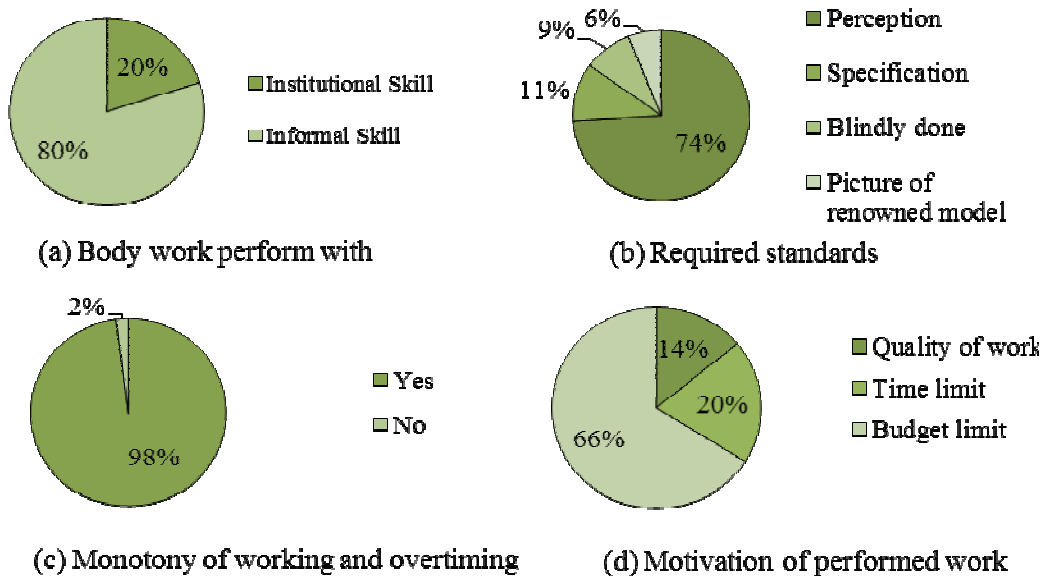
Fig. 5 Characteristics of local vehicle body workers (for the year 2011 and 2012).

angular bars are mainly used for rooftop railing and in-vehicle structures like seats. Use of locally made glass instead of toughened or tempered glass has become widespread especially in window glasses of urban vehicles. As urban vehicle drivers always show aggressive attitude while moving on road, these low quality glasses pose serious threat in case of side collision. By tradition, local modification is performed by a group of naive body workers, who perform mainly under the supervision of an experienced senior. With the growing number of local workshop, number of amateur workers is increasing. During field survey, some of them are observed to perform vehicle body work alone without any guidance. Simultaneously risk is also increasing as no investigation is performed on the accomplished task, neither material checking nor inspection of welding. Hence quality of work solely depends on performance of body makers. Findings of the investigation on detailed characteristics of 35 local body workers from Dhaka are enlisted in Fig. 5 for the time range 2011 to 2012. It is distinctly visible from this figure that major portion of body workers (80%) has no institutional skill; rather they follow the instructions from senior workers. While servicing, mainly they apply their own perception (74%). Specification is mainly followed in renowned

workshops, while in local workshop about 6% workers replicate from picture of popular models. Meanwhile being the only earning member in family, overtime working beside regular working hours (8 h) is preferred by all body workers. Rush of limited time (20%) and budget restraint (66%) accompanied by monotony of working overtime leave a wide scope of questioning the quality of works performed by body makers. Another crucial factor is the poor working environment dominating in local workshops, where workers perform in a hazardous condition without safety precautions as shown in Fig. 6 which was taken from bus workshops in Gabtoli area. No local workshops are found with adequate fast-aid kit, fire extinguishers or gas masks. Even some perform without helmet or gloves while welding work, thus serious injuries like vision problem, skin burn and noise disturbance are very common in local body workers. Another shocking aspect is the existing number of child labors performing in local vehicle body shops. It is derived from a report of UNICEF that, in the year 2002-2003 number of children (aged 5-17 years) engaged in hazardous labor (auto workshops, welding, etc.) is 1.3 million [14]. The prevailing unsafe working situation poses not only a serious threat to the normal physical growth of these

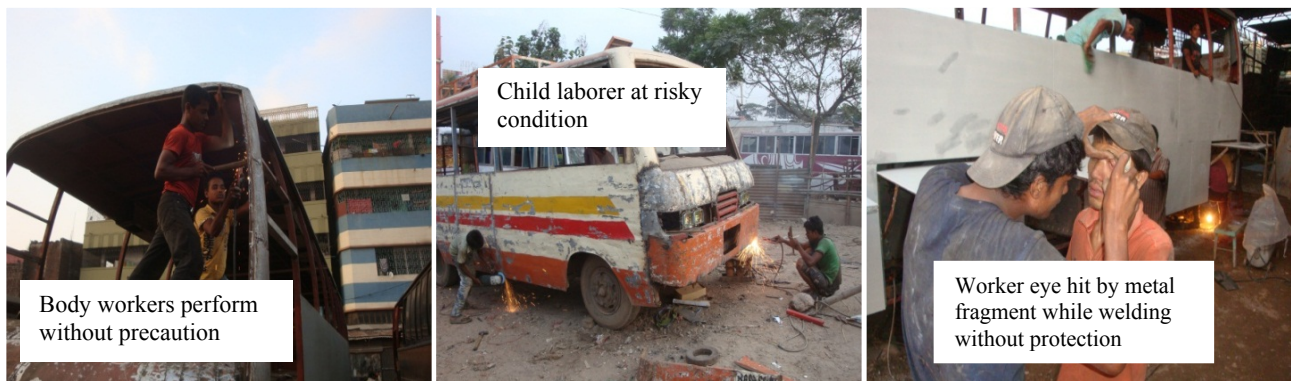
**Fig. 6** Poor working environment dominating in local workshops.

children, but also many of them are found with disturbing mental disorder as an effect of working without necessary counter measures in such polluted surroundings. This in long term affects the quality of the modification work and also thus leaves a wide scope to question about the accomplished work.
