Conservation of Building and Decorative Elements of Ottoman Architecture in the Medieval City of Rhodes

Abstract: The transformation of the medieval city of Rhodes and the modification of its buildings since the siege of 1522 by Suleiman the Magnificent up to the 20th century, were imposed by the social and religious needs of each of its conquerors. In particular, during the period of the Ottoman rule (1522-1912), most of the churches were converted into mosques while new buildings like public baths and mansions were constructed, resulting in alterations in the morphological characteristics of the city. Although the buildings of the Hospitalier's period (1307-1522) were preserved, the additions and adjustments resulted into a mixture of western and oriental architecture, which today determines the multicultural identity of the city. In 1988, UNESCO (United Nations Educational, Scientific, and Cultural Organization) designated the medieval city of Rhodes as a world heritage city for its exemplary architectural complexity and variability, which perfectly reflects the complex historical phenomena and the unique integration of various cultures for more than seven centuries. In this pa

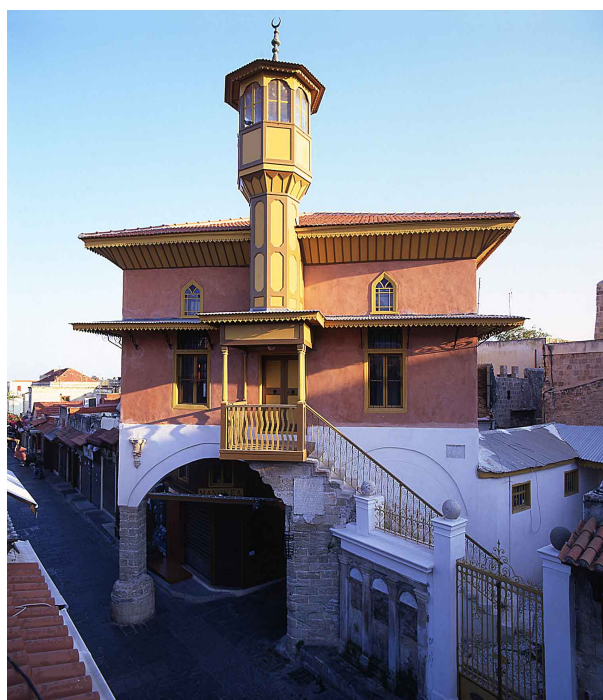
Fig. 1 The restored Mehmed Aga mosque.

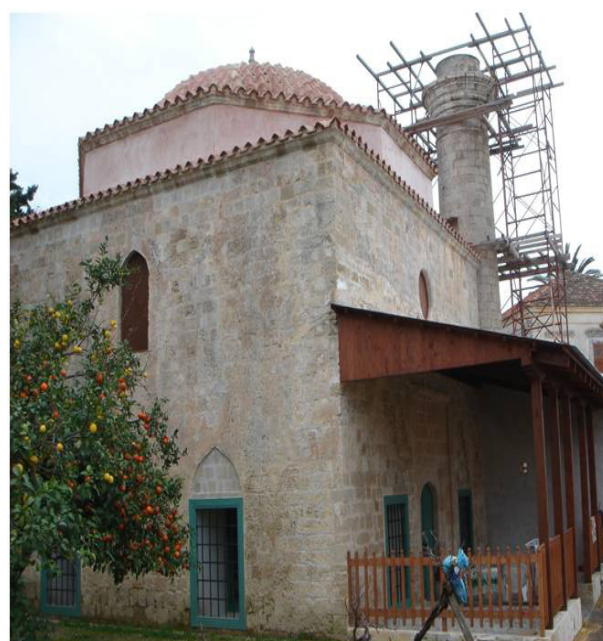
Fig. 2 The restored Hamza Bey mosque.

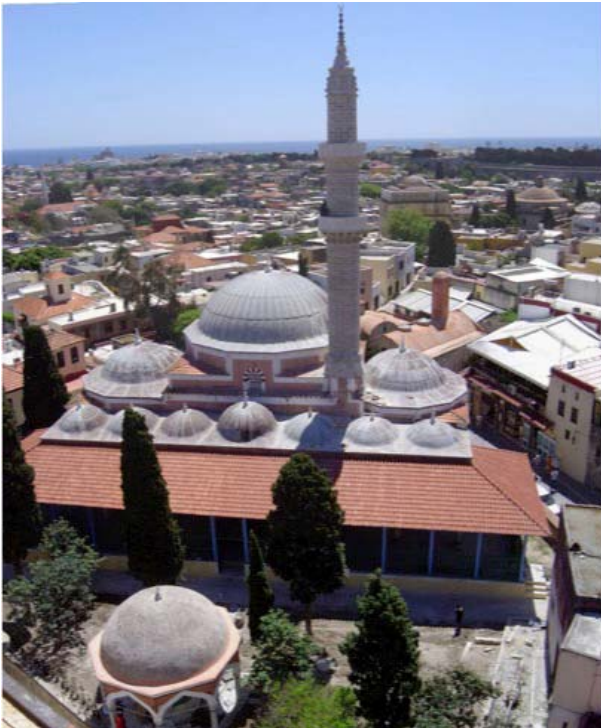
Fig. 3 The restored Suleiman mosque.

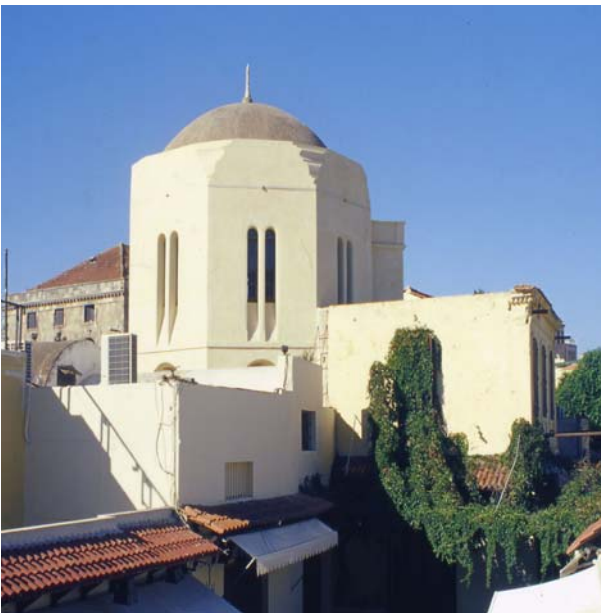
Fig. 4 The restored Sintrivan mosque.
