Behaviors of Rural Structures during Destructive Earthquakes

Abstract: This article deals with the results of the research on the behaviors of the rural buildings made up of local materials during earthquakes. This article reveals the mechanical properties of masonry detected based on experimental research results on wall samples made of local materials such as mud bricks, clay and straw mixture, rubble stones and limestones cut in standard sizes. In addition, the constructive measures prepared for the earthquake resistance of rural structures and the application techniques of these buildings in common construction are also generalized in this article.

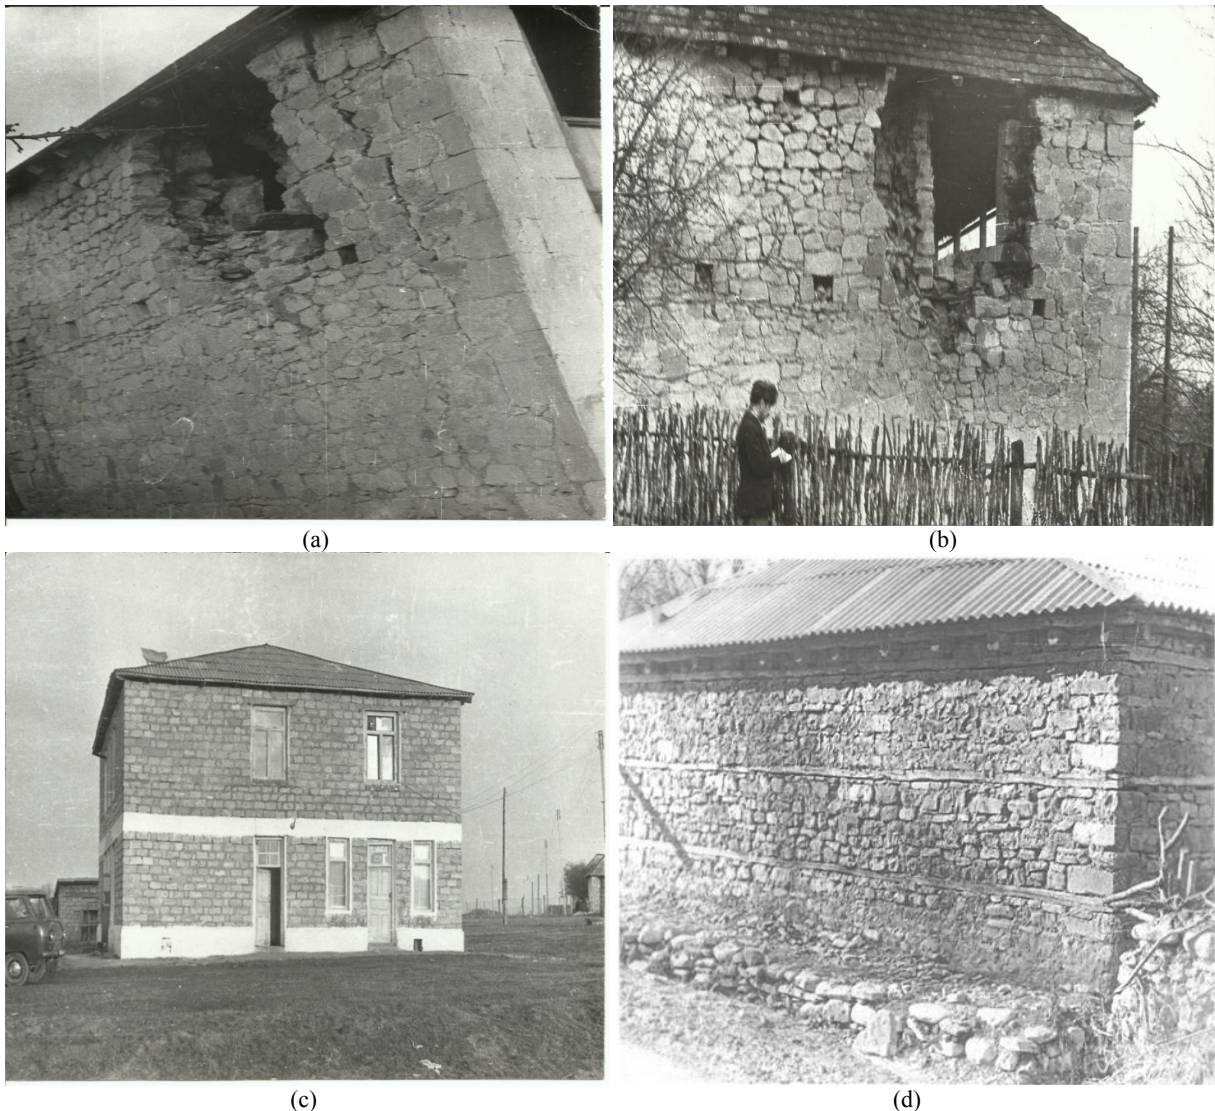
Fig. 1 Damaged buildings in the 1981 Ismayılı (Azerbaijan) earthquake: (a) Level 4 damaged building post-earthquake appearance; (b) Level 4 damaged another building; (c) Level 1-2 damaged building; (d) Level 1-2 damaged another building.

materials with lower mechanical properties, such as mud bricks and rubble stones, and mortar with low mechanical properties exhibit different behaviors. Fig. 1 shows the post-earthquake appearance of two buildings (Figs. 1a and 1b) with level-4 damage according to MSK 64 due to the earthquake [2] with a magnitude of 5.4 and according to MSK 64 with level-7 surface impact, which occurred in 1981 in İsmayılı region of Azerbaijan as well as two other buildings with level-1-2 damage according to MSK 64 with the same design properties close to the buildings above (Figs. 1c and 1d) [3].

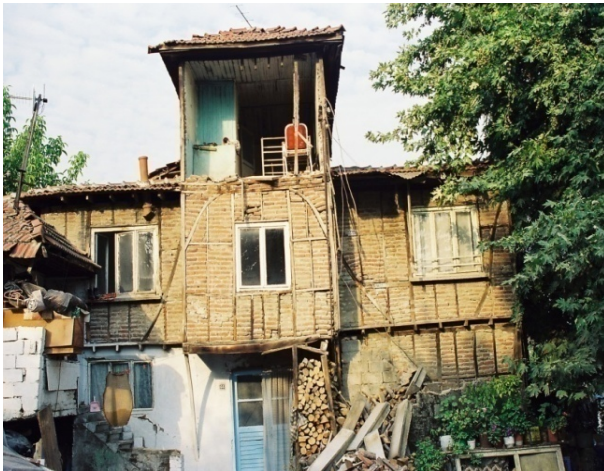
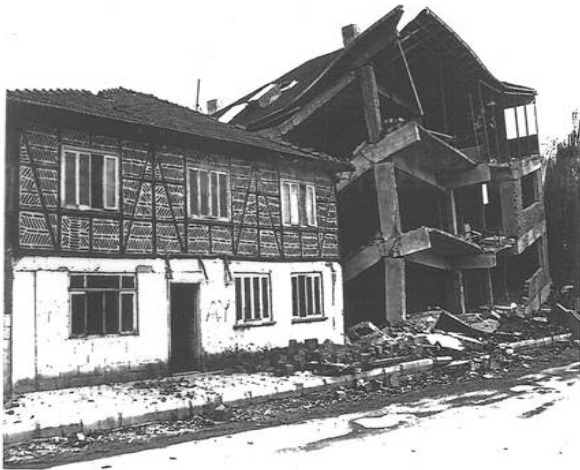
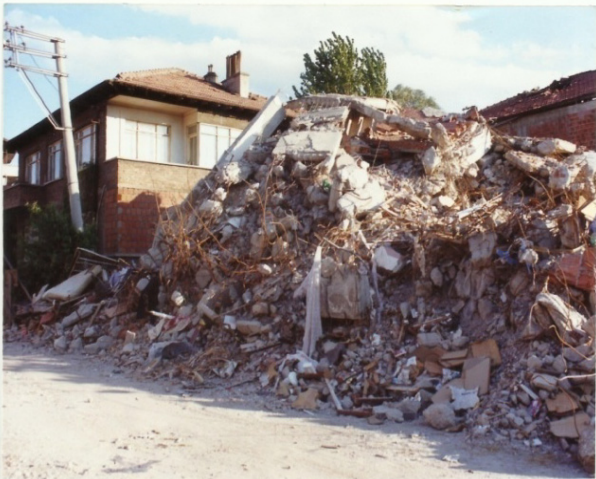
Fig. 2 1999 Kocaeli (Turkey) Earthquake damaged buildings: (a) wooden beams masonry building; (b) masonry and reinforced concrete buildings post-earthquake appearances; (c) masonry building and completely collapsed reinforced concrete building.

Fig. 2 shows the multi-storey concrete building,

constructed in line with the requirements of Regulations for the Structures to be Built in Disaster Areas [4, 5] in force between 1975-1998 in Turkey in an earthquake resistant design, with at least level-5 damage according to MSK 64 in the August and November earthquakes of 1999 with a magnitude of 7.4 which impacted İzmit-Düzce regions of Turkey as well as the 1-2-storey buildings right next to them (distance between the buildings is 3~5 m) that were constructed without observing the contemporary earthquake specifications with brick and mud-brick masonry which survived this earthquake with level-1-2 damage according to MSK 64.

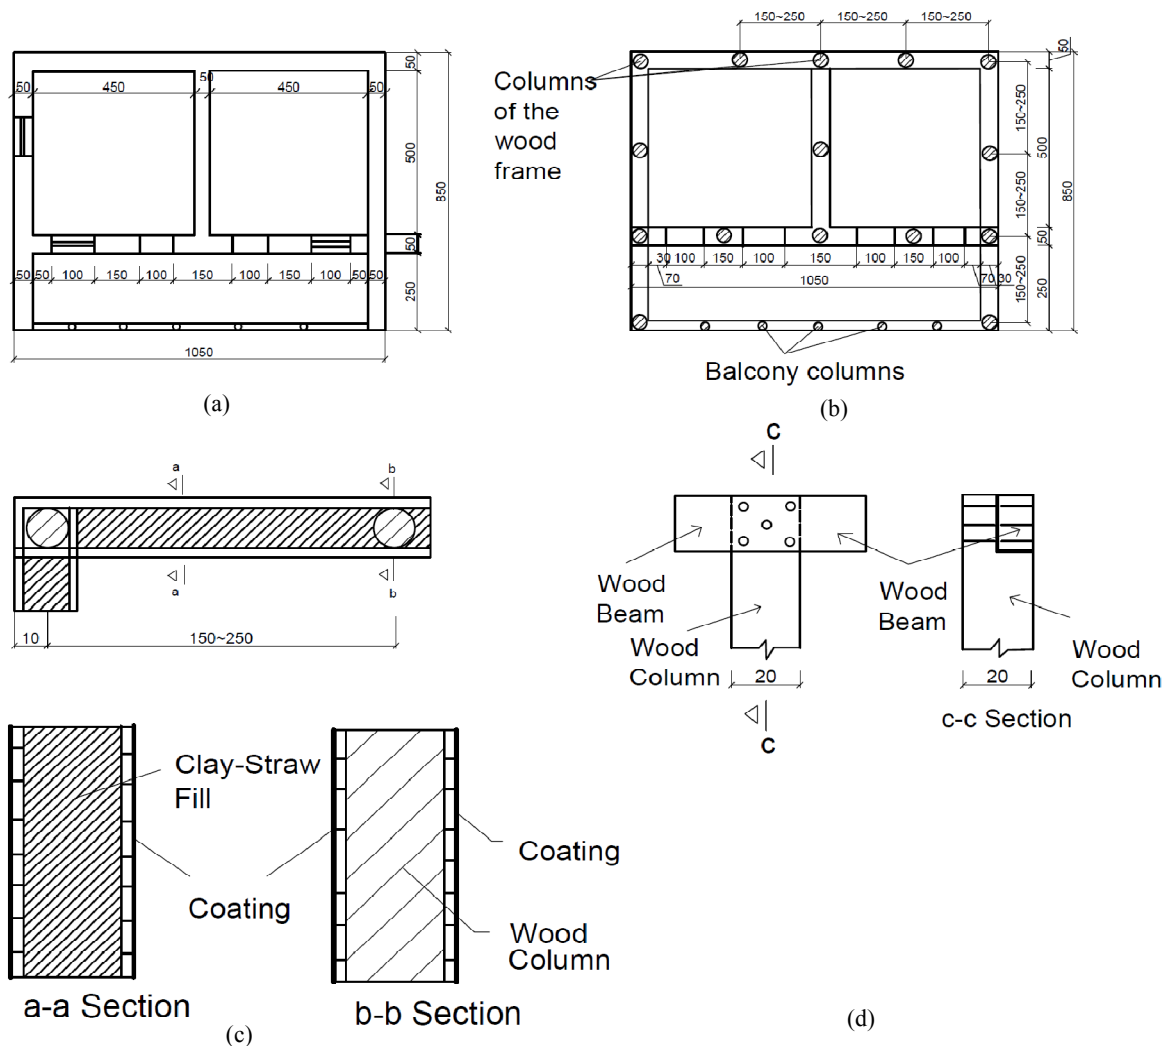
Fig. 3 Constructive formation of the building constructed by filling the carcass with clay-straw mixture: (a) the layout of the building; (b) constructive arrangement; (c) constructive formation of carcass; (d) formation of the column-beam intersection of the carcass.

The constructional characteristics of a building type which is still in use and which is able to maintain its strength and stability during many earthquakes in Azerbaijan constructed by using clay-straw mixture are given in Fig. 3.

These buildings are constructed with basement and ground floor. The height of the basement floor is 1.5~2.5 m and its walls are made of rubble stones with a thickness of 0.50 m with cement, lime and clay mortar. The height of the ground floor is around 3 m. The wall bearing system consists of wooden columns installed on the basement floor at every 1.5~2.5 m and a clay-straw mixture filled between them. The columns are enclosed in the horizontal frame considered at the top level of the basement. At the upper levels of the columns are the under-roof beams, which connect the wall of the building transversely and longitudinally and are connected safely with the columns. Columns are made of wood elements with a diameter of 20 cm or a cross-section of 15 × 20 cm. On both sides of the building wall, the columns are covered with wooden layer trussed with nails and the space between two wooden layers is filled with clay-straw mixture. Mud brick can also be used for this purpose. The clay-straw mixture is applied to both surfaces of the walls as the plaster layer. In the building bearing system constructed

by applying such a technique, wooden-carcass provides high strength and the clay-straw mixture or mud brick filled in the carcass provides the properties of killing the dynamic impact of the earthquake (swallowing the energy), which all together realize the formation of an earthquake resistant system [3, 7, 9, 11, 13, 14]. The constructive formation of the wall cross-section is shown in Fig. 3c and the column beam intersection formation is shown in Fig. 3d.

The constructive plan design of the buildings made of rubble stones is as shown in Fig. 3a. It is carried out in two layers including the outer wall layer and the inner wall layer along the masonry height in the rubble stones applied in the rural areas. The masonry layers are not connected with each other. The connection is only possible with the possible adherence stress strength between the masonry mortar and rubble stone surfaces. Accordingly, these longitudinal masonry layers undergo transverse permanent deformation in

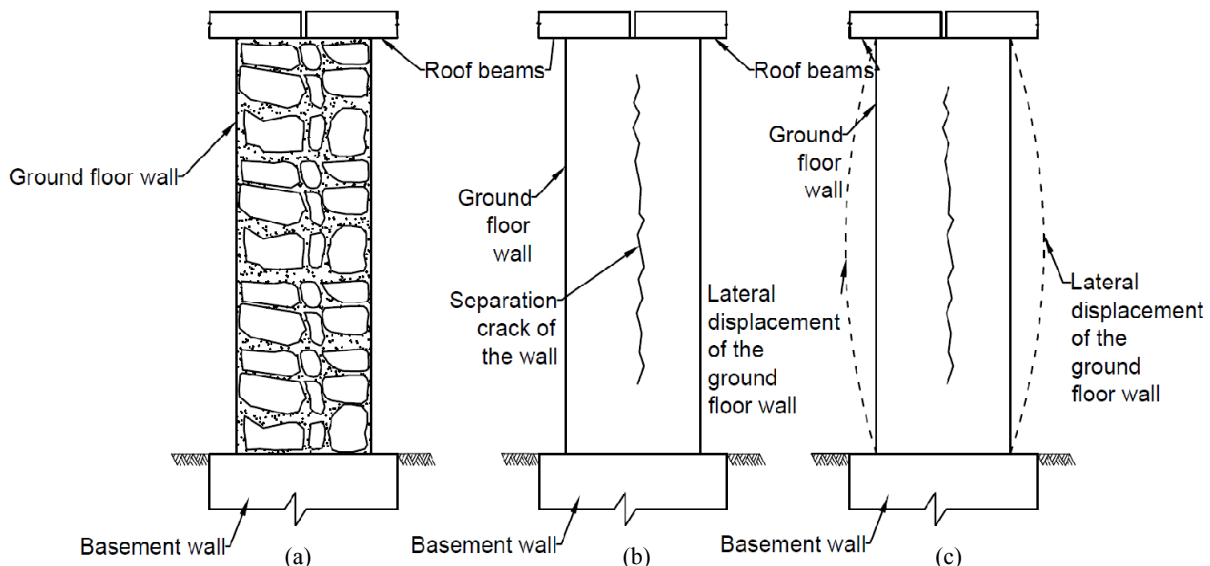
Fig. 4 Behaviors of rubble stone interior walls are: (a) the condition of providing masonry integrity; (b) the formation of cracks in the masonry separating into layers; (c) the formation of significant lateral deformations in the masonry (permanent deformation).

case of eccentric loading of the wall [3]. This is schematically shown in Fig. 4.

(1) Limit State 1: The masonry behaves like a full monolithic element against external factors; the masonry stones and masonry mortar work together and the masonry maintains its monolithic form (Fig. 4a);

(2) Limit State 2: In the middle part of the masonry cross section, cracks are formed in vertical direction between the longitudinal layers; and as the load value or load application time increases, these cracks develop in the longitudinal and vertical directions and this limit state ends with the separation of the masonry into layers (Fig. 4b). Furthermore, in this limit state, transverse deformations start to occur along the wall thickness;

(3) Limit State 3: In the middle part of the wall, a significant thickening is observed due to the transverse deformation, and this transverse deformation value decreases towards the upper and lower ends of the wall. No change in wall thickness is observed at the top and bottom ends of the wall (Fig. 4c);

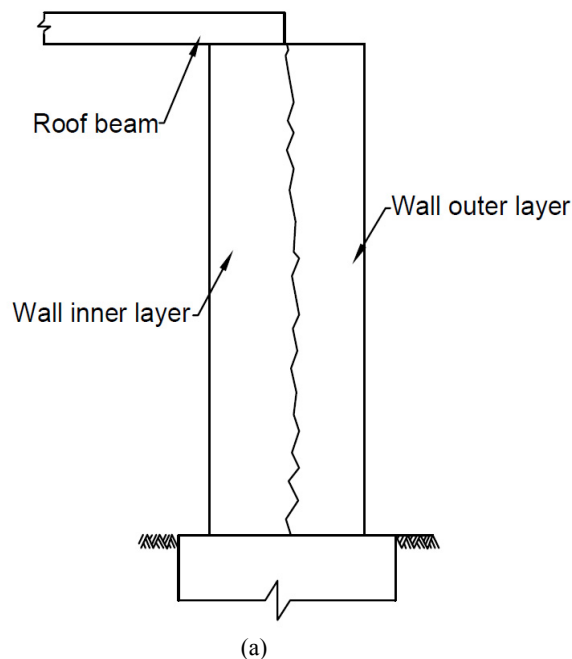
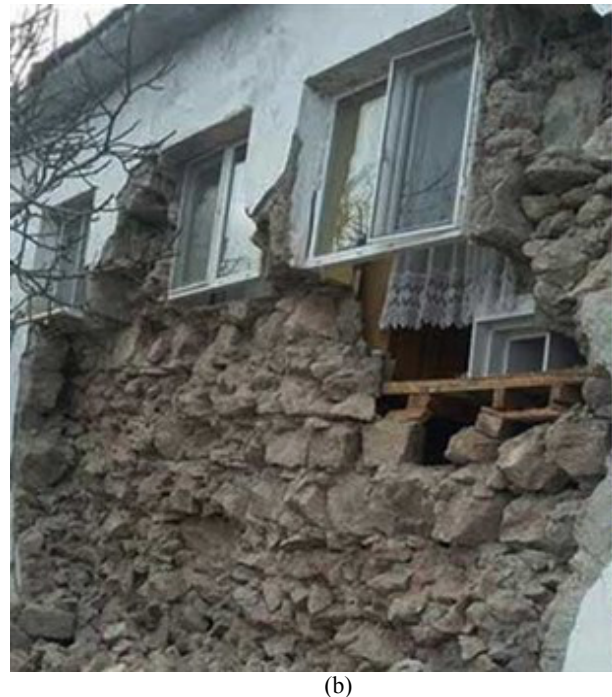
Fig. 5 Behavior of unilaterally loaded rubble stone walls, such as exterior walls or stairwells: (a) crack character; (b) dissolution of the outer layer during earthquake.²

This deformation character can also be observed under the influence of the static loads. Under earthquake impact, the internal walls are completely dissolved due to the accumulation of the pre-existing internal stresses in the wall with the external stresses. There are also cases where the outer layers of the outer walls collapse by the earthquake impact (Fig. 5b):

In case of loading the outer walls, the stairwell walls and the walls similar to those shown in Fig. 5a, the 3rd limit state does not take place; and by the end of the 2nd limit state, dissolution might occur as if at the 4th limit state (Fig. 5b).

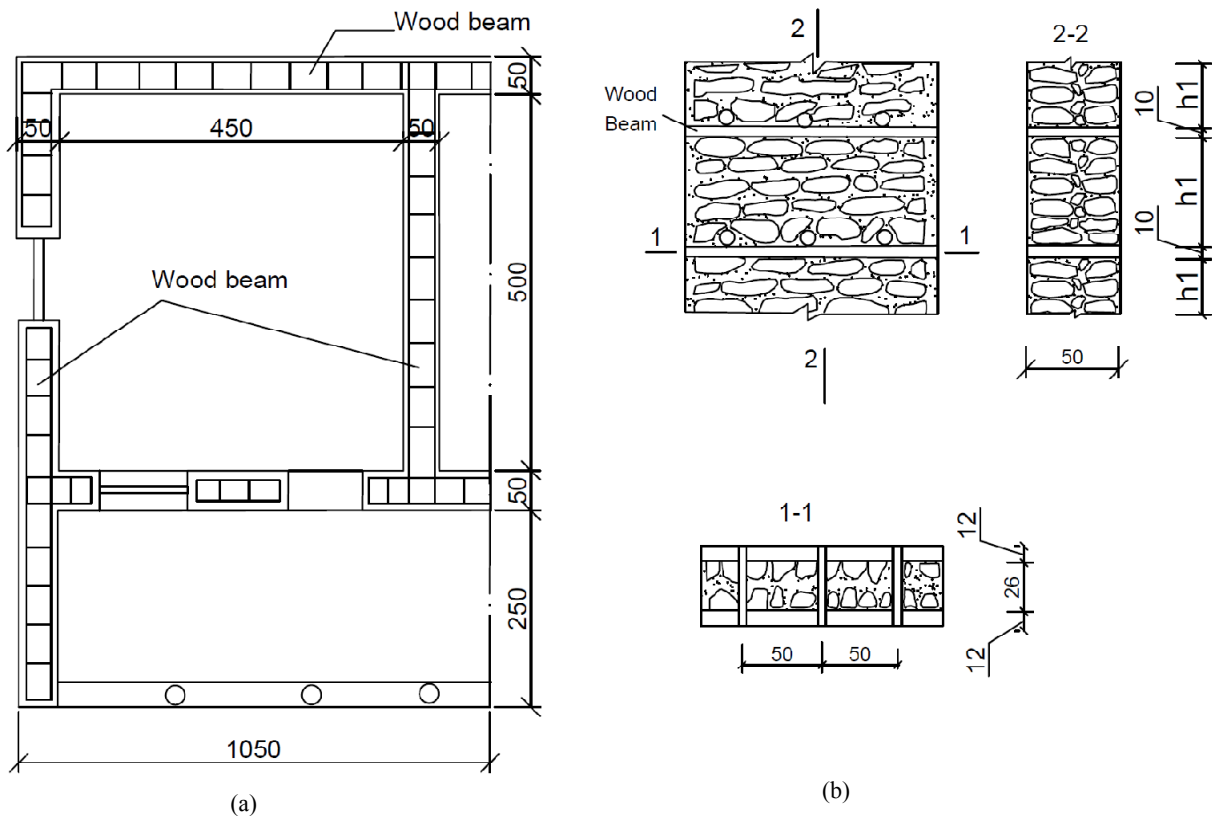
Fig. 6 Constructive system of rubble stone-walled buildings made by using wooden beams are: (a) placement of wooden beams at the building plan; (b) placement of wooden beams throughout the wall height (units in cm).

There are examples showing that the buildings built with rubble stones and wooden beams are standing for several centuries in the earthquake zones of Central Asia, Anatolia and Azerbaijan and that they have not collapsed during destructive earthquakes [3, 6, 15]. The constructive plan design of these buildings is as shown in Fig. 3a. Wooden beams are placed in the wall per 60-150 cm, one being for the thickness and another for the height of the wall. In these buildings, the wooden beams prevent the masonry from separating into vertical layers and allow the supporting walls to work in transverse and longitudinal direction together (Fig. 6).

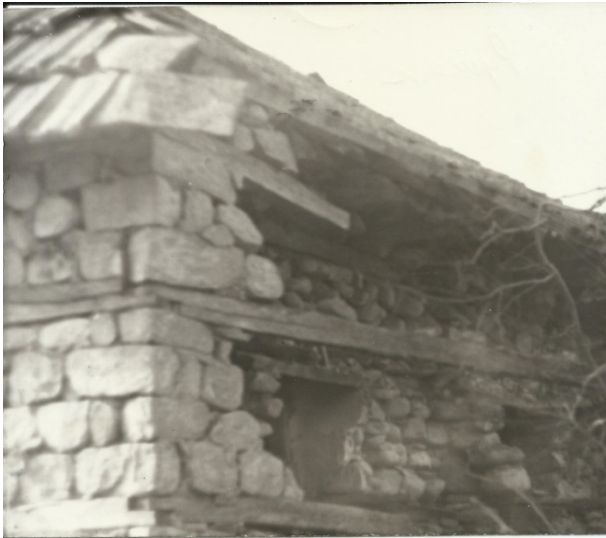
Fig. 7 A building where the distance between wooden beams is not suitable for masonry quality.

In addition, as seen in Fig. 7, the wooden beam considered at the middle of the height of the floor retained its previous state and did not detach due to earthquake effect. The examination of the masonry buildings made of wooden beams in earthquake zones showed that the distance between wooden beams is different in different wall types along the wall height. Detailed investigations have shown that the distance between beams along the wall height is around

60~100 cm in walls bonded with mortar of clay-straw mixture and is around 120~150 cm in walls made of mortar of lime or lime-cement mixture. Thus, these architects changed the distance between the beams along the height, depending on the strength of the masonry. They considered this distance as far in the walls with high strength, and as short in the walls with low strength. When this principle deteriorated, serious damage to the masonry was observed (Fig. 7).

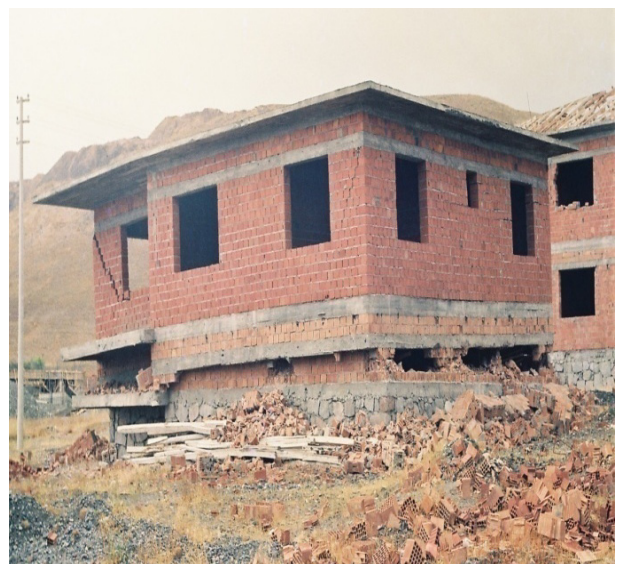
Fig. 8 Complete crushing and dissolution of the ground floor of a two-storey building with a concrete beam at the floor level.

earthquakes in southern California and India [6, 15, 16]. It is known that reinforced concrete beams used at floor levels are also inspired by the wooden beam formations used in rubble stone masonry walls in the past. In many standards in the world today, it is recommended to apply reinforced concrete beams at floor levels in brick and properly cut limestone walls [1, 5]. However, in the researches after Aşkabat (1948), Tashkent (1966), Siyazan (1963), Gasımkent (1966), Dimanis (1978), Ismayilli (1981), Erzincan (1992) and other earthquakes, it has also been observed that there are numerous damages and demolitions in the masonry walled buildings formed with reinforced concrete beams at floor levels. It has been observed that there are no cracks in the reinforced concrete beams at the floor level, although the cracks covering the entire cross section of the wall diagonally and like a plus shape were formed in the space between the walls due to the impact of Siyazan earthquake (1963) [3, 7, 13]. The same behavior was observed during Erzincan (1992) earthquake at numerous brick-walled one and two storied buildings built in Üzümlü village. Here, although the basement and first floors of the buildings completely collapsed, cracks were not found in the reinforced concrete beams at the floor level (Fig. 8).

Thus, the concrete beams formed at the floor levels exhibited different behaviors during the earthquake. The beams formed at floor-level in quality walls formed with high-strength materials increased the earthquake resistance of the walls, and when materials with low mechanical properties are used in the walls, the walls collapsed as shown in Fig. 8.

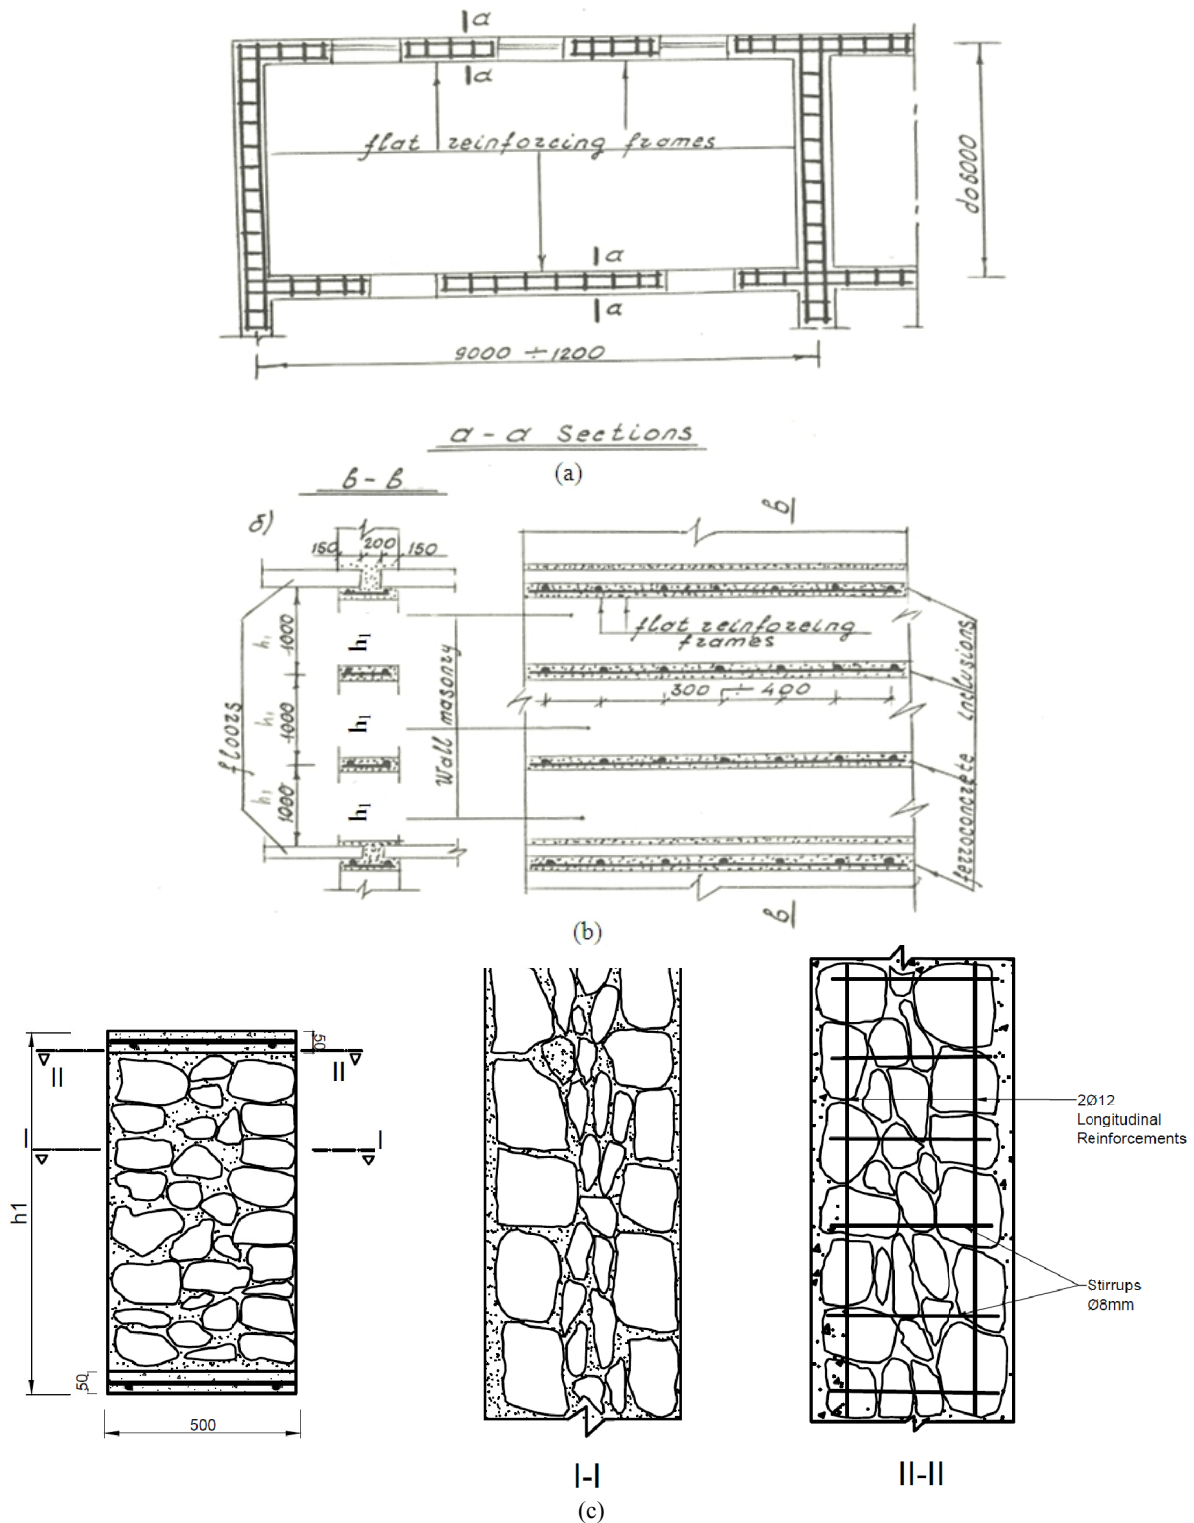
Fig. 9 Reinforced concrete beamed rubble stone walled building construction formation: (a) plan design of the constructive system of the building; (b) the placement of the beams at the height of the building; (c) detail of beamed masonry.

distance between the beams is less along the height of the wall, and more for high-strength masonry. The constructive formations of reinforced concrete beamed rubble stone masonry are given in Fig. 9 [9].

The spacing of reinforced concrete beams along the wall height can be determined depending on the strength and deformation capacity of the masonry by thickness, reinforcement cross section area and concrete class experimental methods. The results of the research carried out in the Earthquake Engineering Laboratory of Azerbaijan Institute of Construction and Architecture are given in Fig. 9.

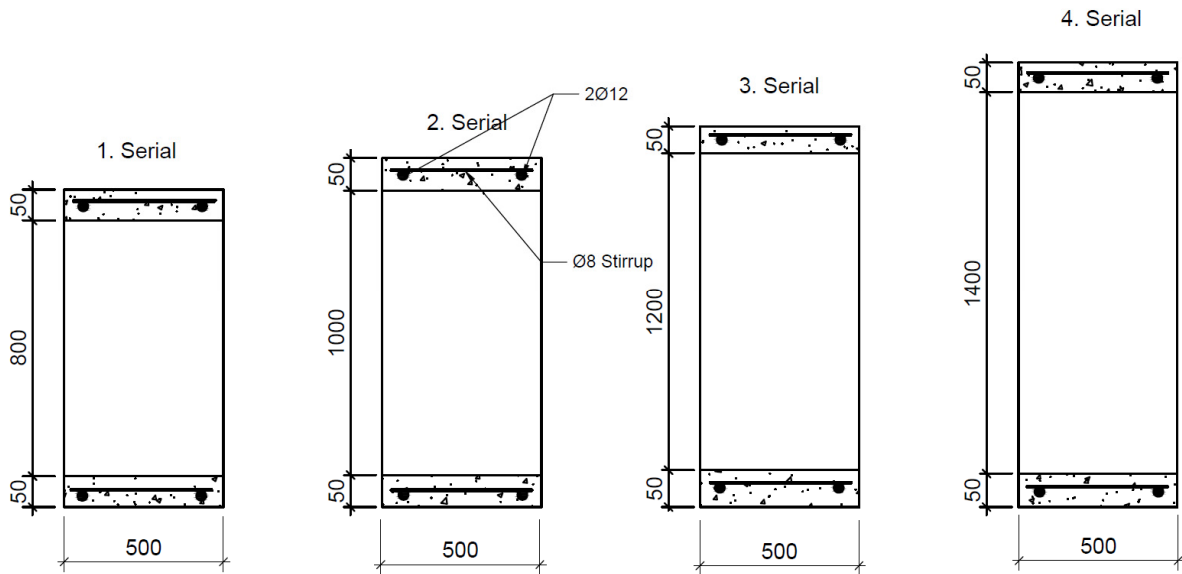
Fig. 10 Geometric measurements of the samples (mm).

In the research to determine the optimum values of the mechanical properties of the rubble stone masonry and the spacing between the beams at floor height, 4 series of masonry samples with a thickness of 50 cm, a width of 100 cm and heights of 80, 100, 120 and 140 cm were prepared (Fig. 10).

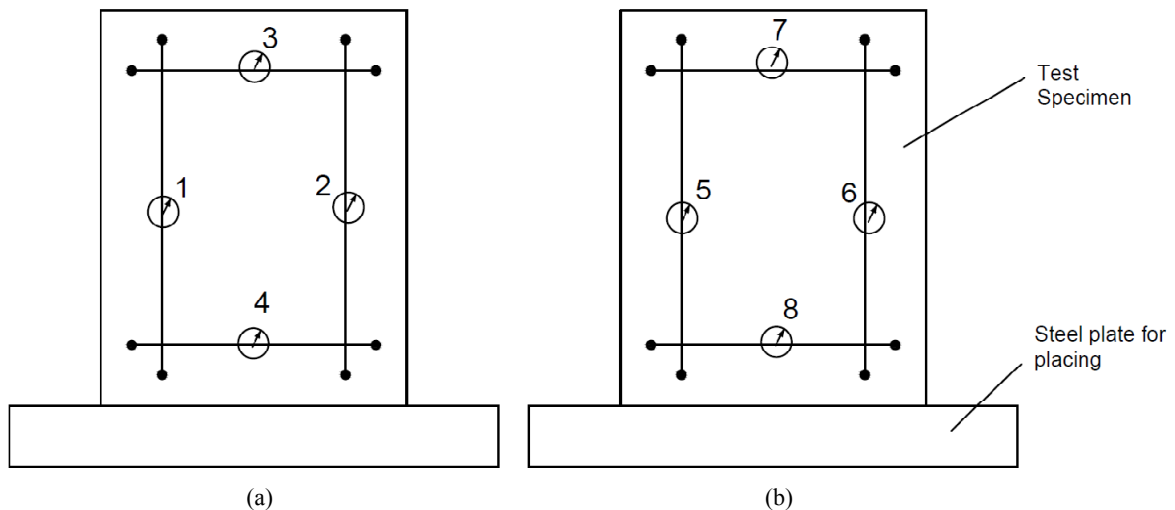
Fig. 11 Setting up the measurement devices: (a) placement of measurement devices on one side of the sample; (b) placement of the measurement devices on the other side.

samples rest for 28 days. Experiments were carried out with hydraulic press of 500 ton pressure capacity. It has been determined that load measurement error of the loading unit this press does not exceed 1%~2%. The vertical and horizontal deformations of the samples due to the load increase were measured with 0.001 mm precision clock-type deformation meters. The layout of the measurement devices in the samples is shown in Fig. 11.

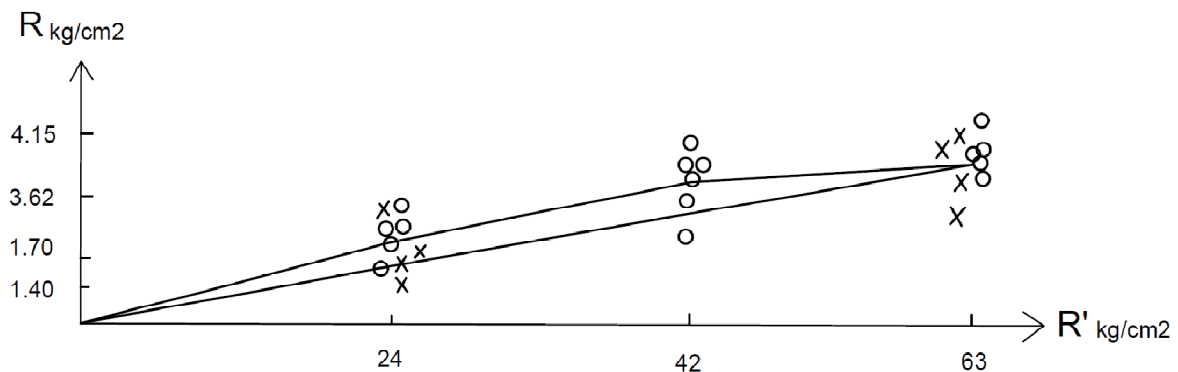
Fig. 12 The connection between the mortar strength and the adherence tensile strength on the rubble stone surface (o: on natural stone surfaces; x: on the surface of detached rubble stone).

In the results of the experiments made to determine the adherence stress between the mortar and rubble stone surface, it was observed that adherence stress is 0.014-0.023 kN/cm² when the mortar strength is 0.24 kN/cm²; when the mortar resistance is 0.48 kN/cm², the adherence stress is 0.034-0.038 kN/cm²; and when the mortar strength is 0.63 kN/cm², the adherence stress is 0.037-0.044 kN/cm². The diagram of the relation between the mortar strength and the adherence stress is shown in Fig. 12, and the cracking characteristics of the samples during the experiment are shown in Fig. 13.

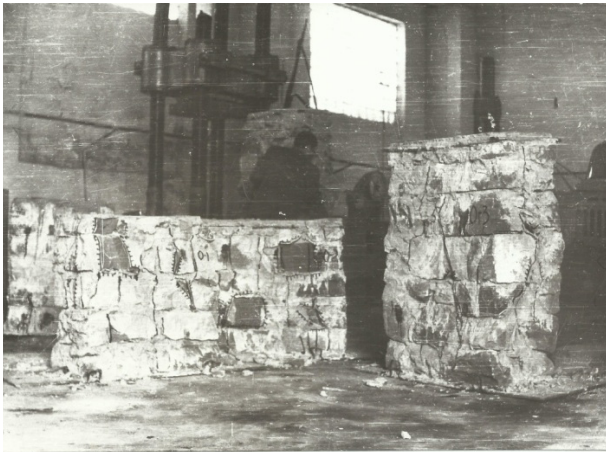
Fig. 13 Cracking characteristics of rubble stone samples during the experiment.

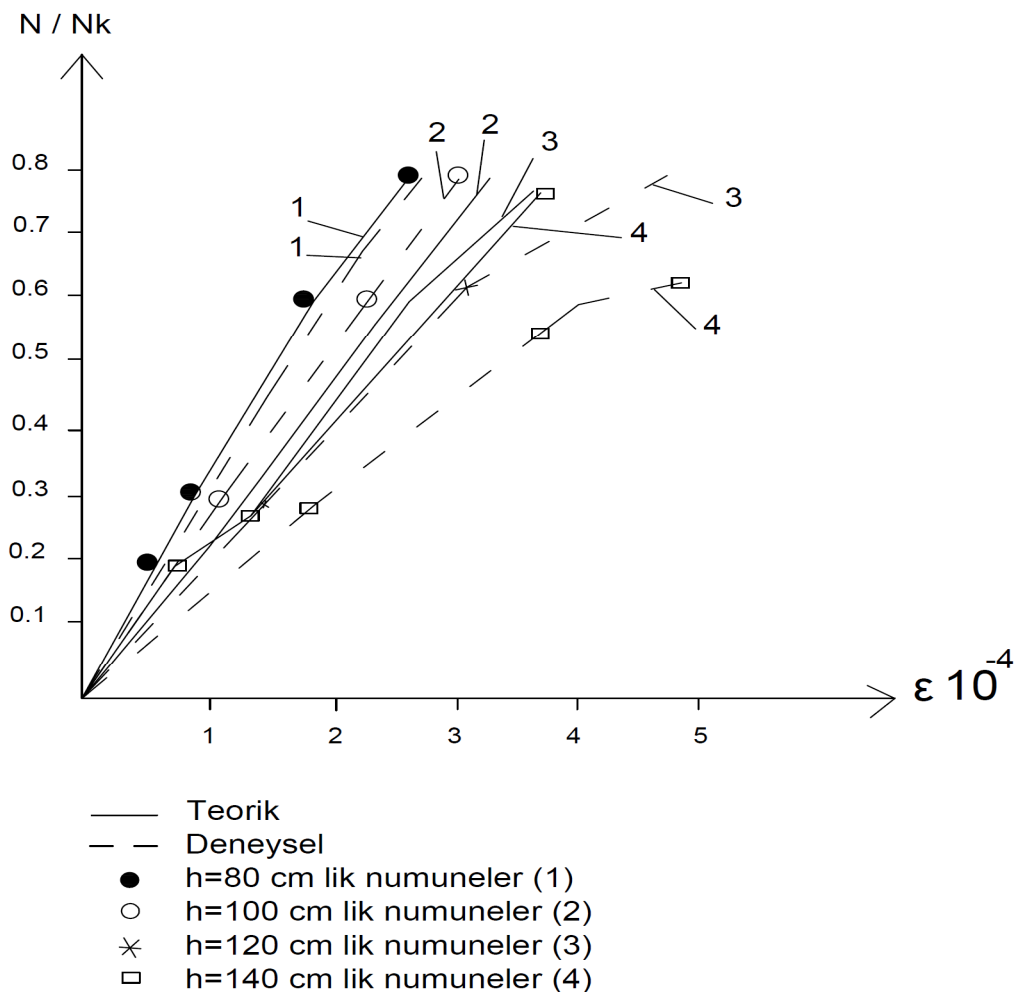
Fig. 14 Diagrams of $f(\epsilon, N/N_k)$ depending on sample height.

Experiments on masonry samples made of rubble stones have shown that the strength of the sample decreases as the sample height increases. Such that, the rupture strength of the sample with a height of 80 cm is 1.25 kN/cm² and strength in crack formation is 0.450 kN/cm²; the rupture strength of the sample with a height of 100 cm is 1.12 kN/cm² and strength in crack formation is 0.325 kN/cm²; the rupture strength of the sample with a height of 120 cm is 0.68 kN/cm² and strength in crack formation is 0.21 kN/cm²; and the rupture strength of the sample with a height of 140 cm is 0.6 kN/cm² and strength in crack formation is 0.2 kN/cm². It was observed that the proportional deformation value increased with the sample height (Fig. 14).

If the height is greater than 100 cm, the behavior character of the samples can be examined in the 4th limit state. At the 1st limit state, the connection between the stone and the wall does not deteriorate and the sample continues to carry load without any cracks in the sample. At the 2nd limit state, capillary cracks start to form on the vertical edges of the sample and the masonry sample begins to separate into two layers with increasing load. At the 3rd limit state, the masonry sample starts to work like a two-layered wall. At the 4th limit state, the sample is separated into separate vertical strips. The ε - N/N_K relationship of these samples determined by the results of experiments is given in Fig. 14.

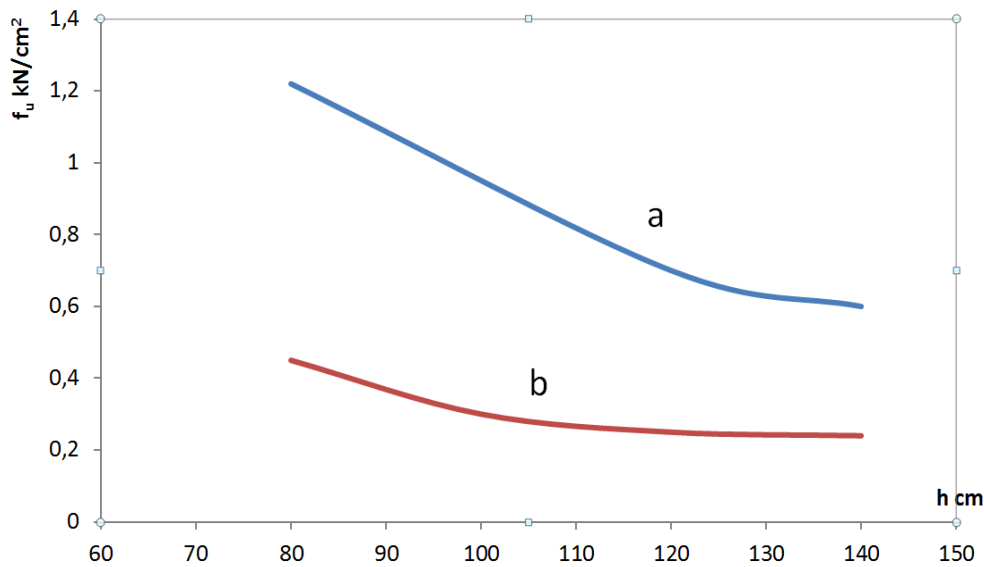
Fig. 15 The variation of the strength of the experiment samples depending on the height is: (a) suitable for rupture; (b) suitable for crack formation limit.

The connection between sample height and rupture strength of the masonry is given in Fig. 15.

The increase of the sample height from 80 cm to 100 cm according to this diagram reduced the rupture strength of the sample by 10.4%. Raising the sample height from 100 cm to 120 cm caused the rupture strength of the sample to decrease by 39.3%. In addition, it is seen from the diagram that increasing the sample height from 120 cm to 140 cm causes the masonry strength to decrease by 11.76%.

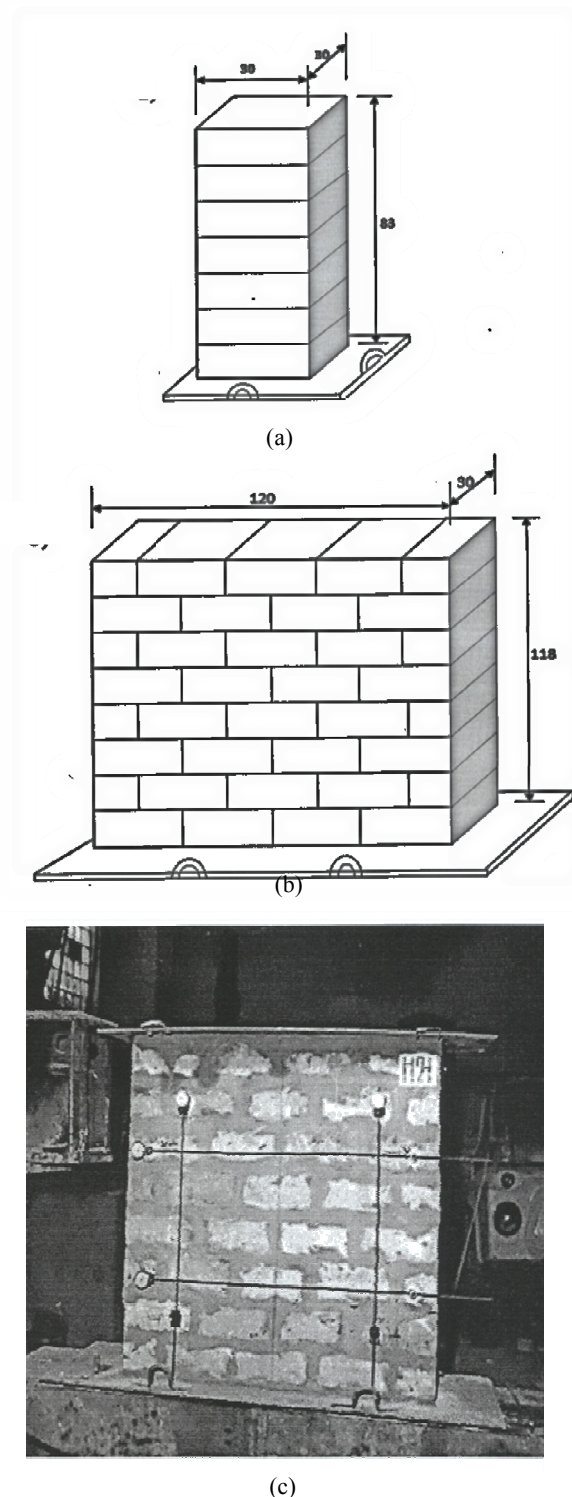
Fig. 16 Construction of the masonry samples: (a) column sample; (b) wall sample; (c) pre-experimental view of sample.

measure the deformations in the error range of 0.01~0.001. Thus, it can be assumed that the error rate in the experiments is below 2%. The layout of the deformation measuring devices on the test samples is given in Fig. 16c.

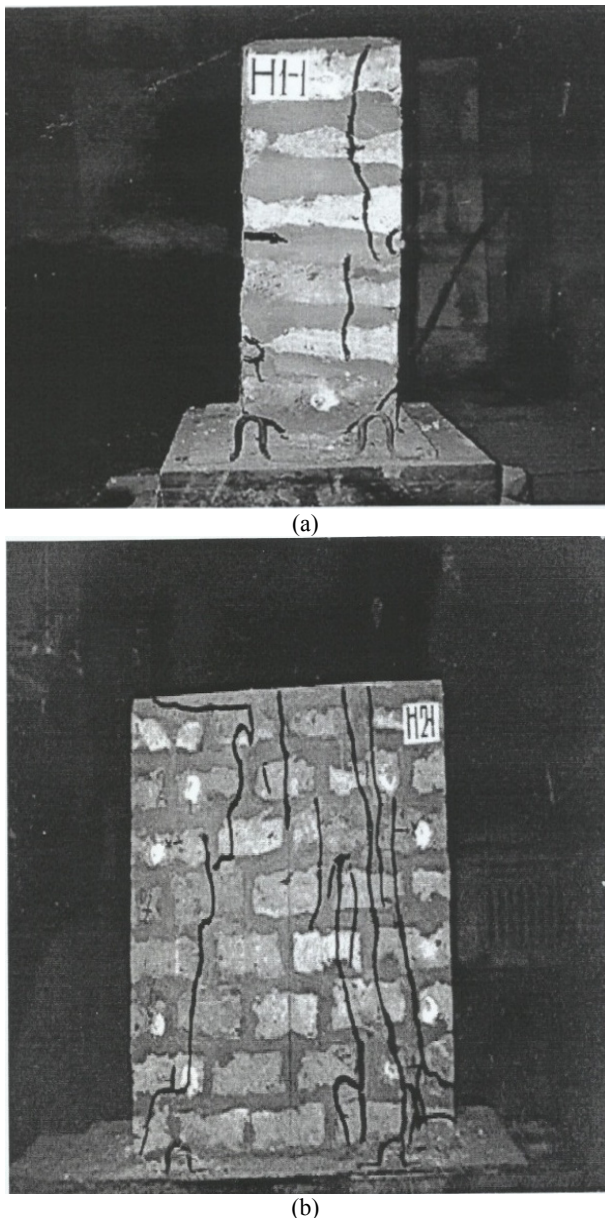
Fig. 17 Cracking characters of test samples: (a) 1st crack formation character of serial samples; (b) 2nd crack formation character of serial samples.

The cracking characteristics of the serial samples are shown in Fig. 17a, and the post-experimental view of

the samples prepared for the series is given in Fig. 17b. As a result of examining the cracking characters of the samples, it has been shown that the cracked planes of the experimented samples are developed by incorporating the stone cross-sections.

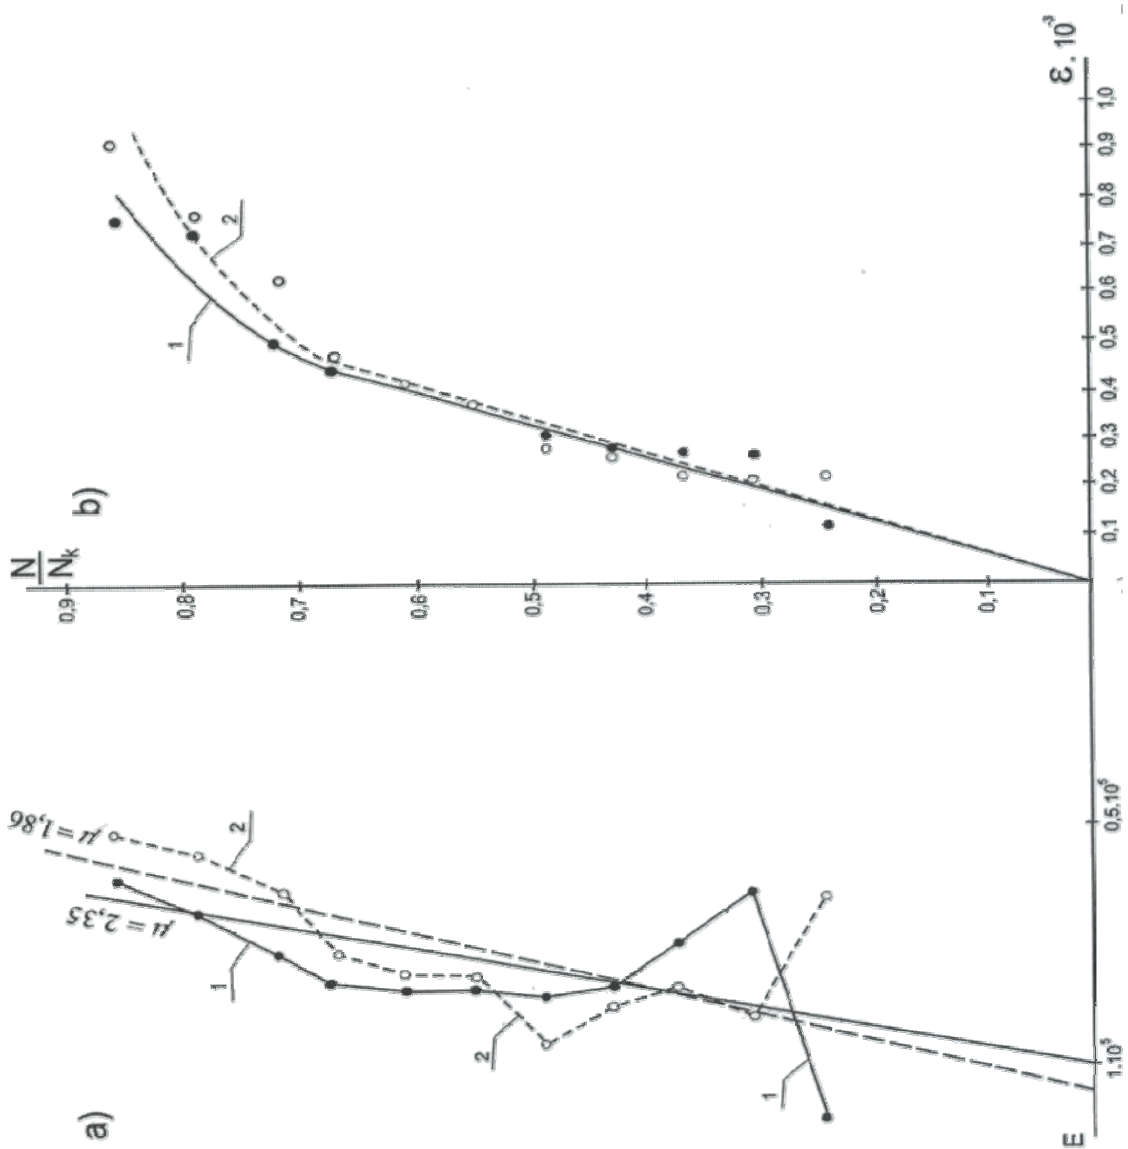
Fig. 18 The dependence between the elasticity module and N/N_k calculated on the basis of the test results: (a) $E, N/N_k$ graph; (b) $\epsilon, N/N_k$ graph.

As can be seen from the diagram $E, N/N_k$ given in Fig. 18, the graph of the ratio of the load value (N) according to the loading step to the distributor load value (N_d) up to the limit of 0.65~0.70 ($E; N/N_k$) develops close to the linear character. This permits the transition coefficient to the calculation resistance ($f_{d,mas}$) from the average compressive strength limit ($f_{c,mas}$) of the determined masonry as $K = 1.4\sim 1.5$ according to Ref. [19]. In addition, K -value recommended in Ref. [19] was assigned for the two-row masonry system. In the study conducted in this article (Table 1), the test results of single-row knitting system samples were obtained as 12%~13%, different from each other for the same series. Therefore, $K = 1.12\sim 1.13$ is possible. For design applications, K value can be rounded to $K = 1.2$.

The link between the modulus of elasticity and N/N_d obtained from the experiment results is shown in Fig. 18a and the tensile-deformation curves are shown in Fig. 18b. The links given in Fig. 18 are prepared by S.A. Semetsov method [25]. It was observed that the difference between the elasticity coefficient obtained from the experiments and the elasticity coefficient calculated theoretically did not exceed 11%. According to the test results on the first series of samples, the average load carrying capacity of the samples was 521.5 kN, the average strength was 0.579 kN/cm^2 , the

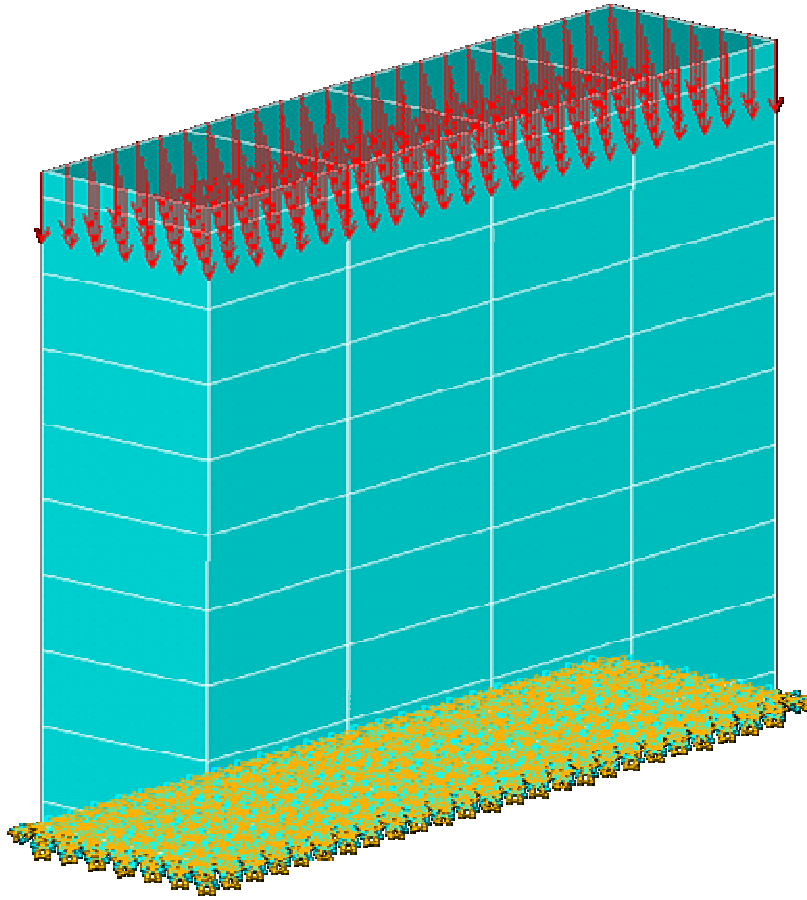
Fig. 19 Finite element model.
