Quick Impact of Protecting, Strengthening and Repairing and Consequences of Fire Damaged Structure — Hotel Union, Kosovo

This paper analyses the consequences of fire events occurring in heritage buildings, especially those already within the rehabilitation process with intension for theirs publication and recommendations to authorities. In particular, the paper summarizes the results and information for an investigation and consequences of fire hazard at damaged structure—Hotel Union in Prishtina, Kosovo.

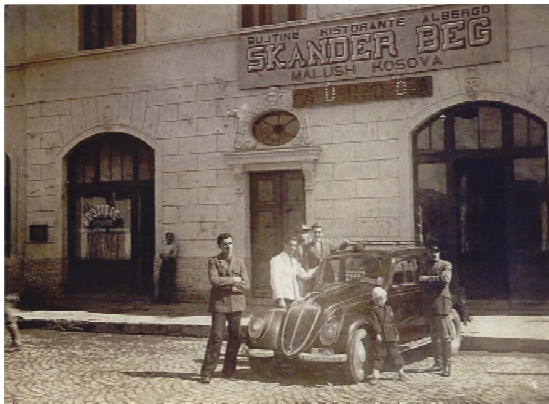
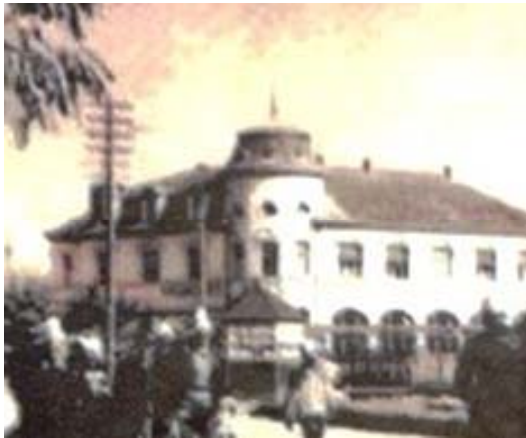
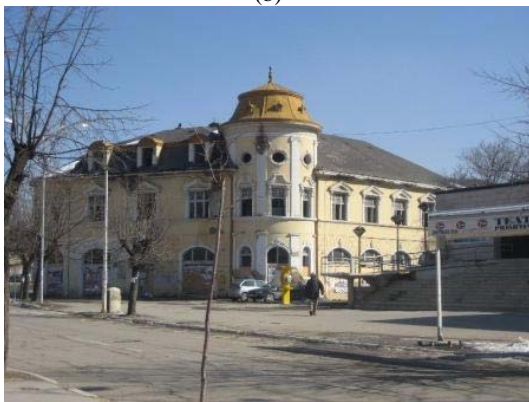
Fig. 2 The main views of Hotel Union: (a & b) the building originally was private owned hotel named Skenderbeg which has been changed after World War II is nationalized and named Union; (c) present time of the building, 2007 (a & b credited by: I. Ganimula, c. credited by Sh. Nixha).

investment for maintenance. Deficiency of quick impact and well coordinated process between preparation of the project for preservation and restoration of the building with its protecting, strengthening and repairing phase, drifted the fire and damaged structure of hotel “Union”. (Fig. 2)

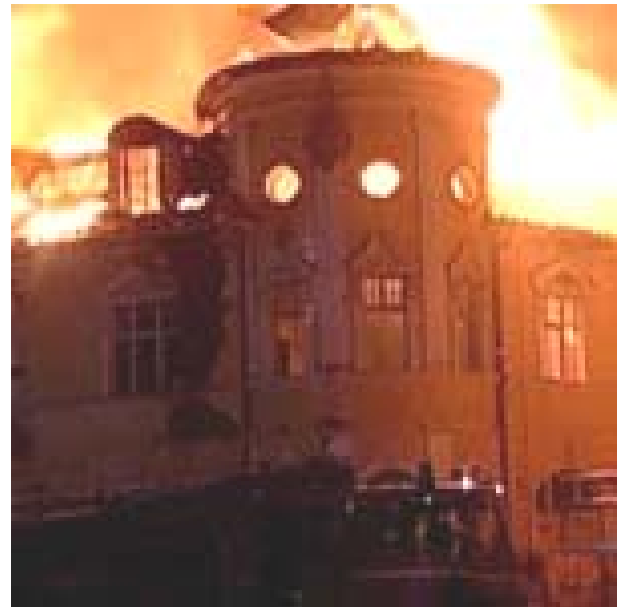
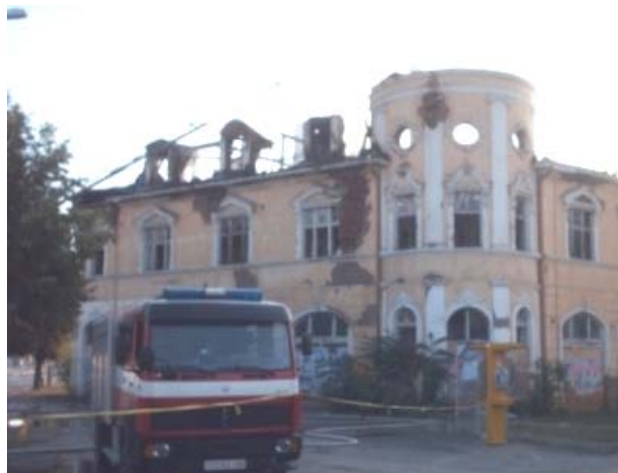
Fig. 2 The pictures taken during the fire and day after.

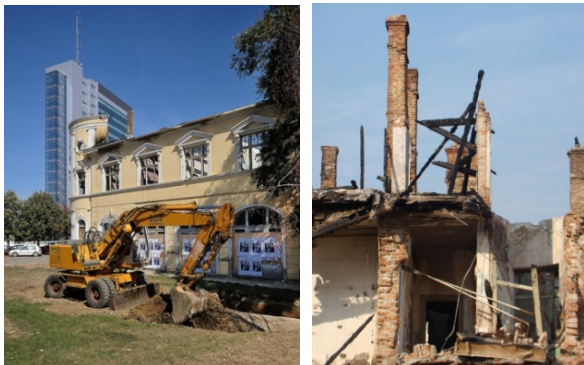
Fig. 4 The building was not professionally protected after the fire.

General findings and recommendations from above research are relatively recent developments, but not responding too closely with cultural heritage building techniques and methods of upgrading the fire resistance at their building elements, respectively at the cultural heritage premises and other areas of premises. This is the main issue, discussed further in this research and basically focused at study case, a cultural heritage building – Hotel Union, due to the following reasons: (1) most of construction elements, such as floor, roof, staircase, doors and windows of the cultural heritage buildings are from timber, which is weak in fire resistance, (2) absence of fire protection precautions, such as observation, guarding, signalization, etc., during the passive stage of intervention, (3) there are lots of valuable items and priceless heritage to be protected from fire in cultural heritage buildings, (4) deficiency of materials alterations that could affect to existing cultural heritage buildings where necessary to effectively increase the fire resistance of entire premises (Fig. 4).

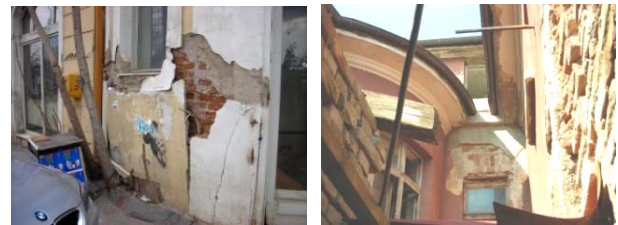
Fig. 5 The views of the building while the diagnostic phase took place in order to prepare the rehabilitation plan.

Due to the lack of administrative procedures, bureaucracy, no clear sharing of the responsibility between authorities and owner the damage of the premises increased rapidly. The process of rehabilitation was stopped and there were no laboratory tests performed. The damaged report issued by professional team for evaluation of damaged walls determined the pending situation while the damages on the building are progressively increased.

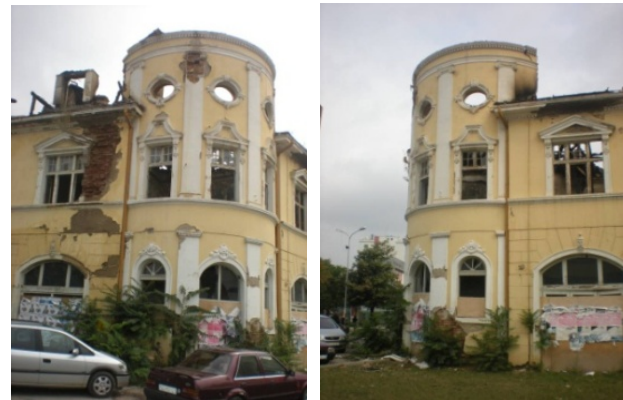
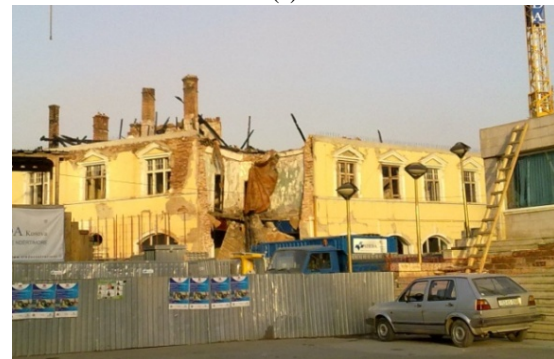
Fig. 6 Increase of building damages within short time, a. Aug 2009 and b. Nov 2009 (credited by: T. Jashari-Kajtazi).

The Cultural Heritage professional commission, after site assessment and construction observation concluded that during the period of Aug 2009 when occurred the fire and nowadays, Mar 2010, almost 60%

of heritage values are destroyed and damaged. The damage is due to the fire, less of maintenance, too much prepermission during the cleaning area of premise from debris of fired constructive materials, lack of owner management when required to take and implement the regulations to initiate the preventive measures against weather conditions and its imprecations to fired premises, the consequences occurred due to the miss usage of digging machinery and/or without professional outputs when he started to conserve, consolidate and rehabilitate south, west and north façade, not properly installation of temporary supported structure prior rehabilitation process, etc.

Since the walls are constructed by using clay as a construction material, and it's known that the binder materials are not fire resistant, their damage under fire is impossible to be recompacted. The part of the edges which are not totally destroyed could be laboratory exanimate (their stability and resistance) in order to prevent and save their position. In this case could be applied the methods which are using the injection with fluid mortars and other additives. In general the reconstruction will enclose the different methods including the strengthening with FRP—glass fibers or/and repairing mortars.

After the research, investigation, interviews, observation and analyzes of Hotel Union data the following are further actions to be taken in regards to establish the procedure, management of rehabilitation or/and reconstruction: to establish cultural heritage professional commission whose responsibility is to initiate and monitor closely reconstruction based upon to awarded rehabilitation project since the damages of the premises happened into very short period of time; to prepare the guide with intent to cover as much as possible the lack of information not only the fire experts such as fire safety engineers and fire brigades, but, more importantly, the people directly concerned with the upkeep and the operation of such buildings; to prepare the guide for using the repairing materials and strengthening materials according to the EN 1504.
