An Important Film: Polychromy in the Pier Luigi Nervi Halls at the Turin Exhibition Center

Greta Bruschi

Key words: Polychromy, reinforced concrete, ferrocement, Turin Exhibition Halls, Pier Luigi Nervi, maintenance, preservation.

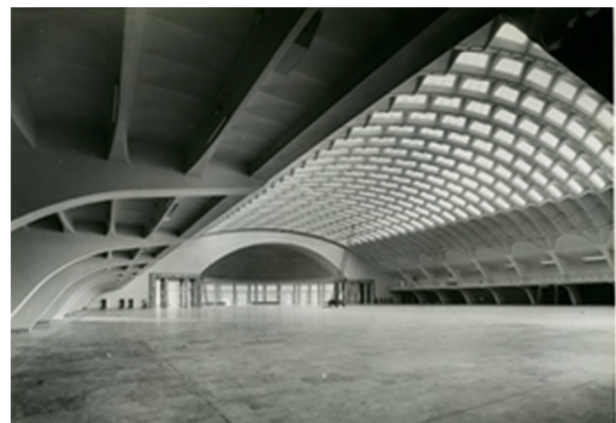
Fig. 1 Hall B, interior by Aldo Moisis (Private collection, Ing. Ravelli).

consists of arches made of ferrocement elements prefabricated on site, raised and assembled with a system of mobile scaffolding. The system of wave-shaped prefabricated ashlar (with inbuilt windows) and scaffolding, along with the half-dome roofing of the apse, obtained with cement castings consisting of more than 300 lozenges (also made of ferrocement and produced on site) are patented by Pier Luigi Nervi himself (Fig. 1).

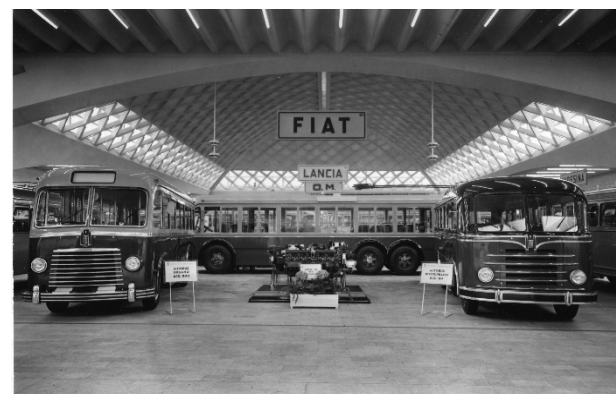
Fig. 2 Hall C, International Car Show of 1950 by Aldo Moisis (Archivio Storico Fiat).

In 1950, *Torino Esposizioni* decided to expand the building's spaces to accommodate the new editions of the Car and Technology Shows, once again entrusting Pier Luigi Nervi with the construction of Hall C. The new Hall (50 \times 60 m) has a pavilion vault supported by four arches, covered with the same ferrocement system as the half-dome of the apse of Hall B (Fig. 2). The perimeter slabs to the roof of Hall C are made of

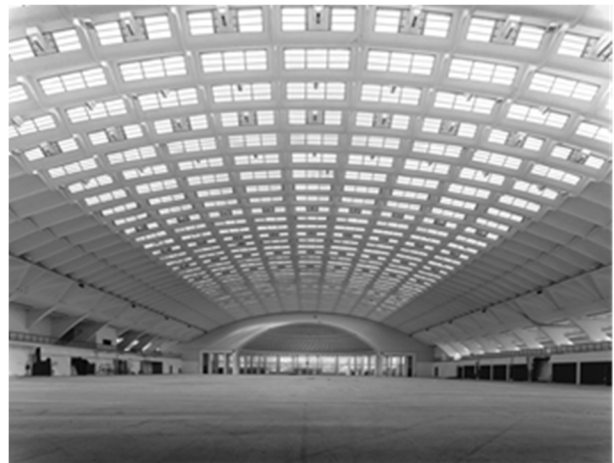
Fig. 3 Hall B, the appearance of the interior in white at present (courtesy of Fabio Oggero, 2022).

There are no published or construction site images which show the colors of the Halls. Even in the publications signed by Pier Luigi Nervi the images are in black and white [6, 7]. The use of black and white images was not only due to the possibilities offered by the technology at the time, or due to the need for low-cost printing, but also due to an intention to improve the perception of forms and enhance the role of light, and volume. The author himself never mentions the choice of color adopted for these buildings, instead, he used his writing to promote his patents and his new fast, cheap and innovative construction techniques. Another influence was the revolution dictated by the Modern Movement: the color white became the starting point for a new story, expressing the cleanliness of forms and the principles of abstraction. Elementary geometry was used to aspire to essentialism [8]. The image of white-painted interiors was therefore consolidated. We think this happened because of a misunderstanding of the principles inherent to Modern architecture, along with the widespread circulation of images depicting the Halls which were used during the 2006 Olympics, and other documents showing their current state of neglect in which the structures are painted white (Fig. 3).

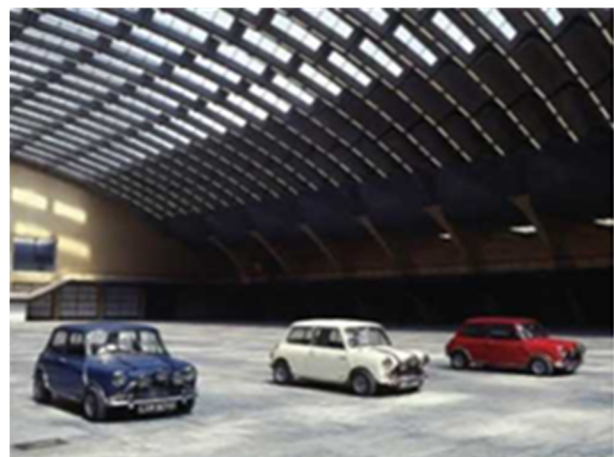
Fig. 4 A scene from “The Italian Job” (1969) set in Hall B directed by Peter Collinson.

The comparative analysis of different historical sources such as archives, images and videos shed light on the use of color, an aspect that is often underestimated. From some sequences of the film “The Italian Job”, filmed in 1969, which has been a fundamental first source for this research, certain colors can be perceived that clearly show how some parts of the building were painted cream, others gray (Fig. 4). What seems certain is the absence of bright white paint.

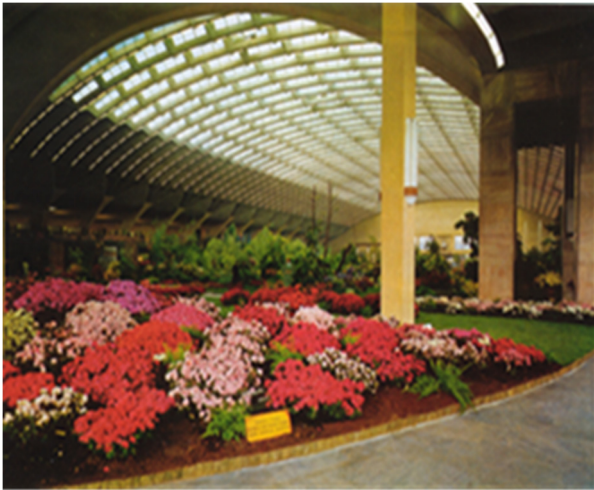
Fig. 5 Hall B, Flor61, 1961 (Archivio Amici d'Italia).

This initial clue led to the consultation of historical images not necessarily aimed at documenting the Center, but rather as the setting for exhibitions, fairs or film and advertising sets, confirming that Hall B was once multicolored (Fig. 5) and raised doubts about the possible presence of polychromy also in Hall C (Fig. 6).

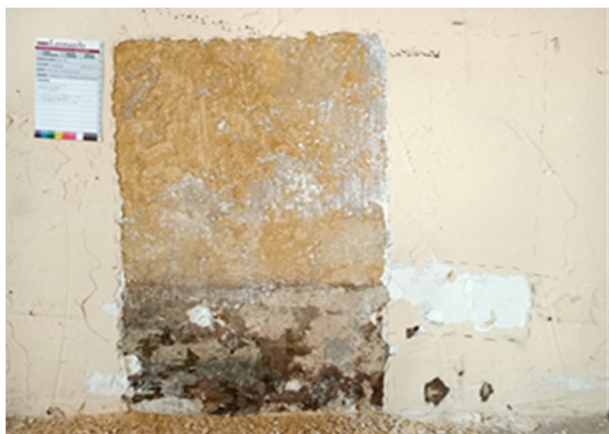
Fig. 7 Hall C, perimeter wall, sample No. 5: bichromy between the upper part, beige in color, and the brownish skirting (*Leonardo srl*).

At the conclusion of the stratigraphic survey, a relative chronology of the resulting stratifications was defined, which is represented through coating diagrams in which the various layers identified in the different tests are related. The diagrams make it possible to interpret the layers of each sample not as point information, but as an integral part of the complex of buildings investigated in a certain execution phase. The bichromy illustrated in Fig. 7 plausibly represents the original configuration of the perimeter wall in Hall C as well as all the pillars in Hall B (apse and balcony) (Fig. 7).

Period 1 (from 1949 to approximately 1969) is the original configuration of the finishes, and the oldest among the finishes found. In Hall C it is characterized by a two-tone effect obtained by differentiating the surfaces of the background walls, of light beige color with brown skirting, while the architectural elements are characterized by a dark gray finish. The chromatic configuration of Hall B is comparable to that found in the adjacent Hall C, therefore distinguished by a bichrome obtained by differentiating the light ochre yellow pilaster surfaces with a brown skirting. The other architectural elements are characterized by a layer of finish with rough textures of gray (wave ashlar and lozenges apse).

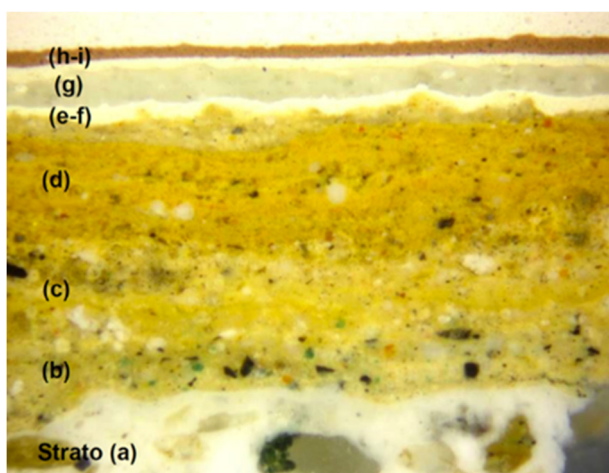
Fig. 8 Hall C, Perimetral wall, sample No. 2, stratigraphic analysis under the optical microscope: “b” and “c” layers without vinyl resins (CMR Center Material Research Snc).

resin (resin not present in the b-c layers of sample No. 2 (Figs. 8-10), in the c layer of sample No. 3 and in the b-c layers of sample No. 7) and a second layer of calcium carbonate mixed only with white titanium particles and silico-aluminate and quartz. In the second period, the layers have a homogeneously distributed microporosity throughout the examined sample, alternating with a macroporosity with relative cavities and blisters caused by the incorporation and subsequent loss of air.

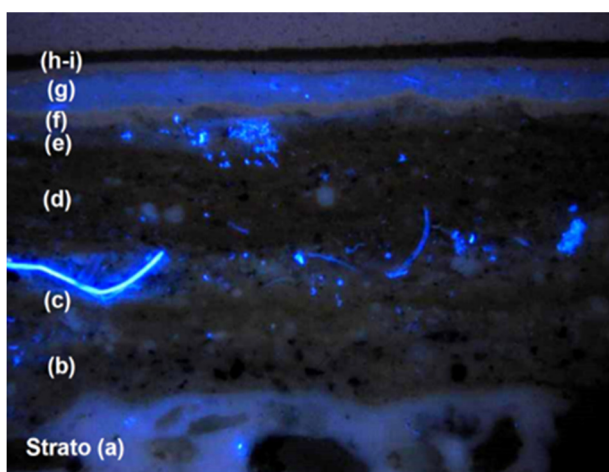
Fig. 9 Hall C, sample No. 2, analysis under the optical microscope with UV (ultraviolet) illumination (CMR Center Material Research Snc).

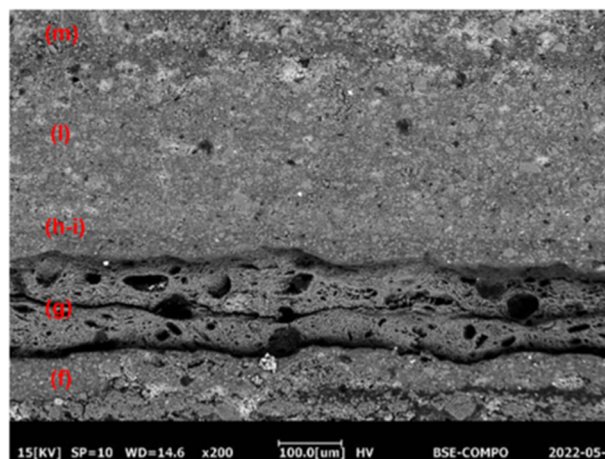
Fig. 10 Hall C, sample No. 2, examination with the SEM electron microscope: layers from “f” to “m” where the alternation between micro and macro porosities is clearly visible (CMR Center Material Research Snc).
