# Laminated Solid Timber Slab with Transverse Prestressing Using the Strategy of Interleaved Vertical Displacement of Lamellae

**Abstract:** This article presents a study on the structural behavior of transversely prestressed laminated timber slabs, focusing on an innovative approach: vertically misaligned lamellae. This misalignment, achieved by sliding vertically the wooden lamellae rather than aligning them, enhances the slab's cross-section moment of inertia, thereby improving load-bearing capacity and stiffness. Testing involved two groups of structural size specimens: one with vertically aligned lamellae (control group) and the other with misaligned lamellae (study group). Results showed the study group exhibited 42% superior stiffness and 10% less load capacity compared to the control. Failures typically occurred individually in the lamellae, particularly in those with defects or lower modulus of elasticity, concentrated in the middle third of the slabs' free span where tensile stresses peak. Despite a higher number of failed lamellae, the study group demonstrated promising performance. Analysis of prestressing bar indicated no damage at all in the thread, suggesting potent

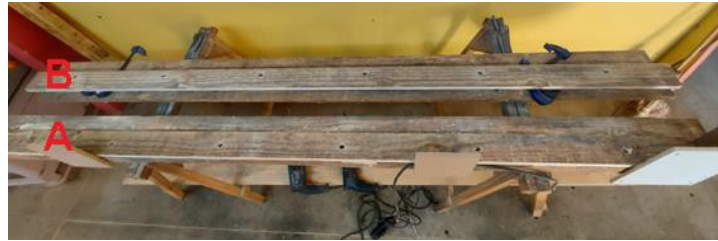
**Fig. 4 Drilling template.**

After separating the lamellae into 6 groups, holes were drilled to pass the threaded bars to proceed the prestressing. To carry out the process of drilling the lamellae, drills with a diameter of 5/8" and two lumber pieces were also used as a template (Fig. 4).

As can be seen, letter "A" (Fig.5) represents the template for the lamellas referring to CP4 and 6 (control group), that is, with centralized drilling. Letter "B" (Fig. 6) refers to the template that was used for specimens CP1, 2, 3 and 5 (study group). The following images illustrate the features of the templates.

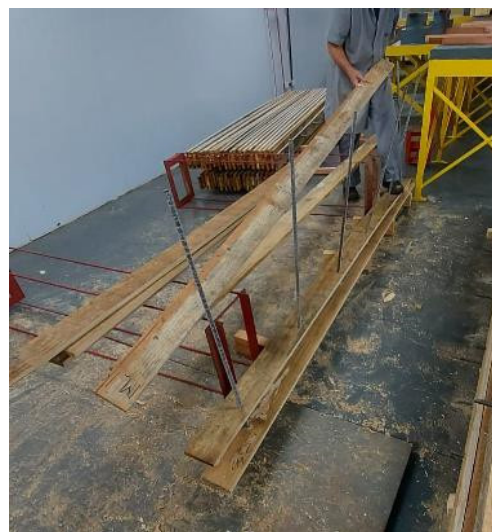
After the process of drilling the boards, the assembly of the test specimens began. Special care was taken to ensure that the pieces on the edges had the highest modulus of elasticity in the whole set to avoid crushing resulting from prestressing. The internal positioning of the lamellae was randomly distributed. To facilitate the fitting of the lamellae, the specimens were vertically assembled (Fig. 7). Initially, all 6 threaded bars were placed in an edge lamella, to facilitate the guidance of the following ones. In this process, it was necessary to apply paraffin to the threaded bars to facilitate their passage into the holes. No care was taken regarding the positioning of knots

**Fig. 7 Lay up of the pieces.**

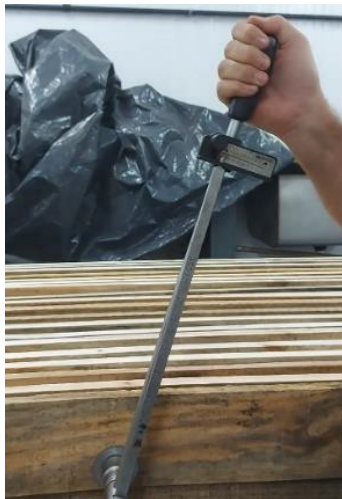
Fig. 9 Application of prestressing.

The prestressing was carried out manually, with the aid of a torque wrench (Fig. 9), and carried out in three stages following the method by Taylor and Csagoly [16] and Ritter [17] who suggest how to prestress: The initial value is 2.5 times the design value, and at least 2 more re-stressing applications to the initial design value level.

In this way, the first prestress occurred immediately after the test specimen was constructed with an applied torque of  $2.5 \times$  design value, that is, 62,181 N·mm. The prestressing sequence was carried out from the center of the component length towards the ends, following the standard recommendations for prestressing in concrete structures (Fig. 10). This approach helps to

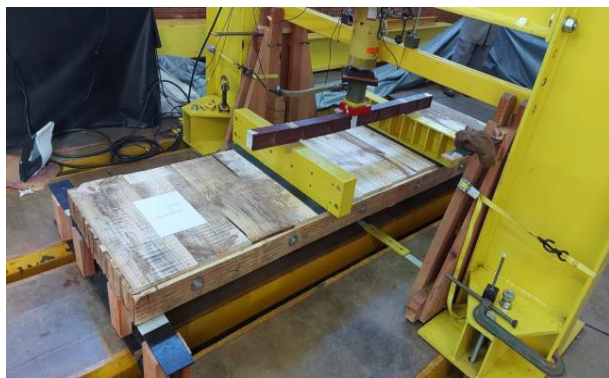
**Fig. 12 Positioning.**

displacements. The loads were applied from top to bottom through the hydraulic actuator, on a metal I bar that transferred the load to two beams placed on the thirds of the theoretical span (Fig. 12). The positioning of the elements is detailed below.

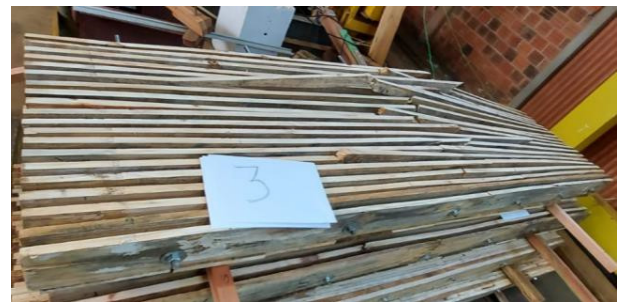
In Figs. 17 and 18, the side faces of the specimens at the moment of rupture, as well as an analysis of the pattern of board ruptures can be observed.

As expected, the failure occurred at the middle third of the component length, where the bending moment is maximum, concentrating the tensile stresses, diagonally with respect to the central axis of the component. Furthermore, in few cases the lamellae broke into more than two parts, and in most cases, only cracks were observed. Furthermore, most ruptures occurred where defects already existed in the lamellae, such as knots (Fig. 19).

Fig. 17 Prototype 3.

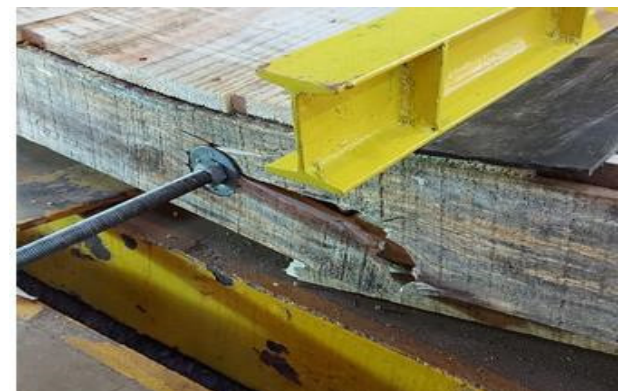
Fig 18 Specimen 4.
