Analysis of Mortars Used in Large-Scale Historic Masonry Walls: An Example from Northwestern Anatolia

Abstract: The article examines the physical, petrographic, mineralogical, and microstructural properties of mortar samples taken from a medieval structure located in northwestern Anatolia. Six mortar samples collected from the structure were analyzed using advanced techniques such as acid loss, ignition loss, sieve analysis, physical analyses, polarizing and stereo microscope observations, SEM-EDS, XRD, and TGA. The mortars examined exhibit hydraulic properties. The hydraulic character of the mortars is mainly provided by brick dust and aggregates exhibiting pozzolanic activity. Acid loss and ignition loss analyses indicate that the binder-aggregate ratios vary between 1:1 and 1:3. The elemental and mineral composition of these mortars was analyzed using EDS and XRD, respectively. Analytical techniques revealed the presence of quartz, feldspar, muscovite, biotite, vaterite, and aragonite crystals. The results were supported by thermogravimetric analysis. This study provides important references for the formulation of compatible repair mortars to ensure the proper preservation of m

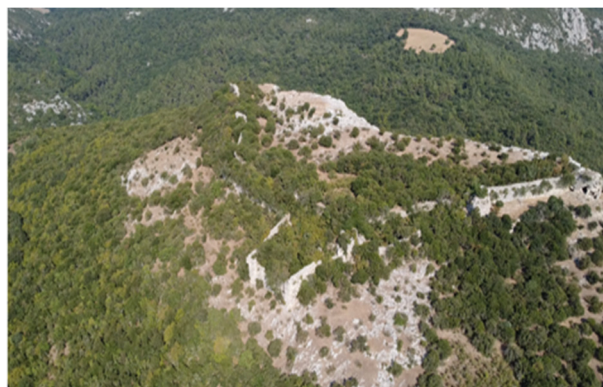
Fig. 1 General view of the structure.

architecture in the Middle Ages [1, 2]. The masonry walls of these structures, constructed by stacking stones or bricks on top of each other and often joined together with mortar, have been preferred by various civilizations throughout history due to their durability and ease of construction. Numerous similar structures were also built in northwestern Anatolia during the same centuries. With its geographical features and geological structure, Balıkesir occupies a privileged position in northwestern Anatolia. It is located at the intersection of the north-south road connecting the Aegean and Marmara seas and the east-west road network [3-6]. One of the medieval castles built to secure these roads, which were used for military and commercial purposes, and to protect settlements is located in the Kadıköy neighborhood of Balya district. Researchers note that the structure was also used during the Hellenistic and Roman periods, but that it is mostly associated with Byzantine remains [3, 4]. The structure is fortified with double rows of walls on the southwest and west sides. The walls extending from west to north are built in a broken line with multiple corners due to the topography of the hill (Fig 1).

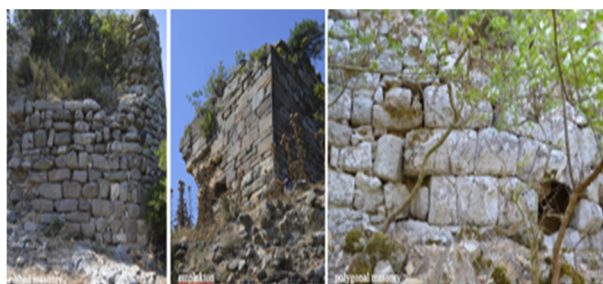
Fig. 2 Types of masonry walls.

The walls were constructed using a double-layered stone masonry filled with rubble stone and mortar. In this type of wall, the wall has two surfaces, inner and outer, with the inner surface filled with rubble mortar; the inner and outer surfaces are made of cut stone or rough-hewn stone; the spaces between the surfaces (walls) are filled with rubble mortar [7]. The strength of the wall is ensured by the filling, which consists of a large amount of rubble stone mixed with lime-based mortar. The south-southwest towers and inner walls of the castle, which have survived to the present day while retaining their original layout, have largely preserved their outer walls. Upon examination of these sections, it was observed that three types of wall masonry were used in the structure. The two towers located in the south and southwest of the castle and the wall between them feature “ribbed masonry,” which is known to have become widespread in Anatolia during the Hellenistic

period [8]. Vitruvius defines this type of masonry as Greek-style masonry, or “emplekton” [9]. The “polygonal masonry” seen in the northern section of the inner wall line turns into “opus quadratum” towards the west. The “irregular masonry” found especially in the northern section is the third most common type of masonry (Fig 2). With the widespread use of lime mortar, which is a mixture of roughly slaked lime, sand, and water, the use of regular blocks in walls became unnecessary, and it was understood that walls could be easily built with irregular stones. The irregular wall masonry formed by stacking multi-sided stones with mortar is called “Opus incertum” [10, 11].
