Strengthening and Restoration of Historical Structures— Mirahor Ilyas Beg Mosque in Korça*

The Mirahor Ilyas Beg Mosque, built in 1496 in Korça, is one of a few Ottoman mosques still existing in Albania and the only Ottoman monument in the city. The mosque was built using cut stone and brick. It has a strong image; a cubic mass rising over a square plan. Inside there are found pictures of the mosque in the past and different famous mosques. During its existence, it was damaged from many earthquakes occurring at this area. Due to amortization, the mosque's structural properties were weakened and architectural values were dimmed. Proper strengthening methods need to be applied, not only to improve structural conditions, but also to preserve architectural features of the mosque. In this paper assessment of existing conditions of the structure is carried out. Based on the obtained results, solutions for the structural problems are investigated. As for restoration, the repair methods to be applied were examined taking into consideration at what extent the historical values of the building will be preserved. The proposed strengthening methods are the ones which would affect the least th

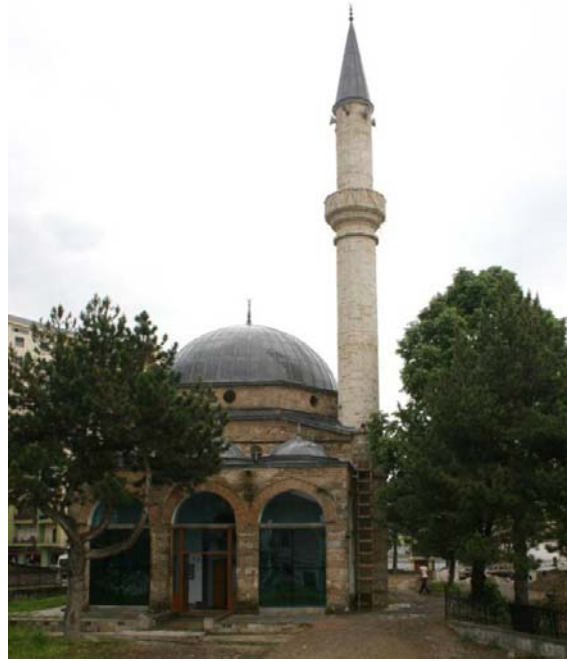
Figure 1. Mirahor Ilyas Beg Mosque in Korça.

The Mirahor Ilyas Beg Mosque, built in 1496 in Korça, is one of a few Ottoman mosques still existing in Albania and the only Ottoman monument in the city of Korça (see Figure 1), it is located near the city center.

From the documents in the archives, it is seen that the used timber in the mosque is original. For this reason it has great values and is to be conserved. The damaged varnish and paste layers above the entrance gate (see Figure 1), will be cleaned. Areas where there are mass losses will be filled with the same type of timber. Then, all timber elements will be varnished with a water based timber protection layer.
