Guy Structure with Galvanic Corrosion: Case Study

Abstract: Reinforcement bar corrosion depends heavily on environment and the processes used. This study will address galvanic corrosion. Based on a case study of galvanic corrosion in a guyed power transmission tower, experiments using a number of methods were made on a small sample of eight poles chosen for excavation and visual inspection, to assess the various resulting diagnoses. Method that provided the best results both in location and classification of the points was adopted, where corrosion had already begun, considering the concern of finding a non-evasive process. To diagnose the status of the poles inserted in rock, after applying the methods, the main types of corrosion affecting them were listed and classified. With the results, the possible means of preventing and maintaining the structure were presented.

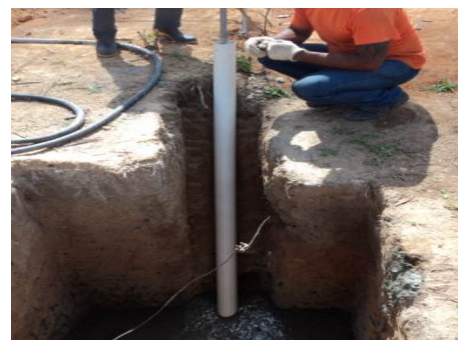
The pole was inserted directly into a rock where it exists to a depth of 1.80 m, limiting the use of the PVC pipe only to the part of the pole outside the consolidated material, as shown in Figs. 1 and 2. Plastic spacers were used to ensure the coating of the bar with cement paste. With such care it was intended to ensure perfect separation of the metal element from the ground, and therefore, to prevent installation of the corrosion process, worsened in this project by using counterweight wires in copper-coated steel, inserted in the same electrolytic medium and connected to the poles at a point above ground. Considering the two failures of poles due to galvanic corrosion, the guaranteed insulation of their coating was stopped and hence the need for inspections.

Fig. 1 Pole encased in a PVC pipe.

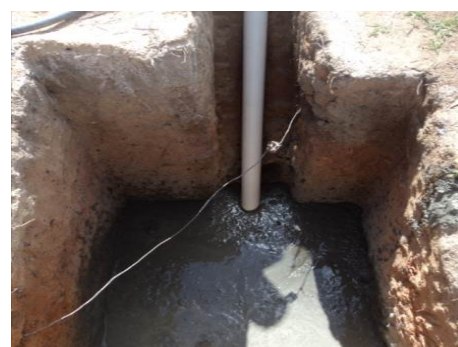
Fig. 2 Detail for application of the PVC pipe.

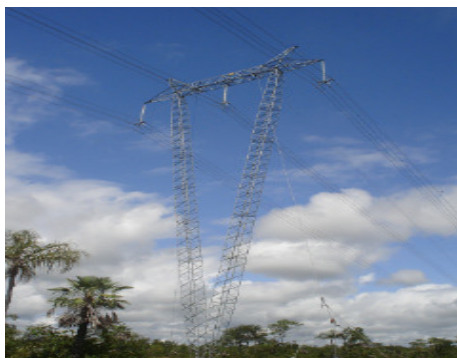
When metal lattice structures are used consisting of galvanised steel profiles, normally the conservation status of the lattice is followed up with periodic visual inspections. In the overhead part of the structures, inspections and corrections of any abnormalities are relatively easy. On the other hand, inspections of underground parts are not so simple, since they require further measures to ensure stability of the structures during the excavation process. When damage caused to a foundation is detected, it generally implies their substitution. In the Teresina II~Sobral III and Sobral III~Fortaleza II power lines, both energised at 500 KV, typical guyed structures type VX6 were implemented, with four guys each as shown in Fig. 3. Caisson foundations and

Fig. 3 Guyed tower VX6.

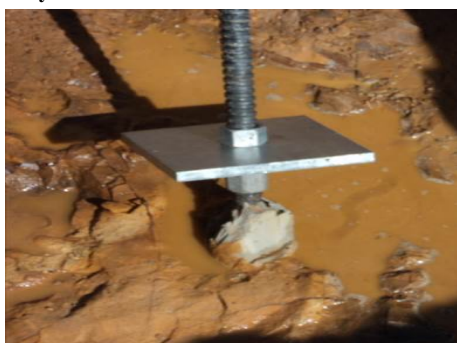
rock-anchored foundations were used as traction supports. The caisson solution comprises unreinforced concrete elements moulded in-situ in the shape of a truncated cone, to which the anchors are fixed as shown in Fig. 4. The rock anchor solution consists of fixing the anchors directly to the solid rock. These guys are fixed to the ground using galvanised steel poles encased in a PVC pipe, filled with cement paste throughout. Plastic spacers were used to ensure that the bar is covered with cement paste. This care was designed to ensure that the metal element was perfectly

Fig. 4 Anchoring the guy pole.
