The Basilica of Santa Maria di Collemaggio in L'Aquila: Modern Provisional Measures

Sabatino Cecchini and Francesca Curotti

Abstract: The case in analysis is Santa Maria di Collemaggio, the church symbol of the town of L'Aquila and the most important example of Romanesque style in Abruzzi, tragically damaged by the earthquake in 2009. The following paper starts with an accurate analysis of the Basilica, whose historical, stylistical cultural characteristics make it an unicum in the whole urban environment. The authors tried to identify in which way these values have been compromised or altered after the earthquake through several analysis (surveys, historical researches etc.) aiming at the recognition of collapses, the cracks profile, the structural transformations caused by the provisional measures: the goal is to provide a kind of Basilica "cognitive manual" that will be useful for the future interventions. This first analysis allowed to understand many aspects: on the one hand, the constructive phases and which damages were caused by past careless interventions of restoration, drawing attention to the vulnerability elements of the Basilica; on the other hand, the innovative te

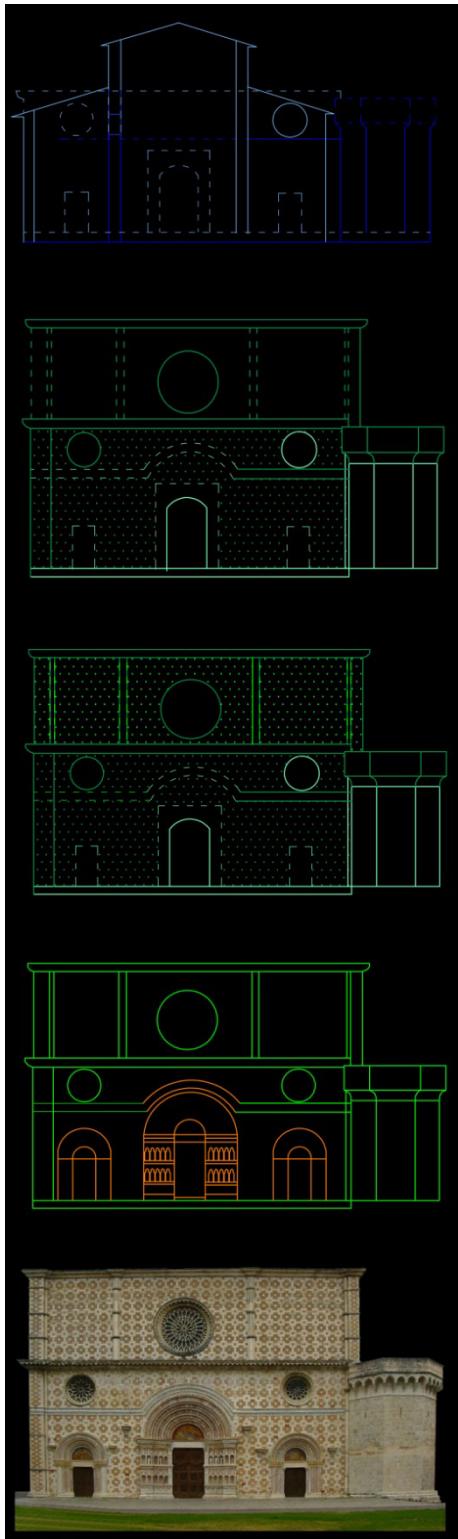
Indeed, the modifications of 20 century were, in a paradoxical way, the most important of all time, after the 1st World War the left corner of the façade was rebuilt (1920) and it was reinforced by a ferroconcrete frame inserted inside brick buttresses placed in the reverse side of the façade, other buttresses were added in correspondence of the longitudinal wall of the aisles: thanks to this intervention (very invasive but efficacious) the façade did not register huge damages after the last earthquake, because that contributed to anchor it with the main body of the building.

Fig. 4 The constructive phases of the façade.

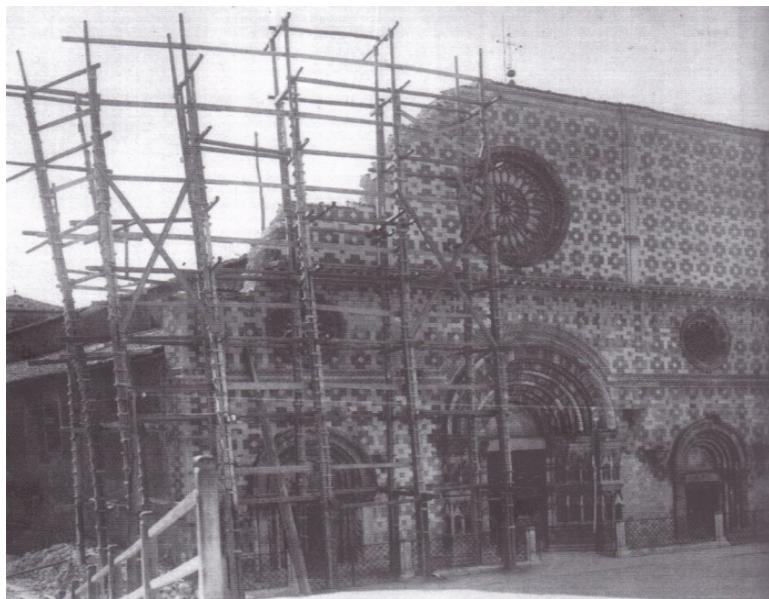
Fig. 11 Restoration of 1920s: disassembly of the left corner of the façade.
