# Renovation of the Centennial Hall

**Abstract:** The Centennial Hall was designed as a monumental building entirely of reinforced concrete. Soon it became a model for modernist buildings of that era. During the years 2009-2011, the biggest renovation since its completion took place. All activities described in the following paper aimed to put the Centennial Hall into good repair and adjust it to the applicable requirements of modern public buildings. The primary aim is to preserve the authenticity of the original materials used in construction through the use of remedial technologies, thereby maintaining the historical integrity of the building.

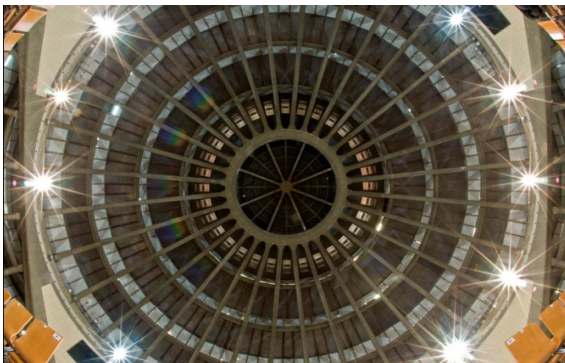
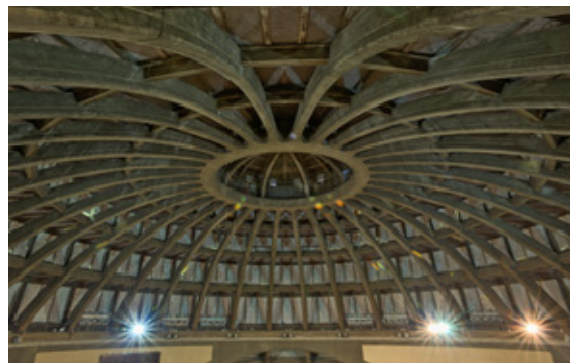
(2) A ribbed dome 23 m high and spanning 65 m (Fig. 1) consisting of 32 arched ribs, crowned by a compression ring resting on a main extended ring at

Fig. 1 Ribbed dome of the Centennial Hall.

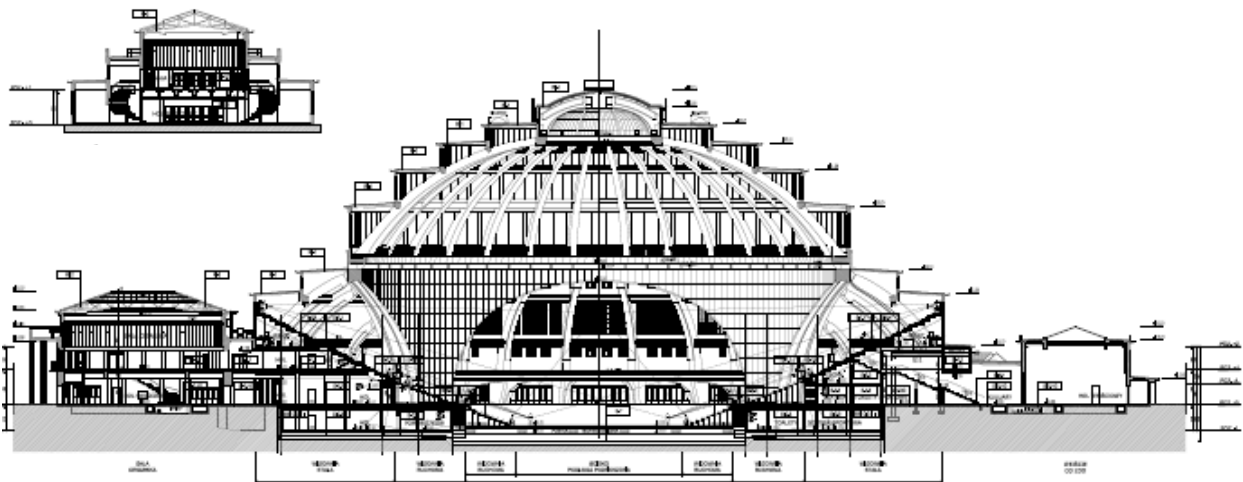
(3) The substructure of the dome was solved in an original way. The essential element of the substructure is a cylinder (Fig. 2), 65 m inner diameter and with a wall of varying thickness (at the foundation approximately 5 m and at the level of the bearings 2 m). Openings were cut in the walls of the cylinder. At the bottom, four arches were cut, each 41 m wide at the base and 16.7 m high. As a result, four arches embedded in massive blocks (pillars of the foundations), remained from the cylinder. The arches of the arcades are double-curved. When burdened by vertical forces from the bearings, they are subject to significant torsional forces. In order to eliminate torsion within the arcs of the arcades, each arcade was supported by six apsidal ribs;

Fig. 2 Technical drawing of the Centennial Hall, cross-section [7].
