Impact of Deterioration of Flare of an Offshore Oil Platform

2.1 Inspection of Corrosion, Cracks and Fissures in Flare System on Offshore Platform (FPSO)

2.2 Case Study Involving Corrosion Problems and Failures in a Flare of an FPSO

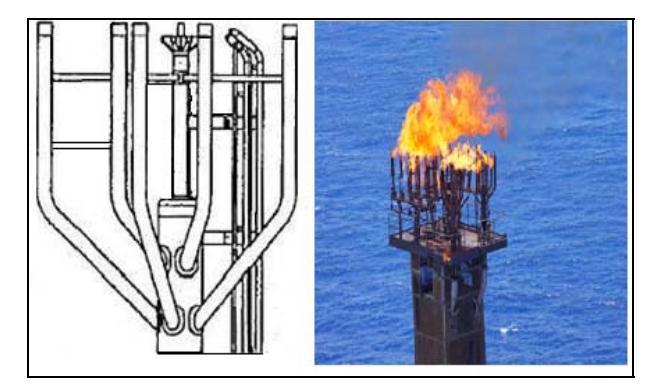
Fig. 2 Top of a flare of an offshore platform.

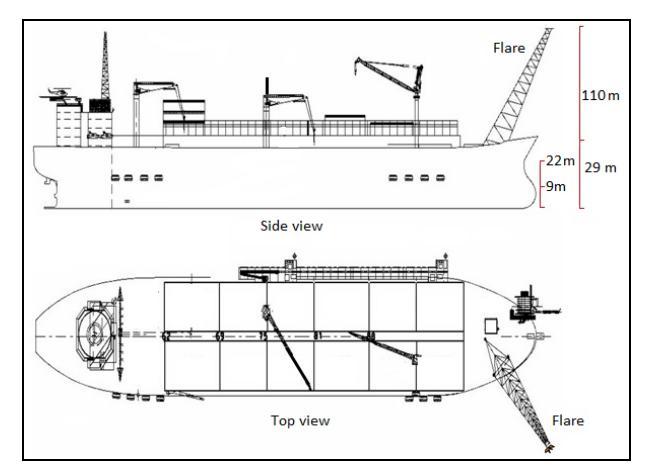
The flare is located on the bow of the FPSO platform. Fig. 3 shows the side view and top of the platform, indicating that the distance from the floor of the boat to the flare top is of 110 m, and the distance

Fig. 3 FPSO scheme with location of flare.

to the seawater surface is 29 m. When the platform deck is empty, i.e. without oil storage or little oil, the level is 9 m, and when on maximum load the level is 22 m.

It is important to note that based on the location of the flare (Fig. 3), due to its height and high temperatures, any maintenance is very complex. It is essential that the platform be stopped, the equipment switched off and inerted, ensuring security for any approach and execution of any services.

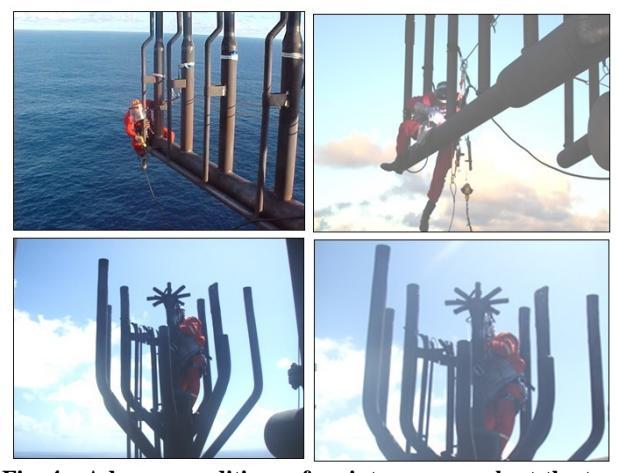
Fig. 4 Adverse conditions of maintenance work at the top of the flare

Fig. 4 shows the complexity of the equipment inspection activity and small emergency repairs undertaken by professionals in the flare, considering the height and environmental conditions that predominate such as strong wind, rain and solar insolation.

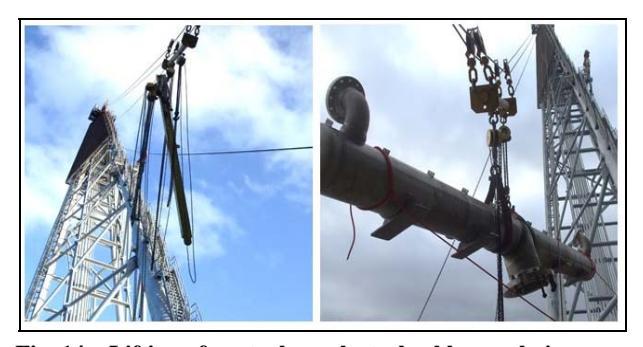
The conditions are also quite adverse for the transportation of parts and pipes that must be replaced after inspection and verification of faults, defects and corrosion. As shown in Figs. 14 and 15, the transport is performed by the lifting of parts through steel cables or chains and by helicopter depending on the wind conditions and load weight. The cost of transport, the time of lost hours and the lost profits as a result of the loss of oil production, can have a significant impact on these operations on the offshore platform.

Fig. 14 Lifting of parts through steel cables or chains.

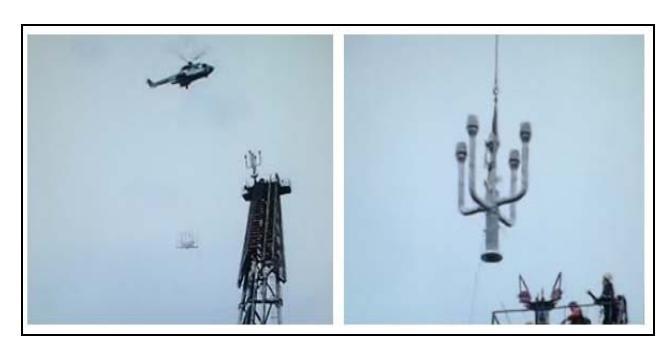
Fig. 15 Transport of parts by helicopter.
