Consequences on the Urban Environment in Greece Related to the Recent Intense Earthquake Activity

George C. Manos

Laboratory of Strength of Materials and Structures, Department of Civil Engineering, Aristotle University, Thessaloniki, Greece

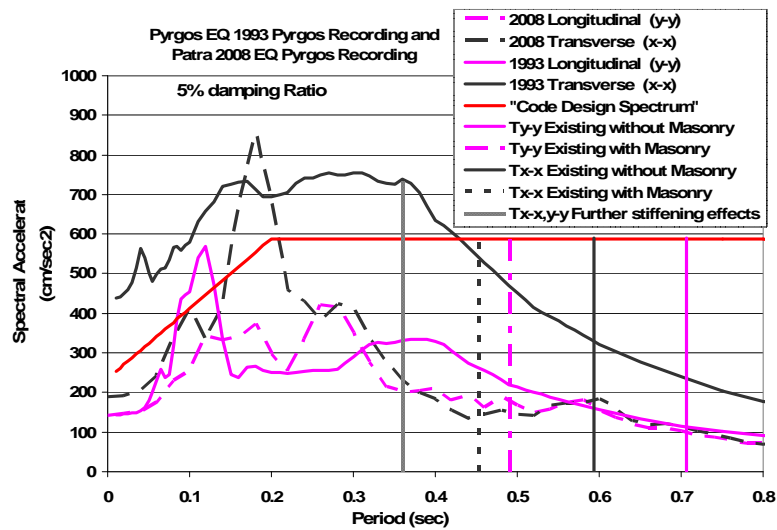
Fig. 21 The spectral characteristics of the ground acceleration recorded at the city of Pyrgos during the 1993 and the 2008 events.

In Fig. 21 the spectral acceleration curves are plotted corresponding to the two horizontal components (longitudinal and transverse) of the ground motion recorded at the city of Pyrgos during the March 1993 main event as well as another event with a magnitude on the Richter scale $M_s = 6.5$ that occurred in June

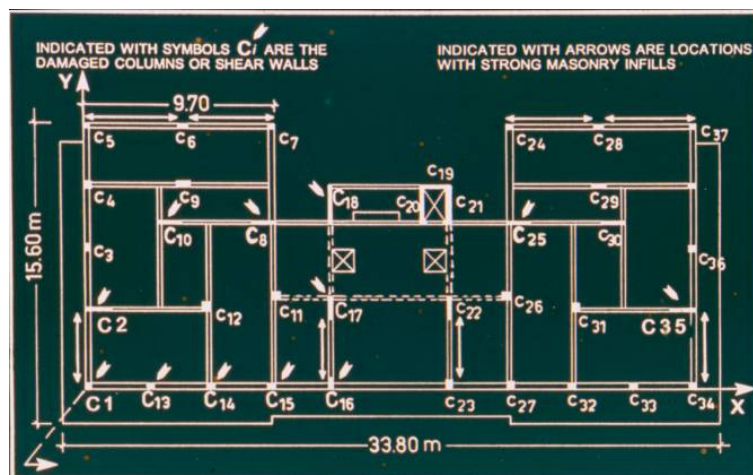
Fig. 23 Plan of the "soft story" of the "Pyrgos Hardas" building.
