Lead and Cadmium Distribution in Tubes of Galvanized Steel by Hot-Dip Used for Drinking Water Supply

Abstract: The main objective of this work was to evaluate the presence of lead and cadmium in galvanized steel tubes by hot-dip used exclusively for drinking water supply. In this research, samples of galvanized tubes were removed from walls of residential buildings with 30 years of use. In the process of hot galvanizing, the manufacturing standards allow or for low cost conveniences, and the use of primary zinc ingot with 1.6% metallic impurities, such as lead and cadmium, is allowed, enabling the incorporation of these metals into the zinc coating deposited on the carbon steel. The associated corrosion of these tubes can release these toxic metals, contaminating the drinking water used by residents. The samples taken from the tubes were evaluated by a square-wave anodic stripping voltammetry technique, and the results for lead and cadmium suggested randomly distributed levels, indicating that the contents of these contaminants depend mainly on the quality of the added primary zinc and the operational conditions of the immersion bath. The metallographic evaluations performed on th

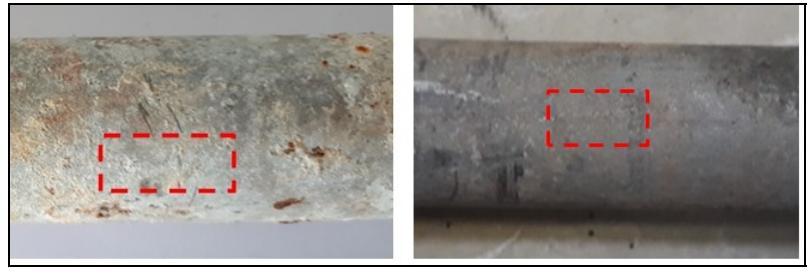
The selected tubes were washed with water and a plastic sponge, degreased with acetone and ethanol, and dried with hot air. An area of 2.5 cm² was fixed to the surface of the tube (Fig. 6), and with a high hardness scraper, filings of the galvanized zinc coating were obtained. All samples were taken from the outside of the tubes, avoiding the corroded areas.

Fig. 6 The scraping area for galvanized zinc samples is shown (highlighted with red boxes).

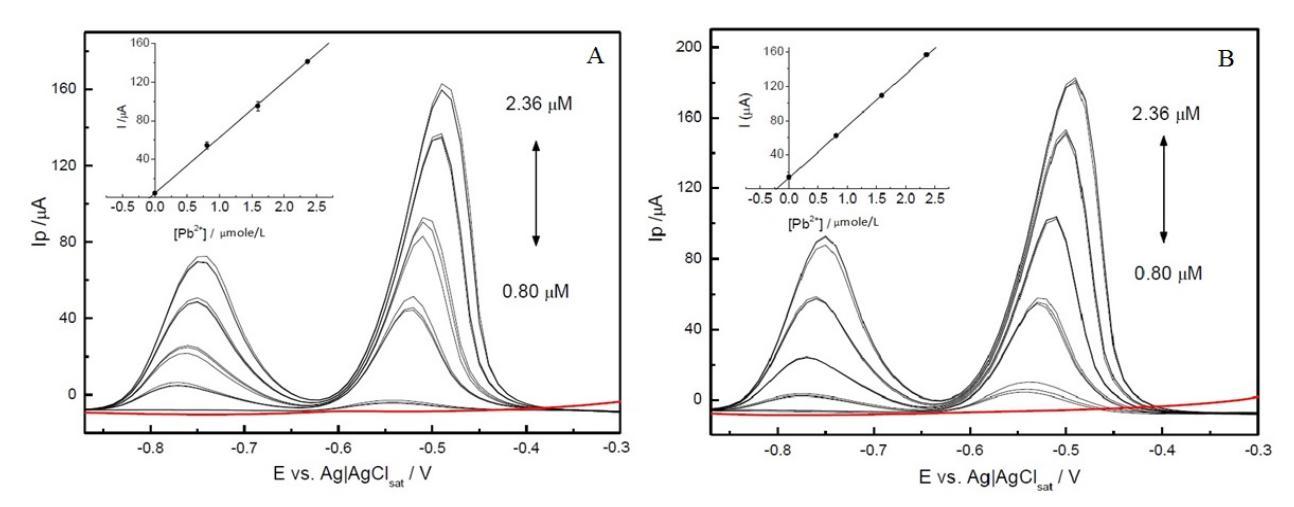
The voltammograms shown in Fig. 7 represent the lead analysis for the two samples that were above the detection limit. The red line represents the average pattern obtained from successive measurements of the electrolyte. The results of the curves show that the additions were satisfactory in linearity, indicating that the prepared electrode is compatible with the determination of Pb^{2+} and Cd^{2+} in the samples removed from the galvanized tubes. Thus, the lead values found in samples A and B are shown in Table 3.

Fig. 7 Voltammograms obtained from standard addition stripping electroanalysis for samples A and B, respectively.
