Study and Evaluation of Advanced TOFD Method for Inspection of Polyethylene Pipes but Welding

Abstract: Polyethylene material has some specification that makes very difficult any kind of inspection based on ultrasonic. The acoustic impedance and sound velocity in this kind of material are near to the materials commonly used in ultrasonic wedges. Also this kind of materials are highly attenuative materials for ultrasound. To inspection of polyethylene circumferential but welds and overcome to all the problems mentioned, the especial technique of TOFD (Time of Flight Diffraction) method which employs low frequency probe and concentrate on the inspection area that longitudinal waves turn into transverse waves has been used. The purpose of inspection is determining the exact location of surface and internal welding defects. For this purpose, two separate polyethylene pipes with 10 inch in diameter, 15 mm thickness and also 25 inch diameter, 28 mm thickness, were selected. In total 40 artificial defects which involve 28 side drill holes in deferent depths and 12 surface and sub-surface notches were created. All artificially created defects were detected with very good accuracy. Unlike

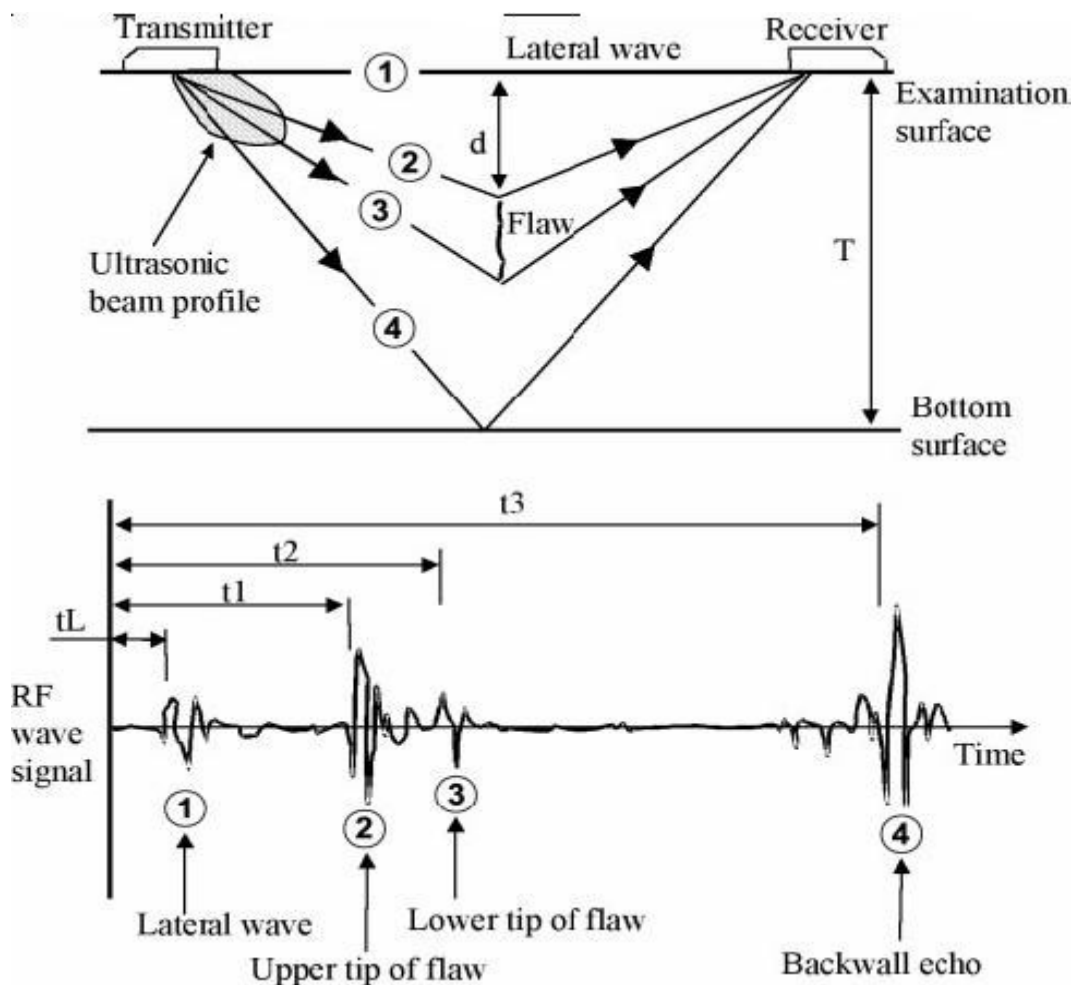
Fig. 1 Schematic of TOFD method represents A-Scan signals.

Typically the TOFD inspection technique is concentrated in an area between the waves from the surface (Lateral Wave) and from back wall (Back wall echo) in steel materials [6]. Fig. 1 shows an overview of the TOFD technique.

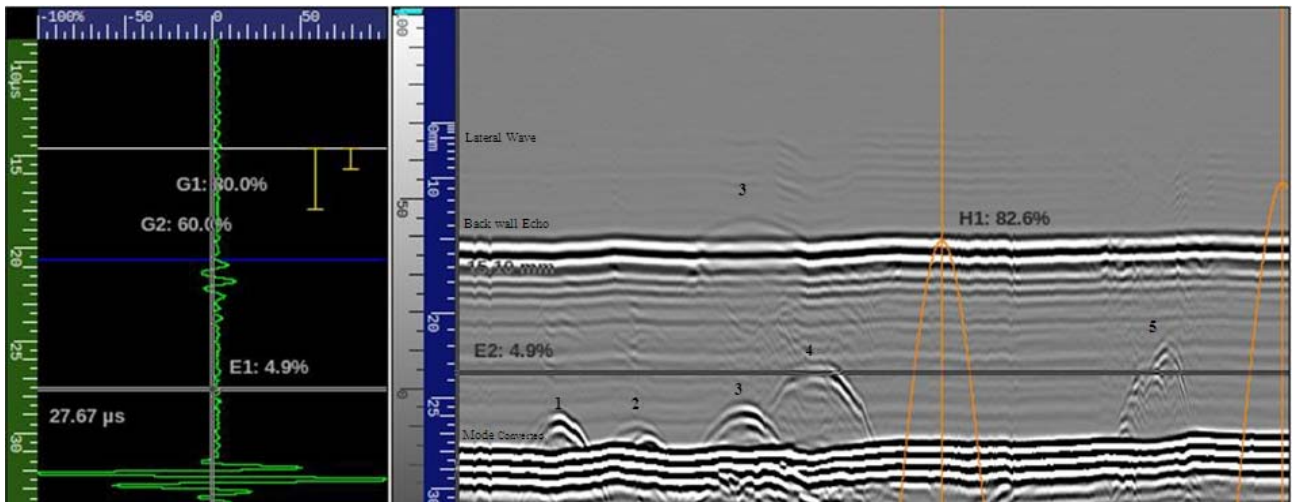
Fig. 2 Scan of artificial defects from 1 to 5 involve five notches.

In the case of 10 inch pipe with 15 mm thickness, 16 side drilled hole with different depth and also 5 notches in upper surface and lower surface were created. Fig. 2 is scan of artificial defects from 1 to 5 which involve notches on upper and lower surface of specimen.

All five notches are well recognize in mode conversion area but the defect 3 which is groove in inner surface of the sample is detectable in the main area between lateral and close to the back wall.

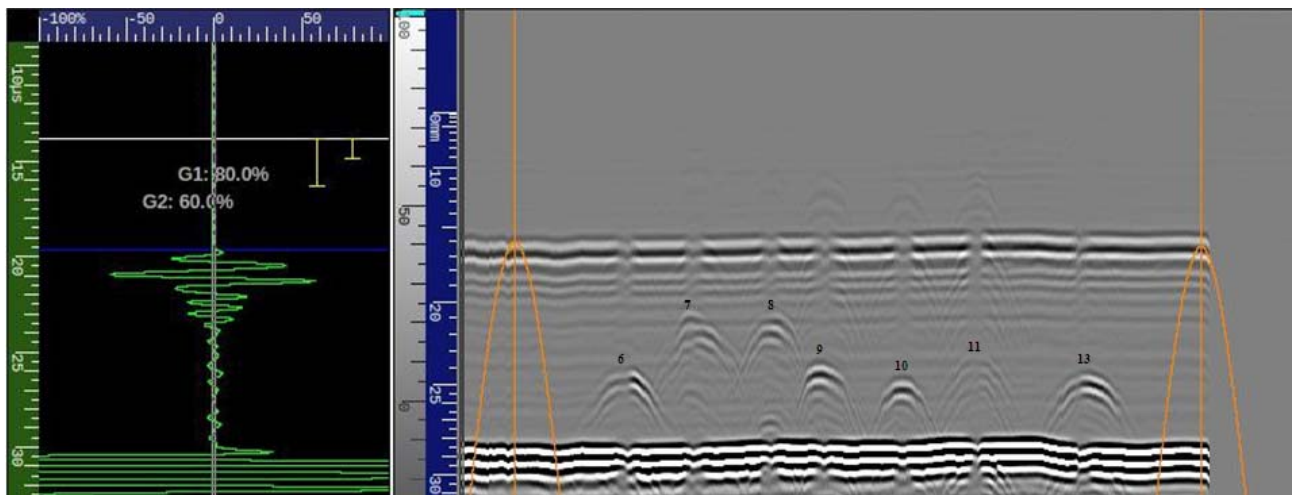
Fig. 3 Scan of artificial defects from 7 to 15, including nine side drilled holes.

Fig. 3 is a scan of defects from 7 to 15, including the side drilled holes with depths in the range of 2 to 14 mms. The defects 12, 13 and 14, 15 are holes in a same

position with different depths.

In this case, it can be seen that from 9 side drilled hole only 7 holes are visible. It shows, from two defects at the same position with different depths, one of them is not detectable. For this purpose in the scan file, the energy of the sound increase up to 20 dB shows in Fig. 4.

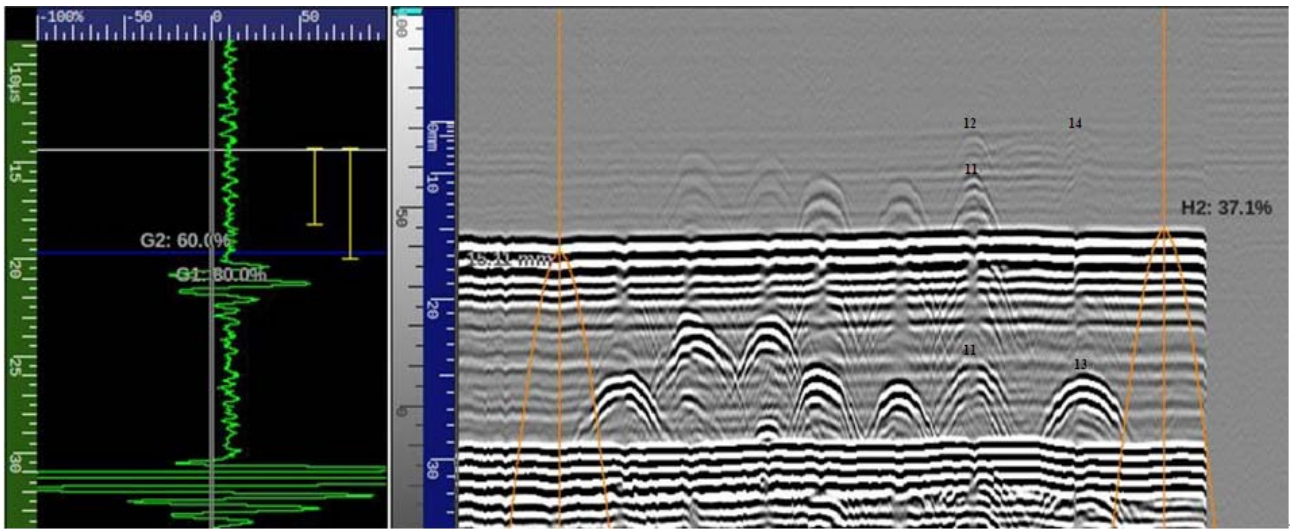
Fig. 4 Scan of artificial defects from 7 to 15 with increasing ultrasound energy up to 20 dB.

As shown in Fig. 4, all artificial defects are detectable in both main area and mode conversion.

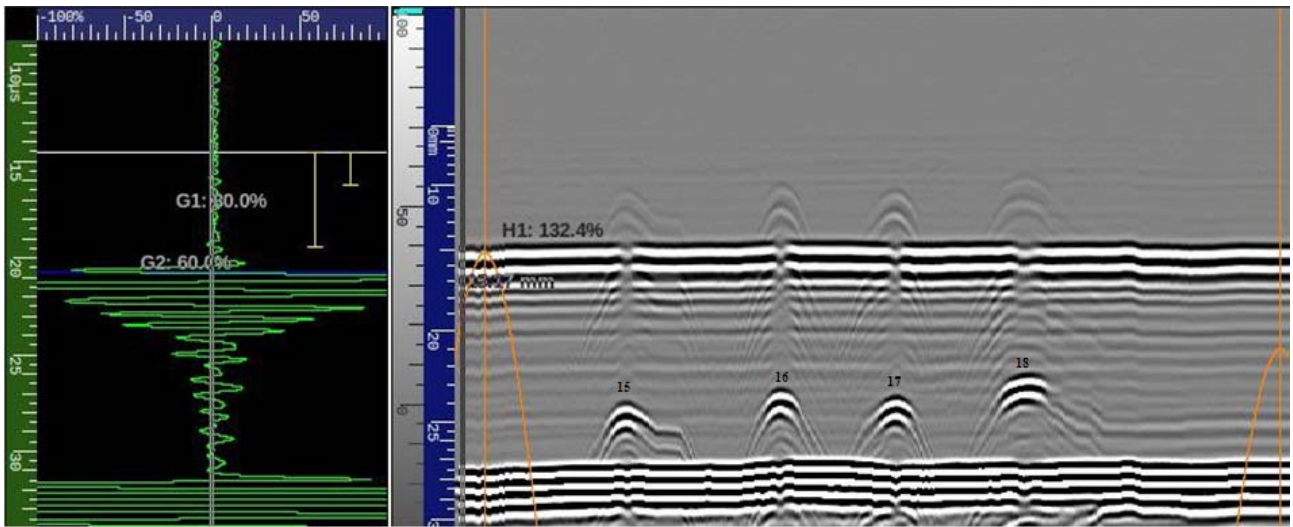
Fig. 5 Scan of artificial defects from 16 to 19 involve four side drilled holes.

Fig. 5 is a scan of defects from 16 to 19 which are side drilled holes respectively with depths of 12.5, 10.5, 10.7 and 9 mm. It is obvious that all of these artificial defects are visible in both areas.

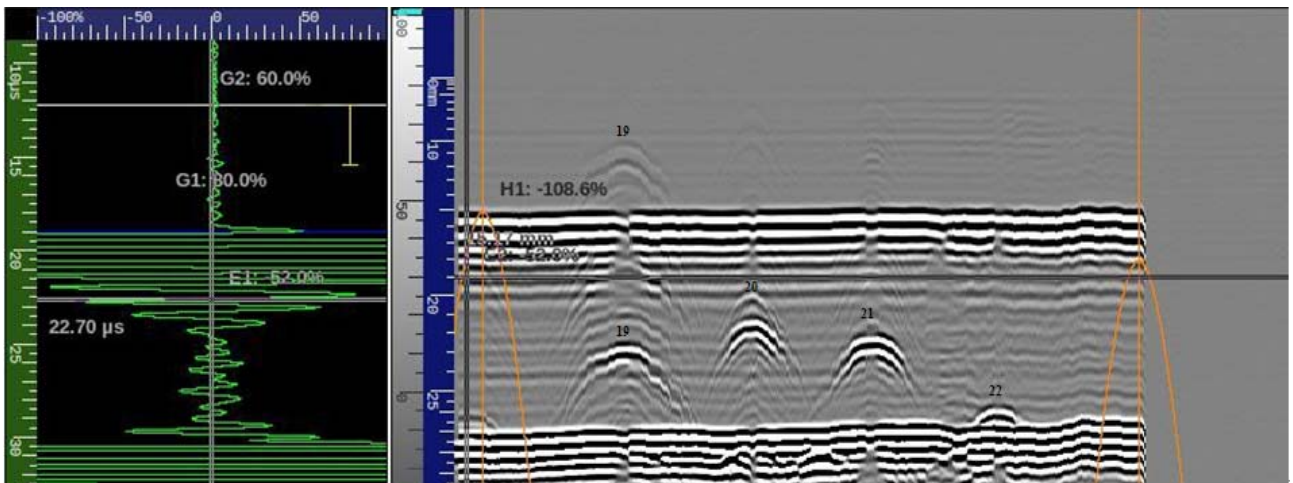
Fig. 6 Scan of artificial defects from 19 to 22 involve four side drilled holes.

Fig.6 shows the scan of defects 19 to 22 which are side drilled holes respectively with depths of 9, 7, 4,

and 1 mm. All of artificial defects are detectable in both of inspection area.

The important point of this scan is, the defect number 22 is the side drilled hole with 1 mm depth from upper surface of sample. It is well detected in mode conversion area. Normally this kind of surface indications because of dead zone are not detectable in main area between lateral and back wall.

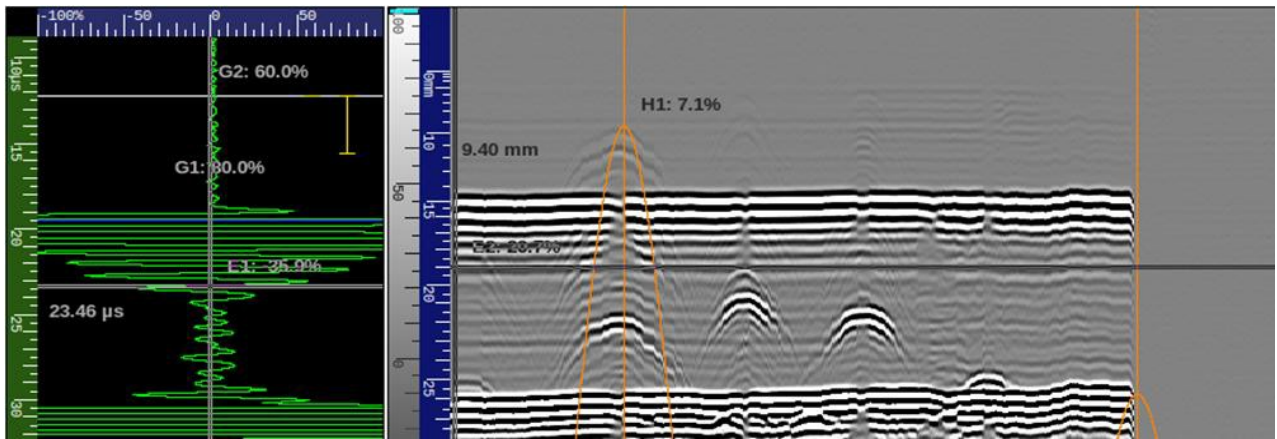
Fig. 7 Depth measuring of indication 19 by TOFD method.

However, in this study the focus is on the detection of defects and not sizing of indications, in Fig. 7 tried to measuring the depth of indication 19 by TOFD method. The real depth of indication is 9 mm.

Fig. 7 shows that the depth of indication in TOFD technique is 9.4 mm. The difference from real depth is only 0.4 mm.

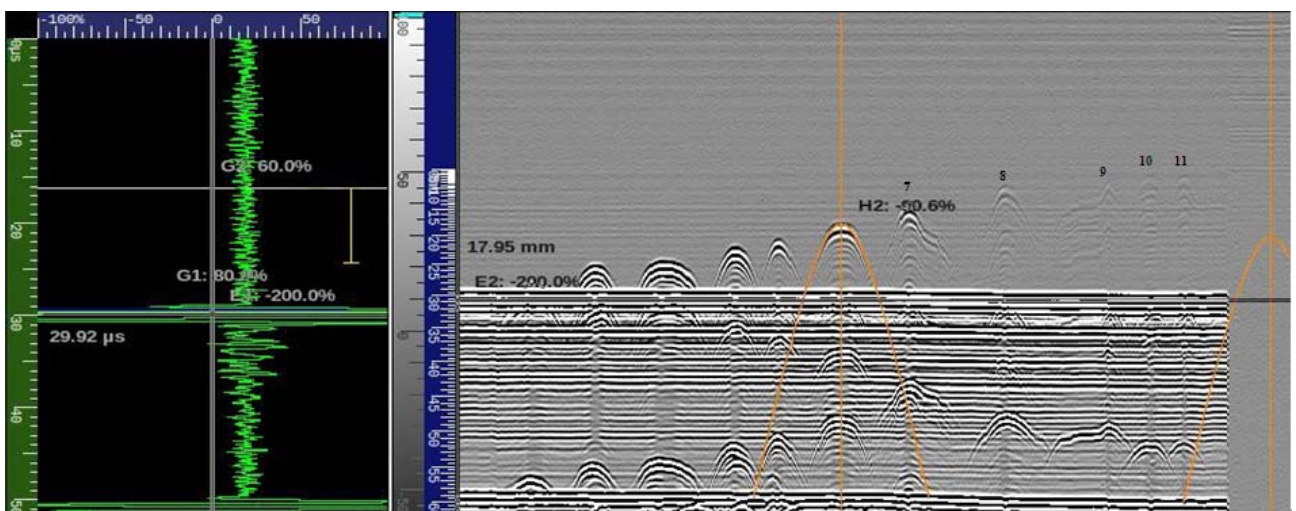
Fig. 9 Scan of artificial defects from first to 11 with increasing ultrasound energy up to 15 dB.

According to the Fig. 9, all artificial defects are detectable in both scan area. Also measuring depth of defect Number 6 with real 17 mm depth is 17.95 mm, so the difference from actual depth is 0.95 mm.

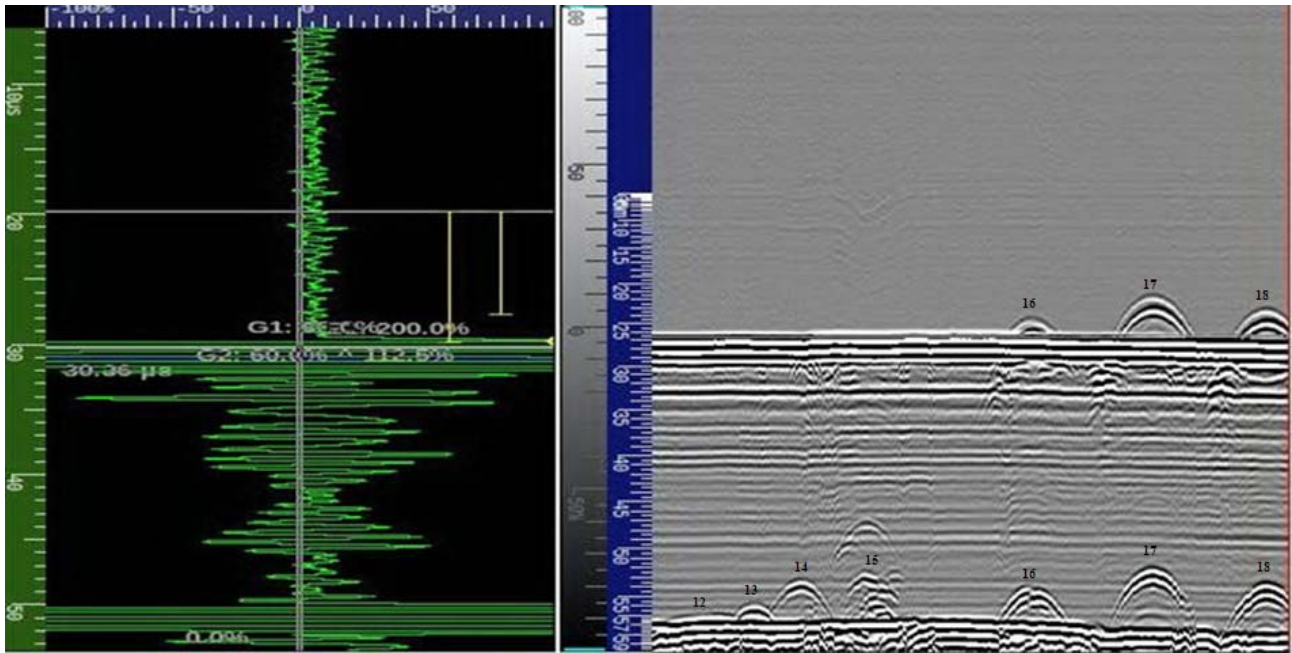
Fig. 10 Scan of artificial defects from 12 to 18 involve seven outer & inner notches.

Fig. 10 shows scan of artificial defects from number 12 to 18 in 25 inch pipe sample.

According to the Fig. 10, all artificial notches are well detectable in mode conversion area. Also, the artificial notches which are near to the inner surface of sample are well detectable in main inspection area between lateral and back wall. The notches near to the outer surface of sample are not detectable in main inspection area between lateral and back wall.
