# Generating a 3D Tool to Represent Graphically the Damages of Santa Barbara Castle (Alicante)

Víctor Echarri, A. B. González Avilés, J. Garabito, M. I. Pérez Millán, A. Priego

*Department of Building Constructions, University of Alicante, University of Burgos, Spain*

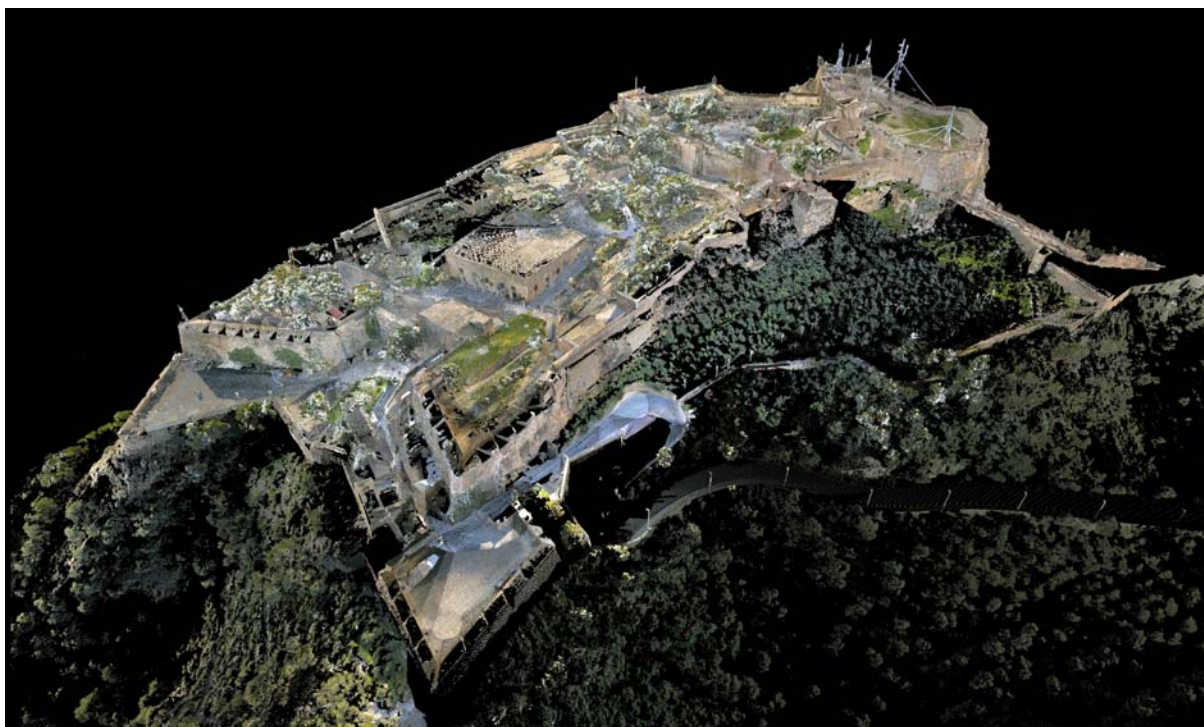
Fig. 1 3D view of the object, Santa Barbara Castle, Alicante.

different shots, getting a 3D object consisting of a point cloud. It is possible to incorporate color to this object, with the limitations of light that incises in each one of the shots, and taking into account that initially it does not apply color to the interstices between points (Fig. 1). The light conditions vary greatly during the scanning process when working outside.

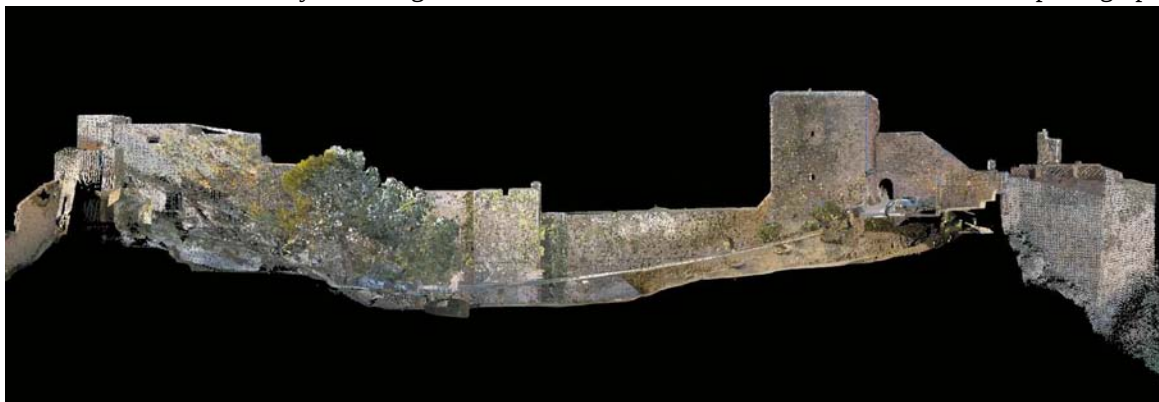
Fig. 2 Front elevation of the castle with the Santa Catalina tower, Muslim style.

This is how it has been done in the present example, Santa Bárbara Castle in Alicante. First of all, it was the planning of the positions in which a priori the laser scanner would be located. Whereas the buildings and walls of the castle are situated in the highest point of Alicante city, we had to deal with this issue very carefully. In some elements, such as coronations of parapets or loopholes, it could not be obtained point clouds. Besides in some of the roofs was not possible to position the laser-scanner because of the security and the accessibility issues. We used a laser scanner Riegl LMS-Z420i for the data collection [8]. The work was done in two phases: in the first phase we took 120 shots and 60 in the second one, because it was required due to the magnitude of the built compound as well as the complexity of its architecture. We did not take shots inside the buildings. The clouds of points in the second phase were treated as described above, generating a cloud of points every 2 cm separated of 700 Mb size. Later we employed the program Pointools View 1.7

Pro to generate plans and general elevations, and plans and elevations of details of the various buildings and architectural elements of the castle (Fig. 2).

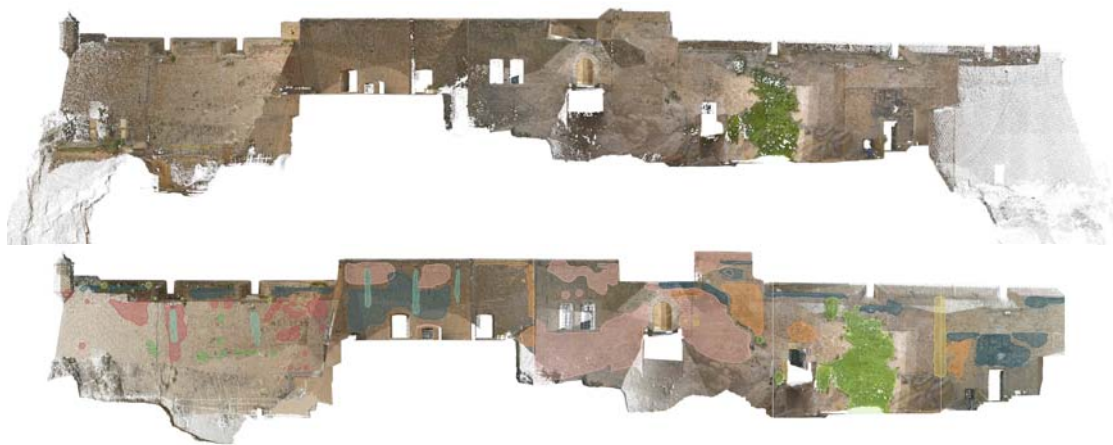
Fig. 4 North-east elevation of Macho del Castle, before and after the graphic representation of pathologies.

Elevation plans were generated in an importable Autocad format through Pointools View 1.7 Pro software. In the process of delineation damages we looked for accuracy -the elevation plan generated

through the 3D object had a great precision, with an average deviation of 10 mm for each facing of 50 m length- and that the information transmitted the reality of the facings. The laser scanner provided a picture close to reality. We thought that when we did the graphic representation of damages, we had to use a technique that respected the reality vision of the stones and mortars while determined the lesions at the same time. To do this pattern types were generated in different colors — one color for each type of lesion — made out of small dots that create transparency. The final aspect of the plans complied with the realism, at the same time that transmitted the information that we wanted to demonstrate and quantify (Fig. 4).
